2015 ANNUAL REPORT

TENNESSEE STATE BUILDING COMMISSION

This Annual Report describes preservation and significant maintenance and management work completed on historic and cultural resources at Andrew Jackson's Hermitage by the Andrew Jackson Foundation (AJF) in calendar year 2015 and proposed work for calendar year 2016. This annual report submission to the State Building Commission (SBC) is required under Tennessee Code Annotated section 4.13.104. The following is a brief description of proposed property acquisition, construction, demolition, alteration, restoration, or preservation works in progress. Projects involving routine maintenance and minor repairs are not included. Projects are listed in order of priority.

Hermitage Mansion

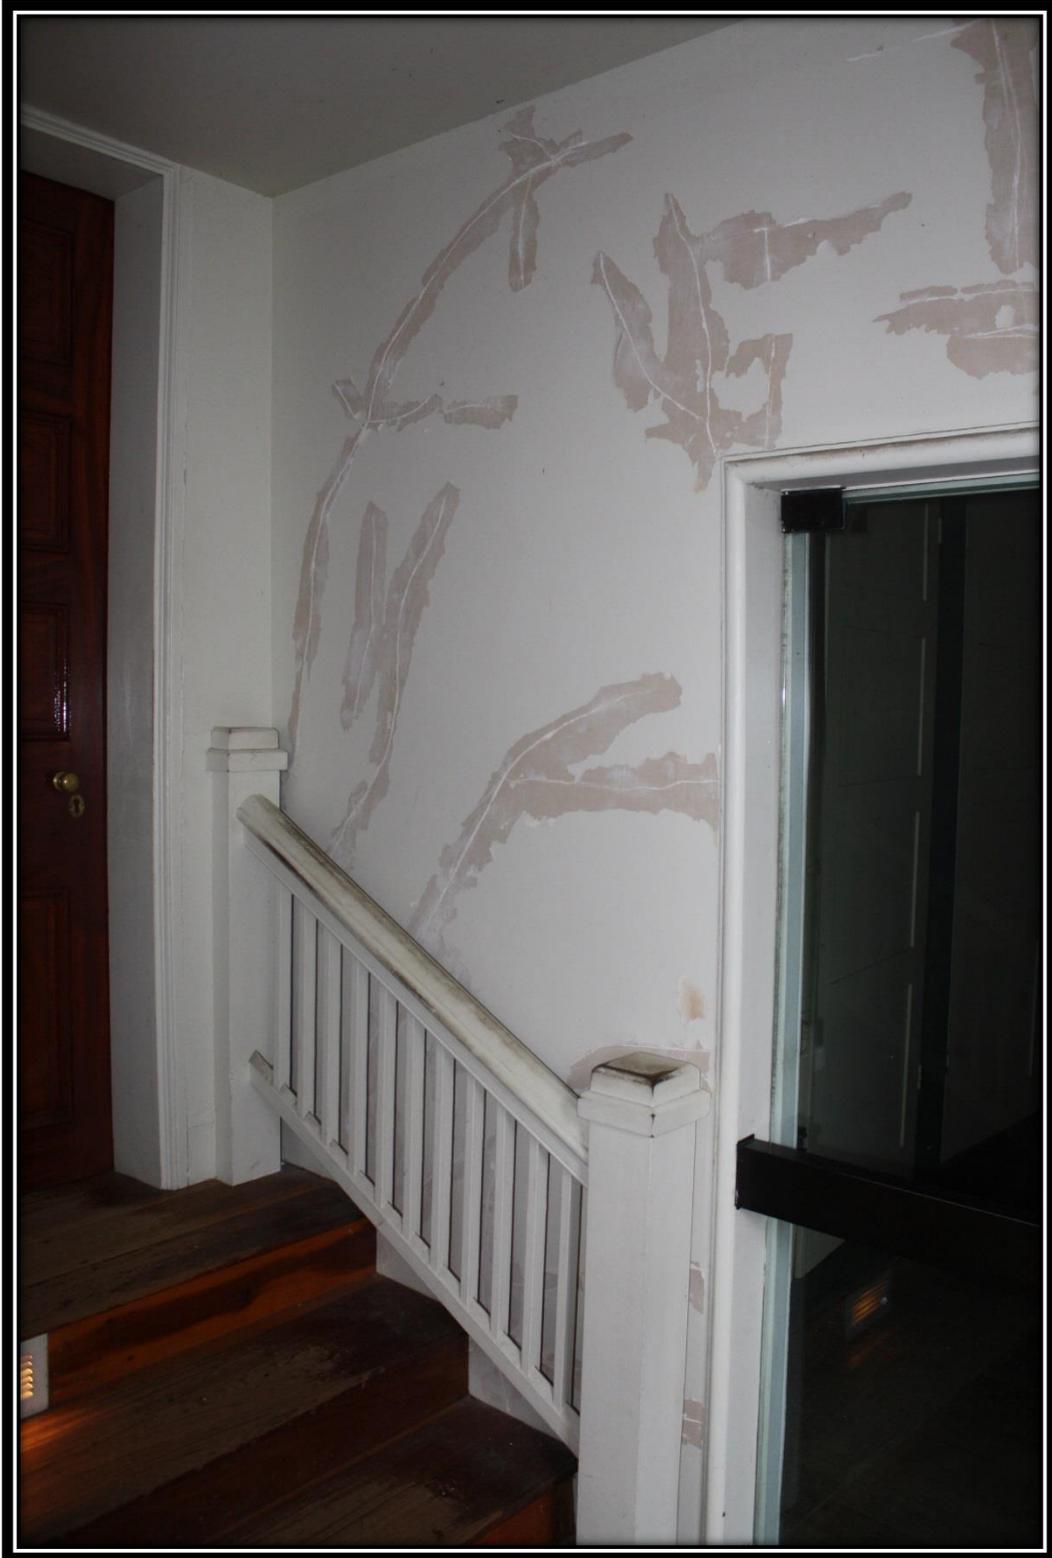
Plaster damage caused by a sprinkler system pipe failure in January 2015.

Because of the estimated \$650,000 cost to replace the Hermitage mansion sprinkler system Hermitage staff prioritized the available \$241,000 in State funds toward the fire detection and security systems. However, staff dedicated a portion of these funds to further analyze the water pressure issues previously reported by engineers and by installation of a nitrogen generator. Please note that the AJF considers the replacement of the fire suppression system as its top capital priority and is actively seeking funding to replace it.

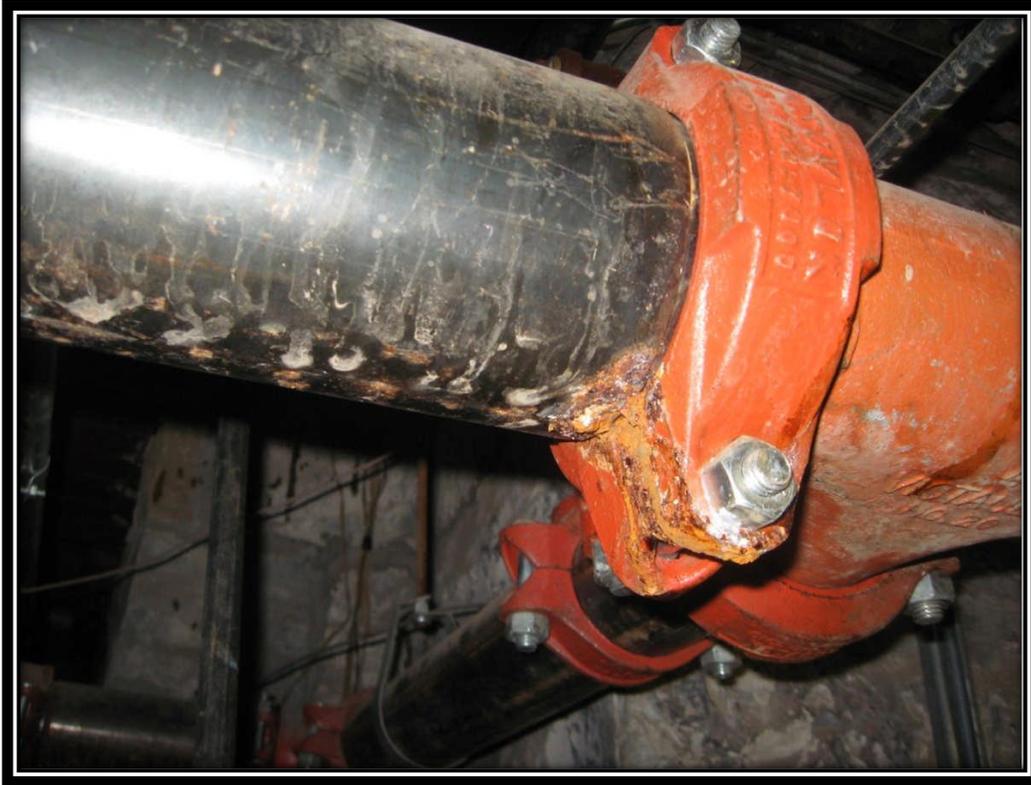
Typical sprinkler pipe corrosion in the Hermitage mansion, May 2013.

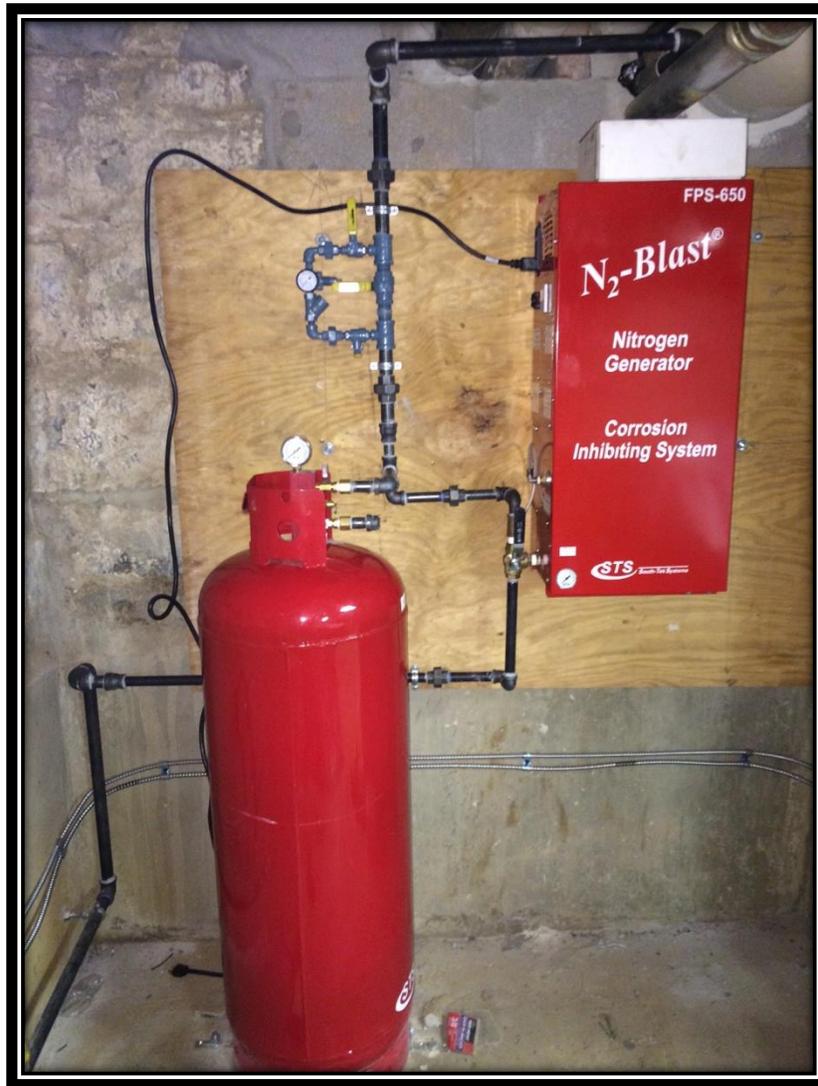
Landmark Facilities Group recommended the installation of a nitrogen generator system to purge oxygen and moisture from the Hermitage mansion sprinkler piping to slow the corrosion in the sprinkler piping system. Landmark sufficiently sized the nitrogen generator system to supply the current piping system with nitrogen and any future dry pipe sprinkler system that might replace the existing. In summer 2015, Century Fire Protection, as a sub-contractor for Beacon Technologies, installed a South Tek Systems N-2 Blast 650 nitrogen generator in the

Hermitage mansion. Since installation, the system has maintained its guaranteed 98% nitrogen purity in the Hermitage mansion sprinkler piping. The total cost for this system was \$24,000.

The nitrogen generator in the Hermitage mansion basement, August 2015.

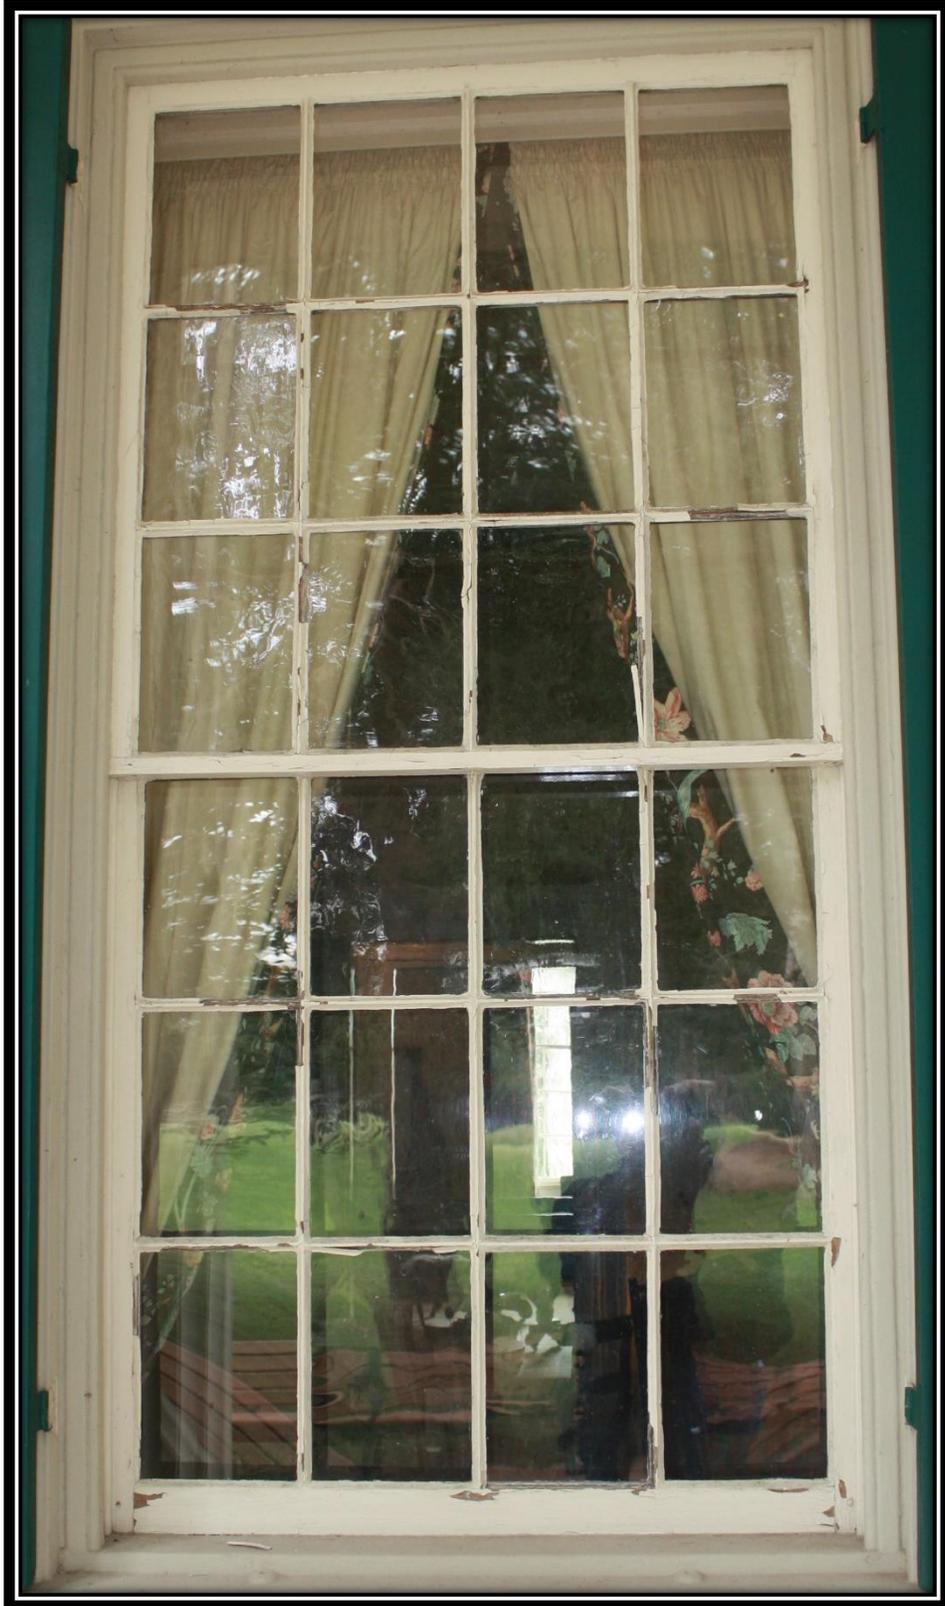
Typical condition of Hermitage mansion windows from the exterior. Note missing and flaking glazing and paint failures, November 2015.

As part of the FY 2016 Budget, the State of Tennessee awarded the AFJ a grant of \$154,000 in to replace the interior storm windows and repair the windows. In August 2015, the Andrew Jackson Foundation engaged preservation architect Joseph K. Oppermann to design the new interior storm windows and repairs to the existing windows. In October 2015, the Andrew Jackson Foundation awarded a contract to Allied Windows of Cincinnati, OH to manufacture and install the new interior storm windows for the Hermitage mansion. Allied will deliver and install the windows in the second quarter of 2016 for a total cost of \$41,000. The AJF is still identifying a qualified company to repair the windows. The AJF hopes to have a qualified contractor in place during the first quarter of 2016. All window work should be complete by the fourth quarter of 2016.

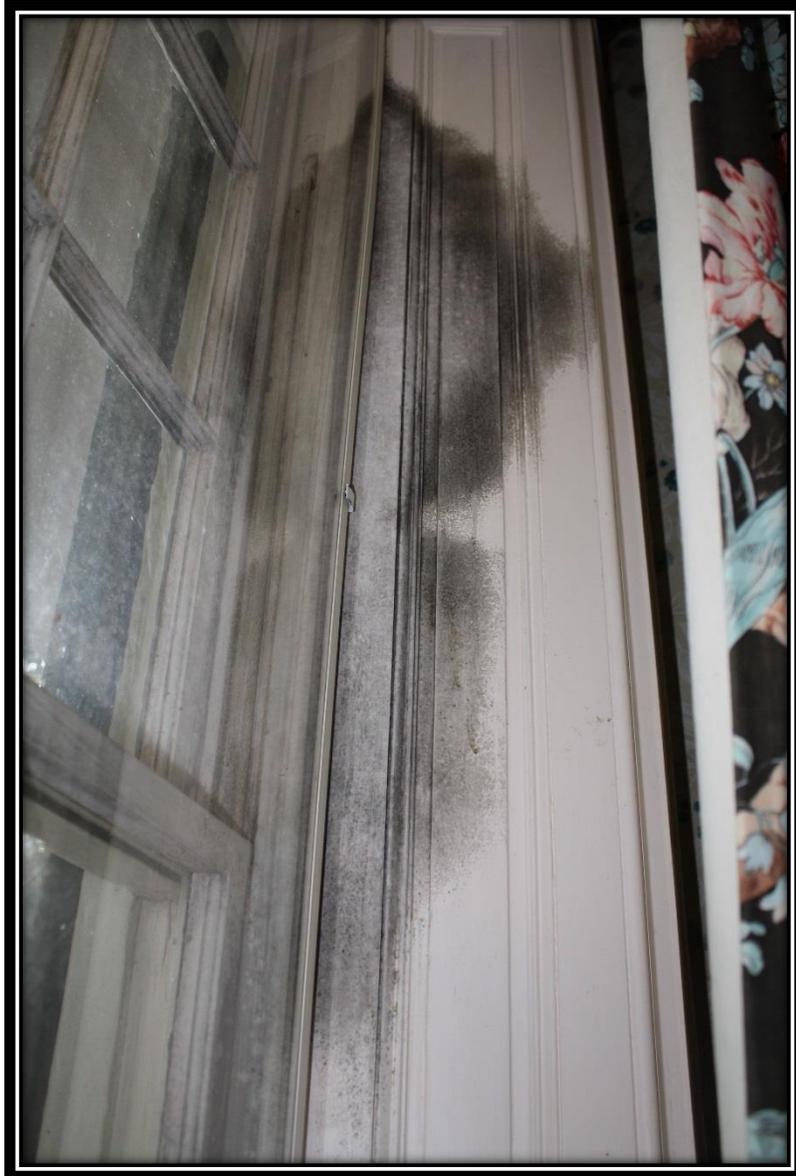
recommended replacing all existing interior storm windows. The existing Plexiglas windows had sagged over time causing the interior windows to pull away from the magnetic anchor strips. Additionally, rust on the metal anchor strips had prevented a tight seal allowing warm moist air into the space between the storm window and the wood window. The preservation architect identified a window system used at Monticello, Thomas Jefferson's Home, that provided for a tight seal, a mechanical not magnetic attachment, and will not damage original material during installation.

Mold cause by failed interior storm windows and voids behind wood trim, November 2015.

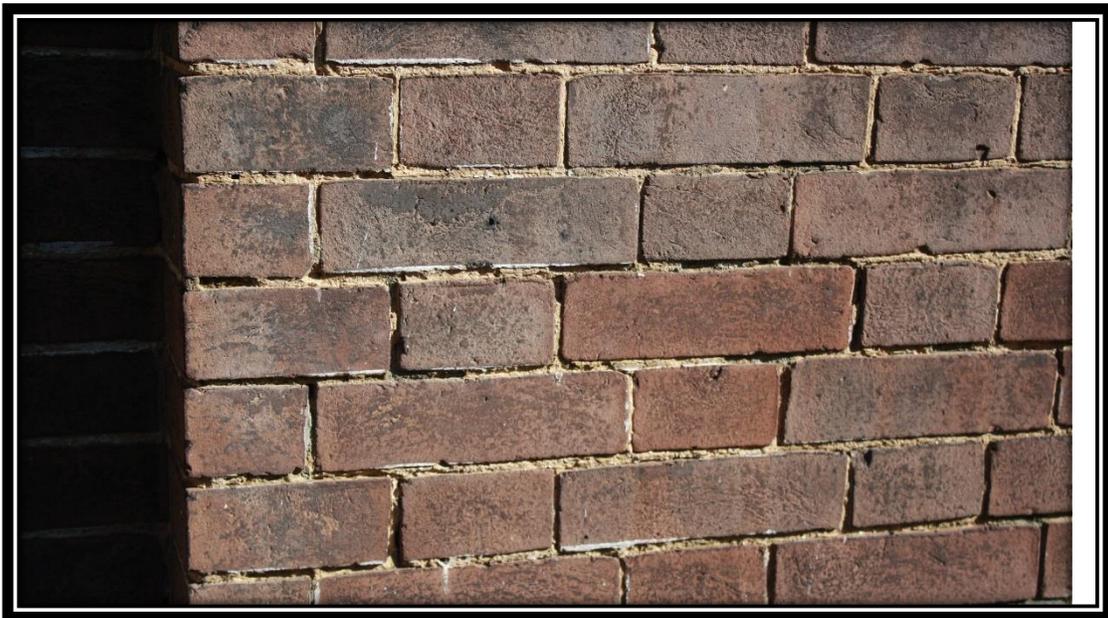
A previous repointing effort at Tulip Grove was not installed deeply enough into the joint. That repointing mortar failed and took off the face of the historic lime sand mortar underneath it. Tulip Grove requires complete repointing on all elevations, December 2015.

Tulip Grove requires significant repairs to ensure the integrity of the building's envelope. This includes completely re-pointing the walls and foundation, gutter, downspout, and site drainage upgrades, replacement/repair of wood trim, re-glazing all windows, and painting. The AJF does not expect to have funds in place to pursue this work in 2016 or beyond. The AJF continues to seek funds to complete an analysis of Tulip Grove's building shell problems by a qualified preservation architect. This analysis will include preparation of measured drawings, a condition report, and an historic structures report. Cost estimates for this work are \$55,000. By taking these steps the AJF will have a firm foundation to begin fundraising for repairs once the legal issues surrounding Tulip Grove are settled.

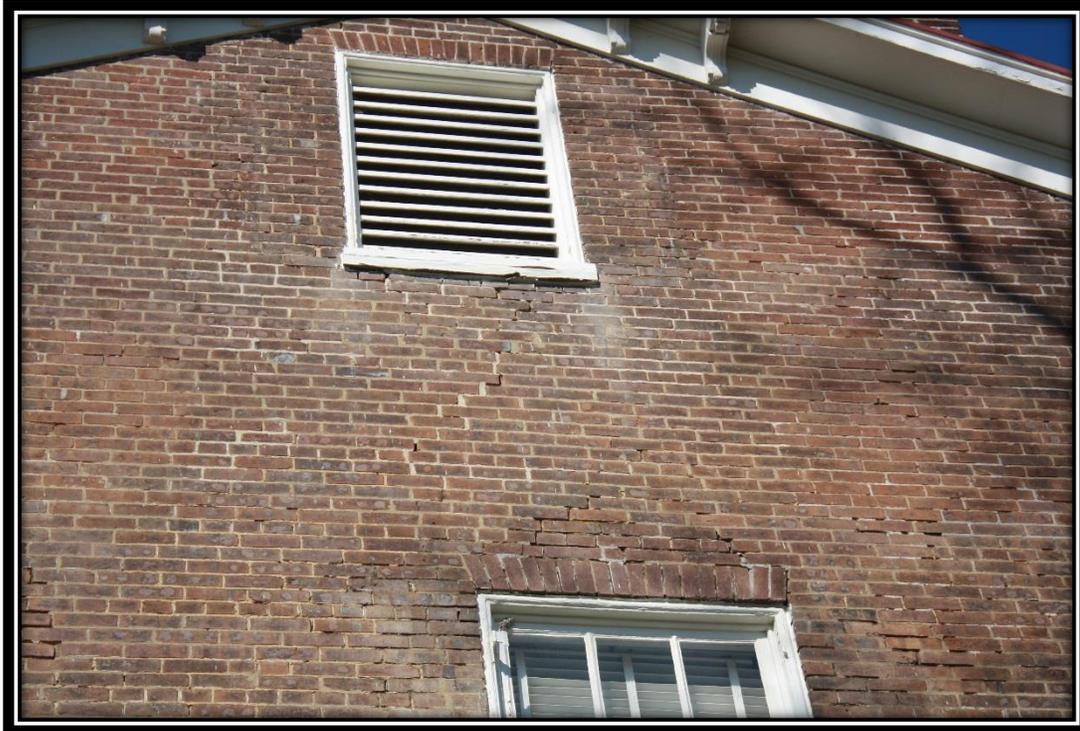
Progress of mortar joint decay on South Elevation, December 2015.

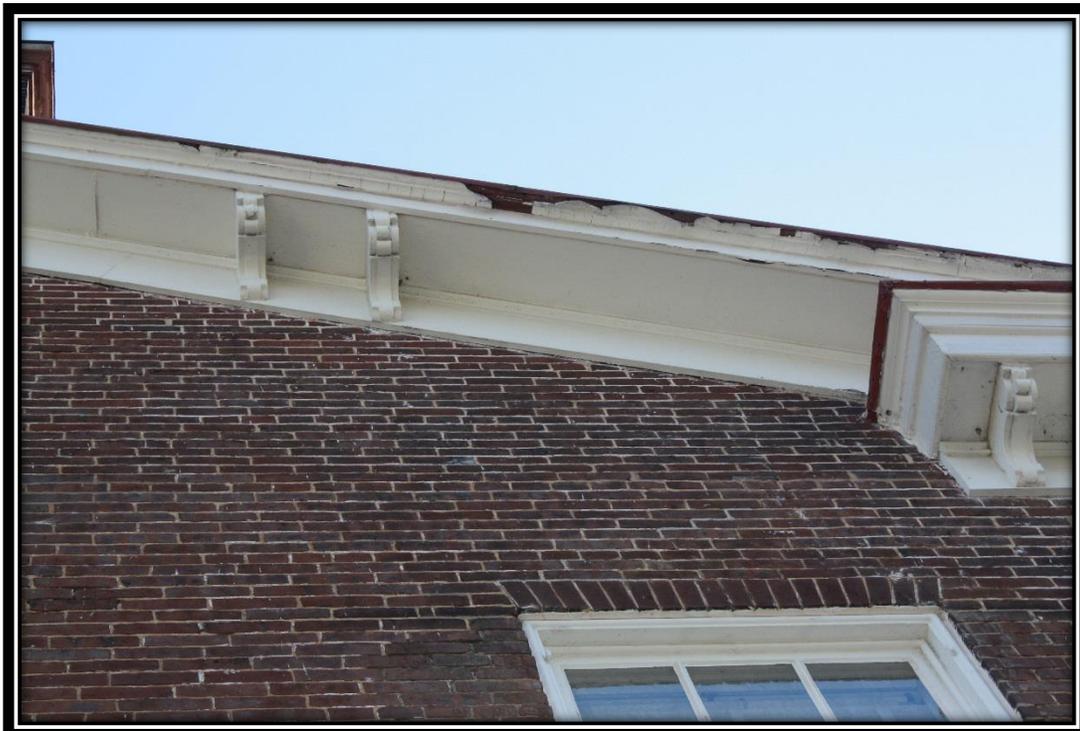
Rotted trim board on north elevation at roofline, December 2015.

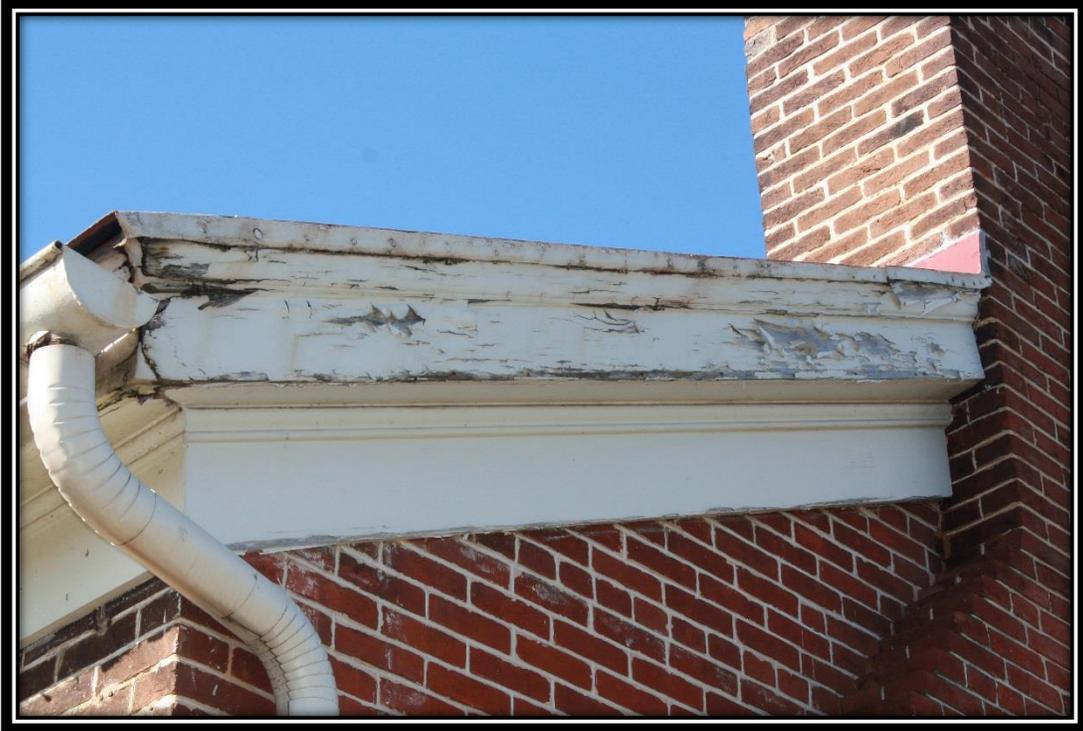
Trim deterioration at southeast wing east elevation, December 2015.

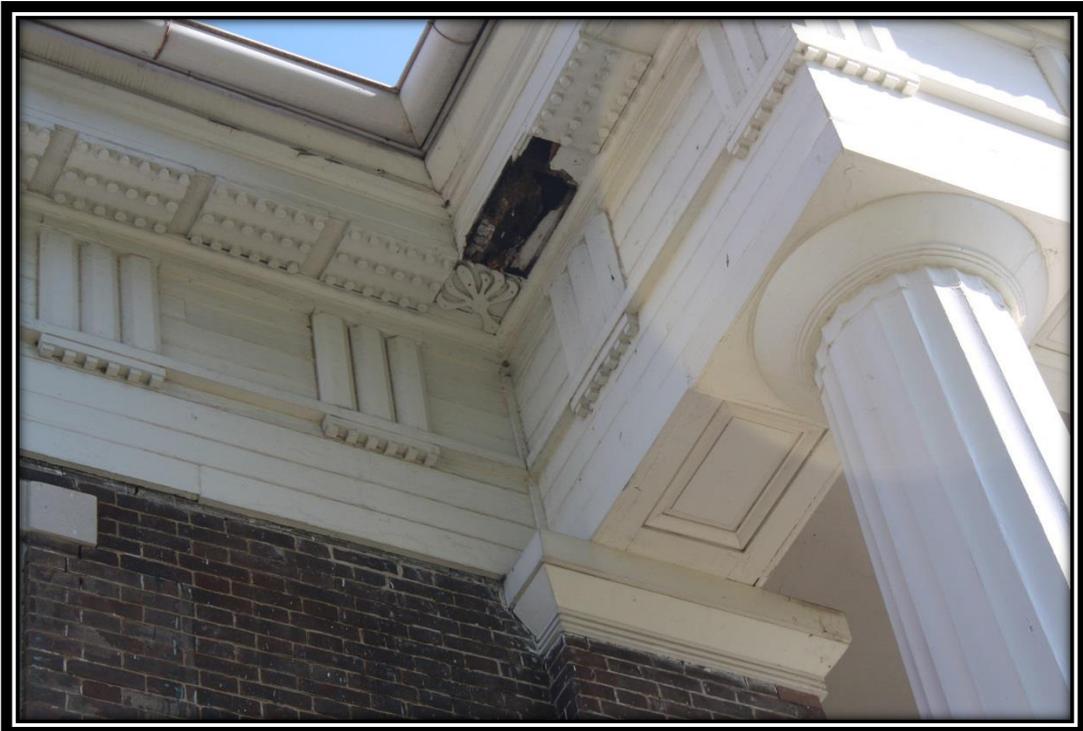
Decorative dentil trim failed due to leaking gutter, December 2015.

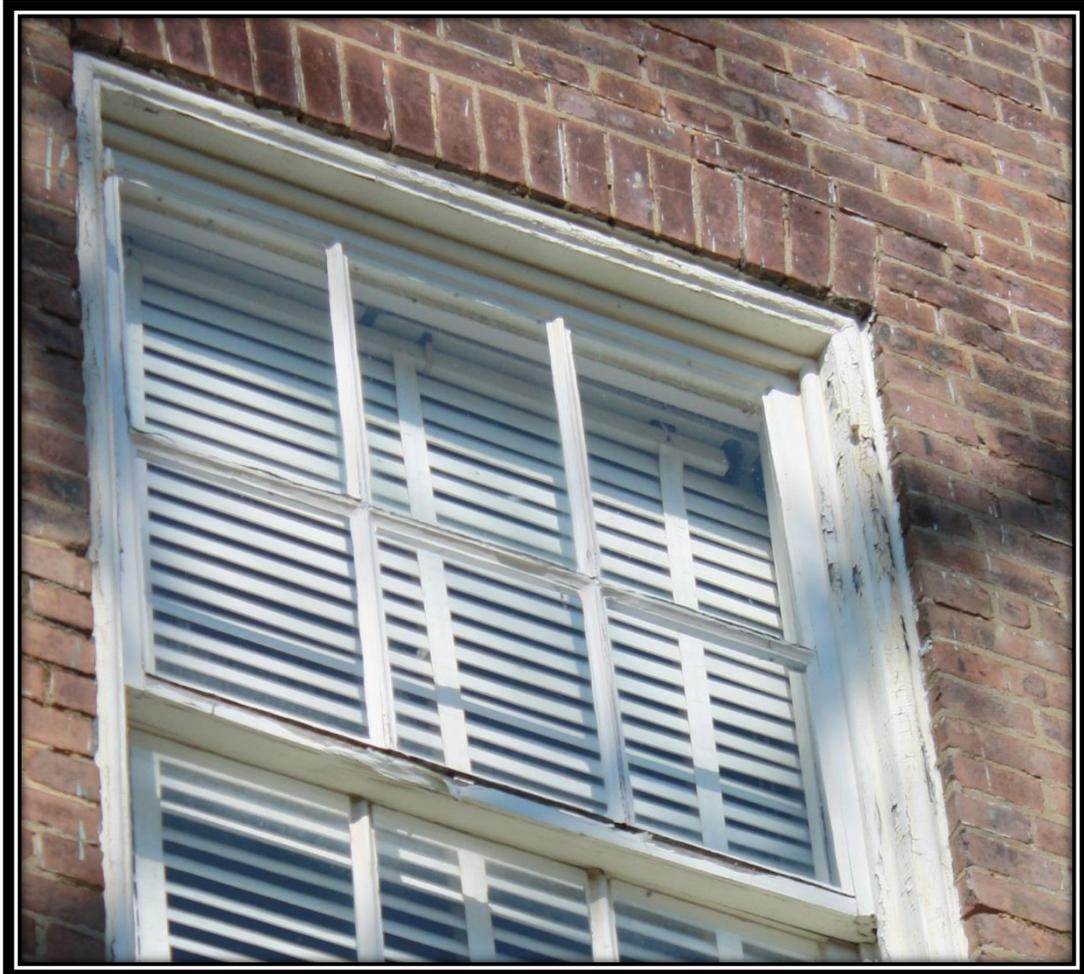
Typical window glazing and paint deterioration, December 2015.

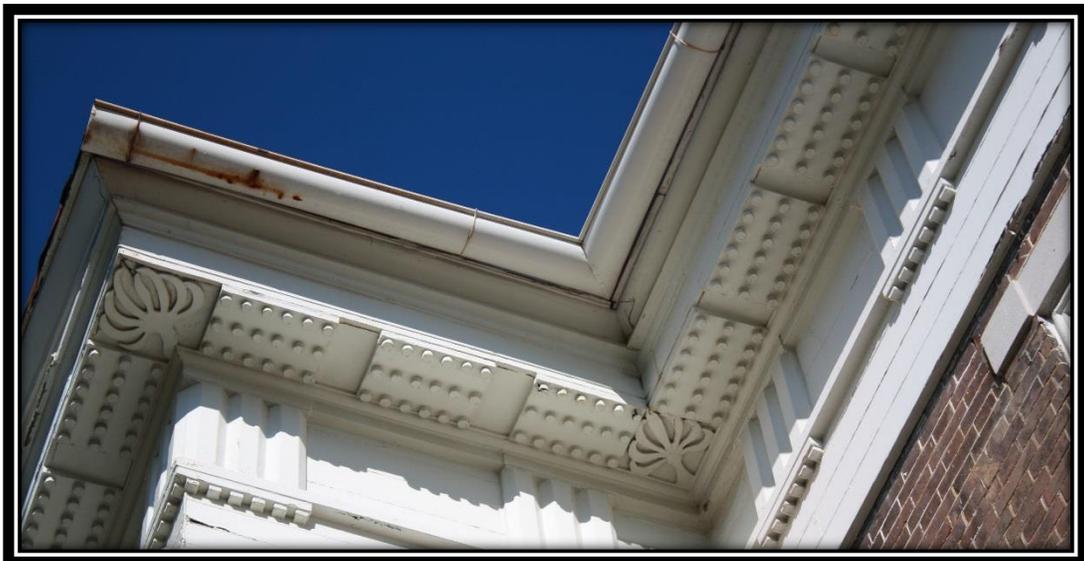
Gutter deterioration, west elevation, December 2015.

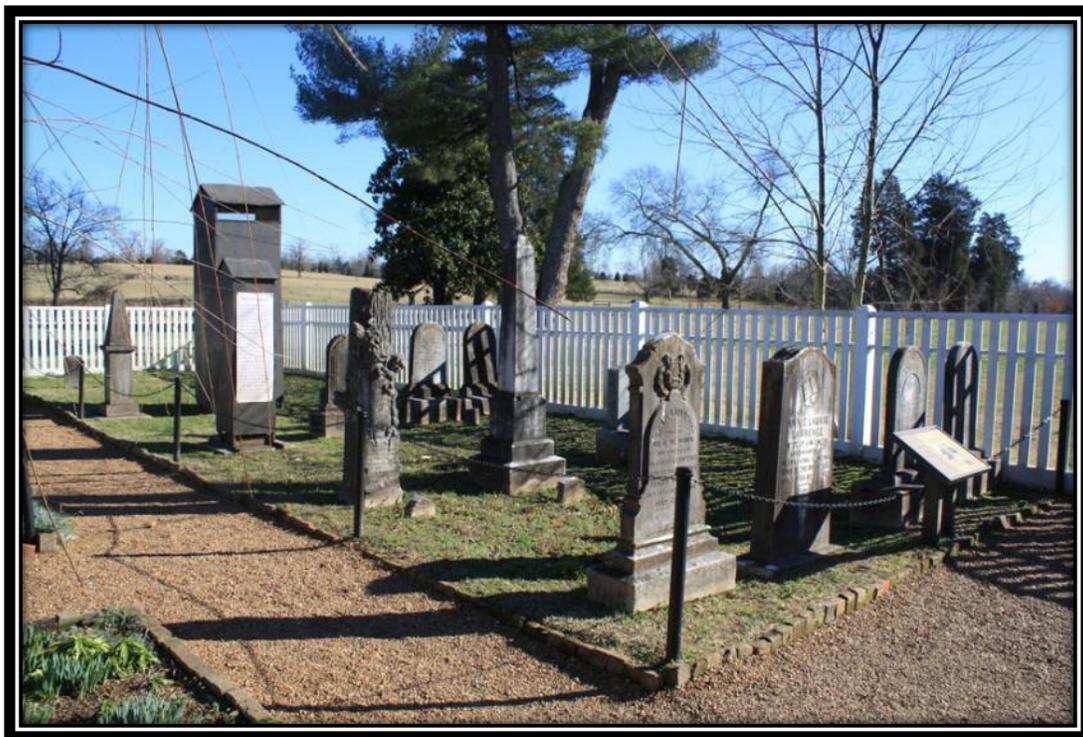
In general, the gravestones in the Jackson and Donelson Family Cemeteries are in fair condition. All require cleaning to remove pollution and biological deposits. The Jackson Family Cemetery requires significant soil backfill to correct soil subsidence likely caused by collapse of caskets and rotting tree roots. In addition, the shared gravestone of Andrew Jackson Jr. and his wife Sarah and the gravestone of Jackson family friend and portraitist Ralph E.W. Earl need immediate attention. Both are made of limestone and the limestone layers are delaminating. Both of these monuments will need to be replaced. In the Donelson Family Cemetery, the vault style memorials for Captain John and Mary Purnell Donelson are unstable because of cracks in the stones and require immediate stabilization.

Overall image of the Jackson Family Cemetery showing darkening of stones from airborne pollutants and biological growth. The two gravestones in wood boxes are those of Sarah and Andrew Jackson, Jr. and Ralph E.W. Earl.

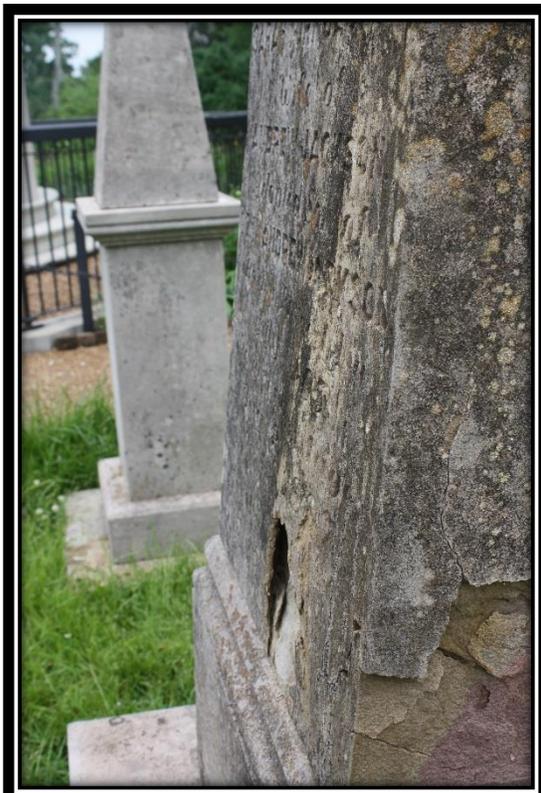
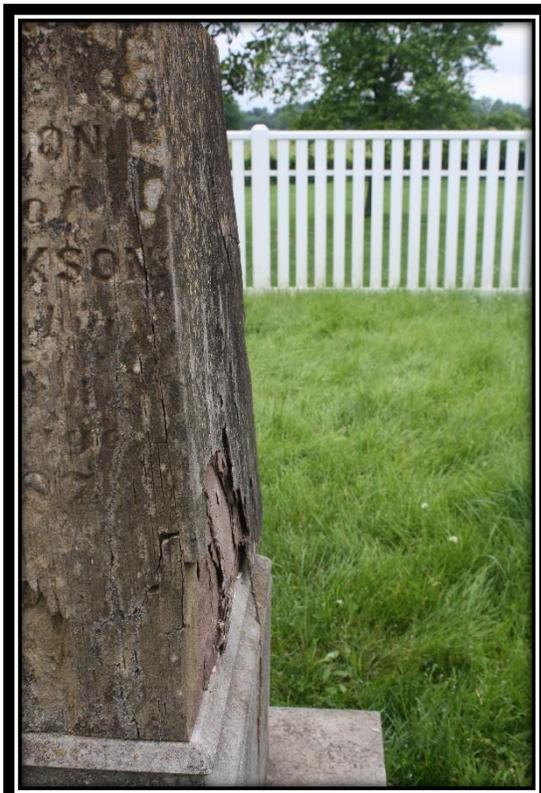
Deterioration of Sarah and Andrew Jackson Jr's shared gravestone in the Jackson Family Cemetery. This delaminating stone cannot be repaired. Replacement is the only option, May 2015.

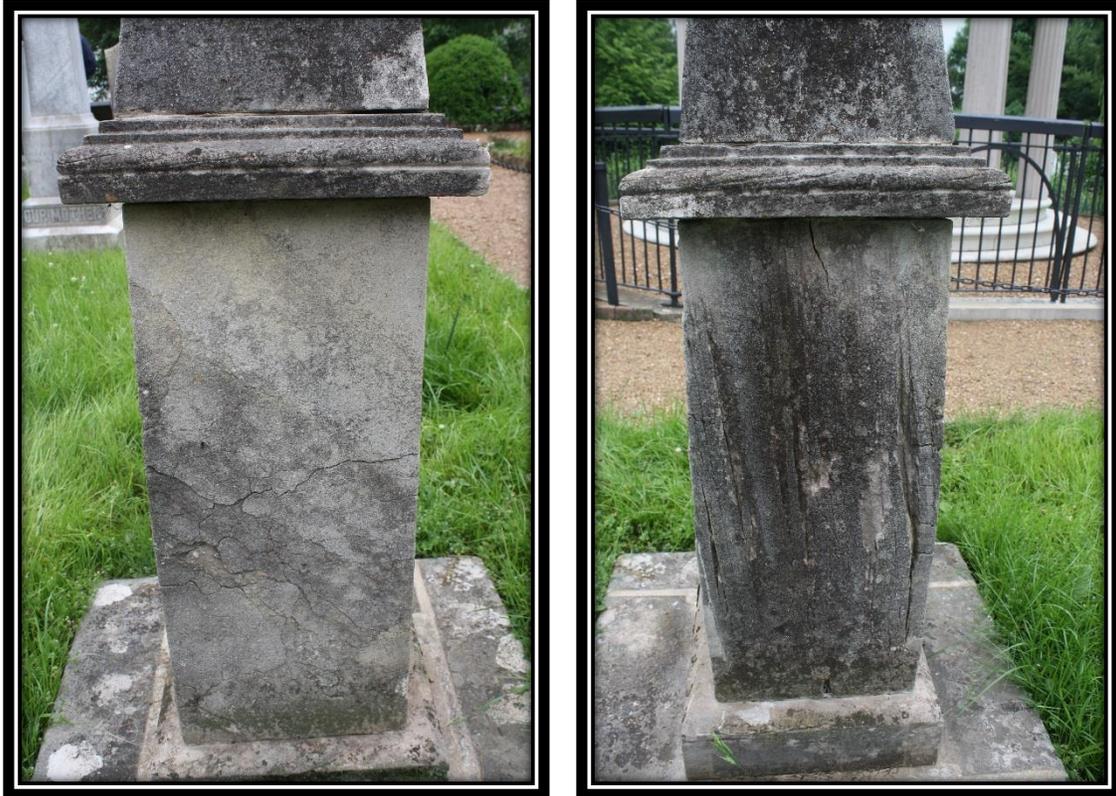
Deterioration of Ralph E.W. Earl's gravestone in the Jackson Family Cemetery. This delaminating stone cannot be repaired. Replacement is the only option, May 2015.

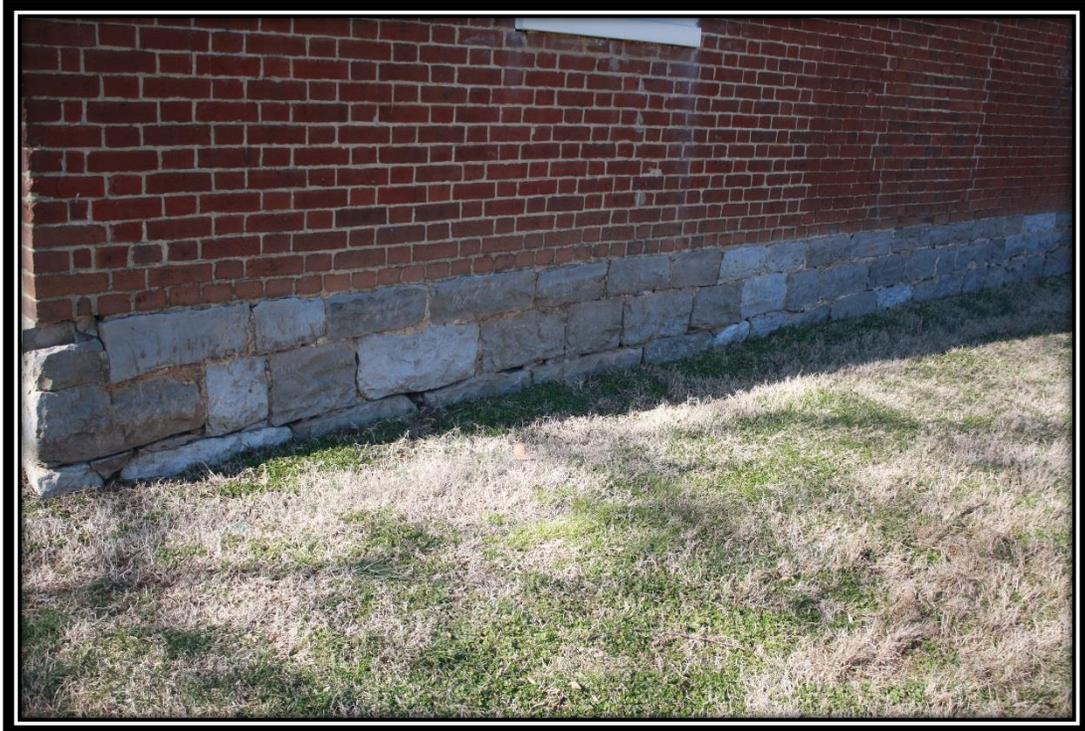
Typical condition of foundation mortar joints, December 2015.

Overall the Hermitage Church is in sound condition, but repairs are needed to maintain the building's exterior shell. First and foremost, the foundation requires repointing as soon as funds are available. The brick walls exhibit mortar deterioration, especially around windows and doors. The building's shingle roof exhibits significant deterioration and must be replaced immediately. The Hermitage Church doors, which are not original to the building, are badly deteriorated as are the locks for the Hermitage Church. Lastly, the wooden wheel chair ramp for the Hermitage Church is deteriorating and should be replaced with a metal ramp. The estimated cost of this work is \$117,000. This project is not currently funded. The AJF is actively seeking funds to repair the Hermitage Church and will complete the work in 2016 if funding becomes available.

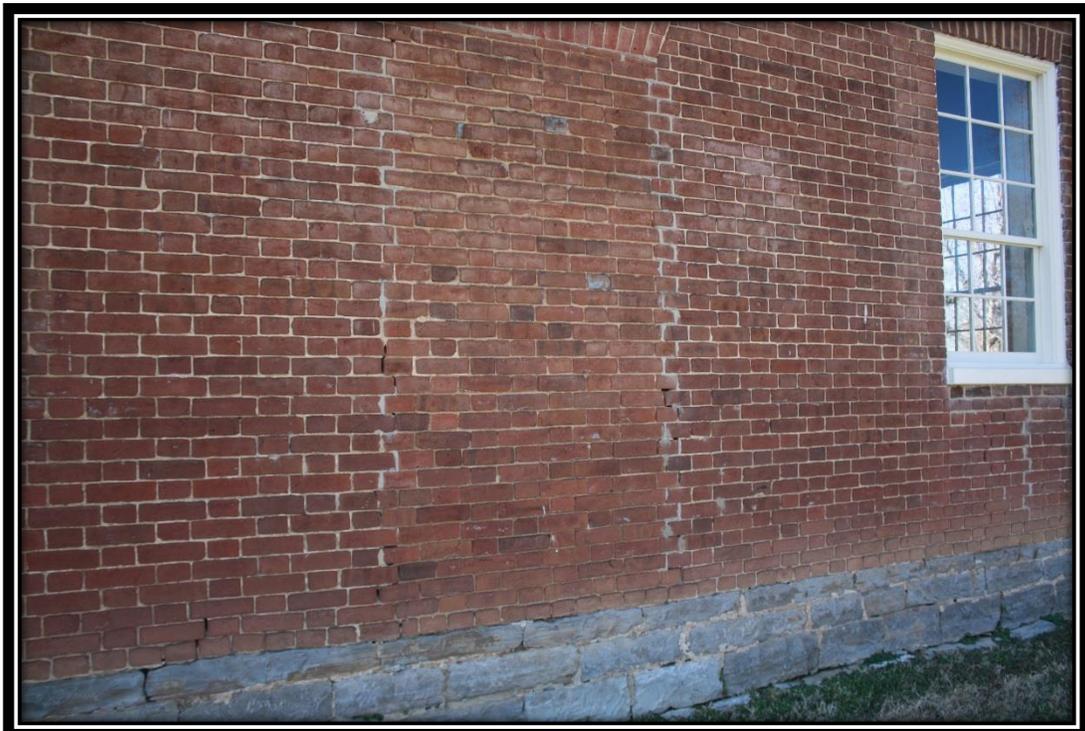
Typical condition of mortar in wall joints, December 2015.

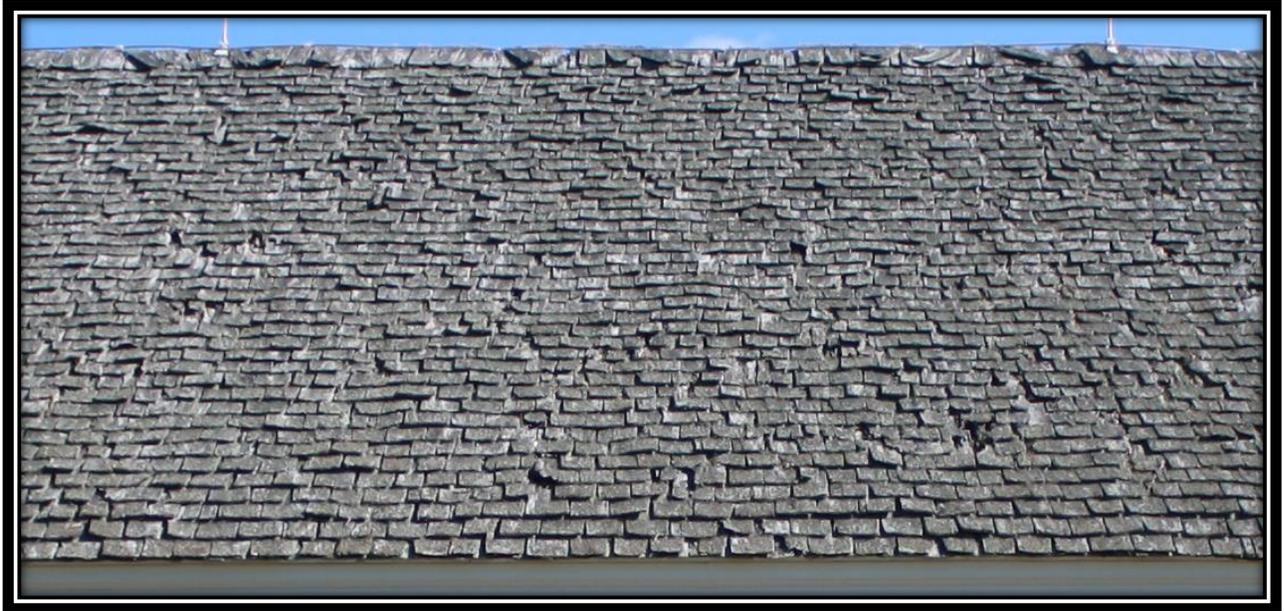
Section of roof shingles showing typical deterioration, December 2015. Please note holes in shingle coverage.

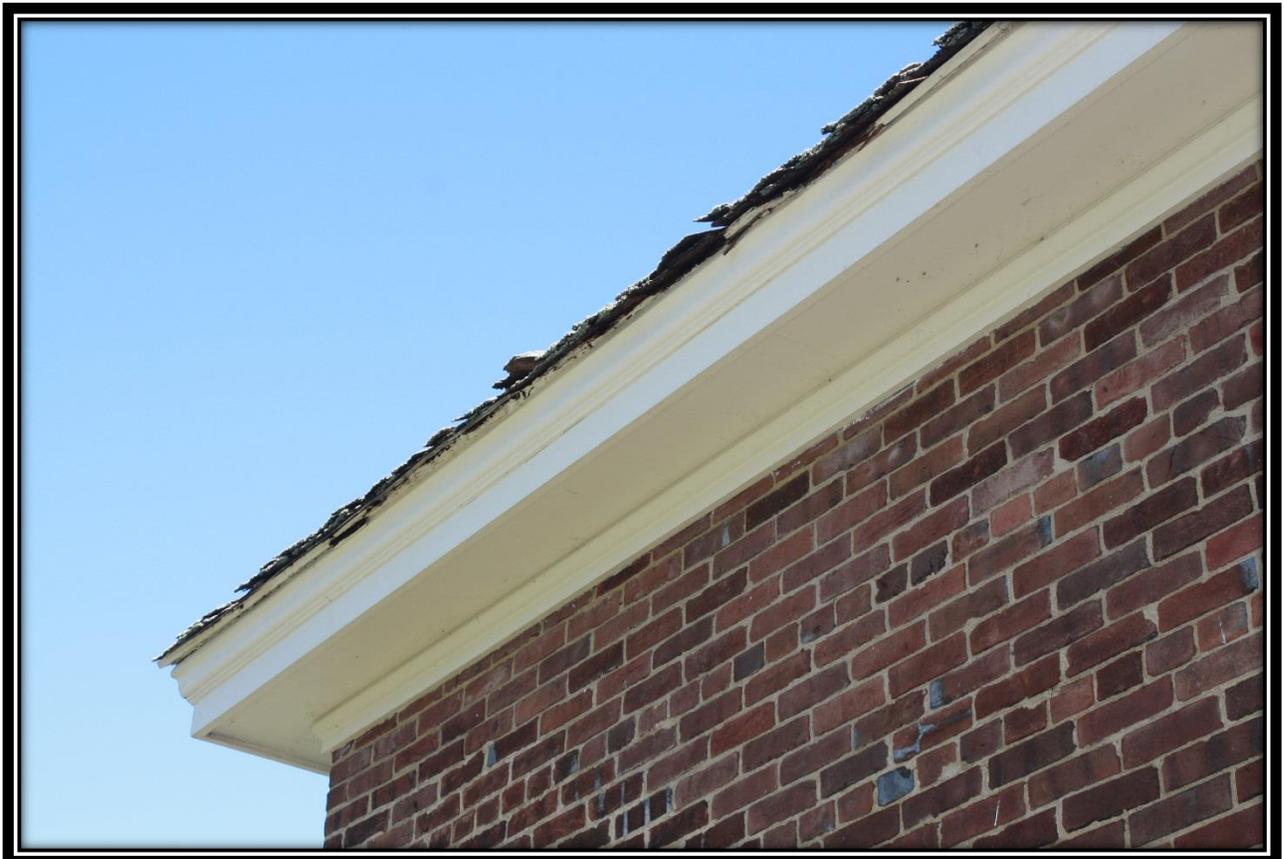
Typical condition of roof decking exhibiting rot and deterioration, December 2015.

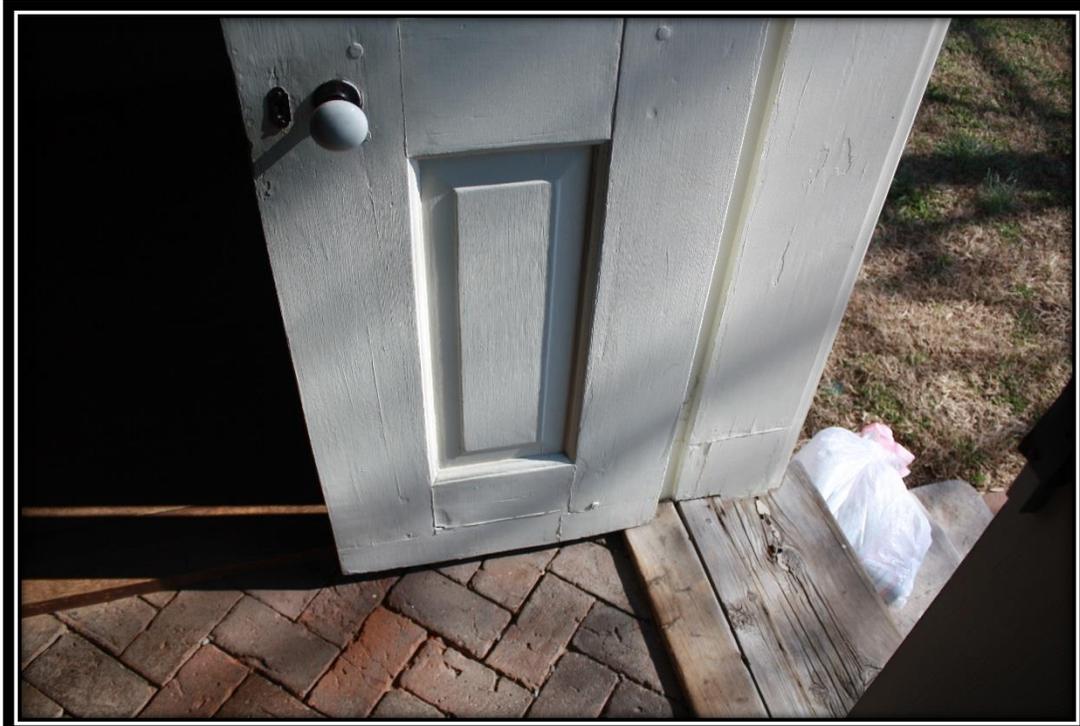
Image shows twice repaired door bottom and new rot at bottom left, December 2015.

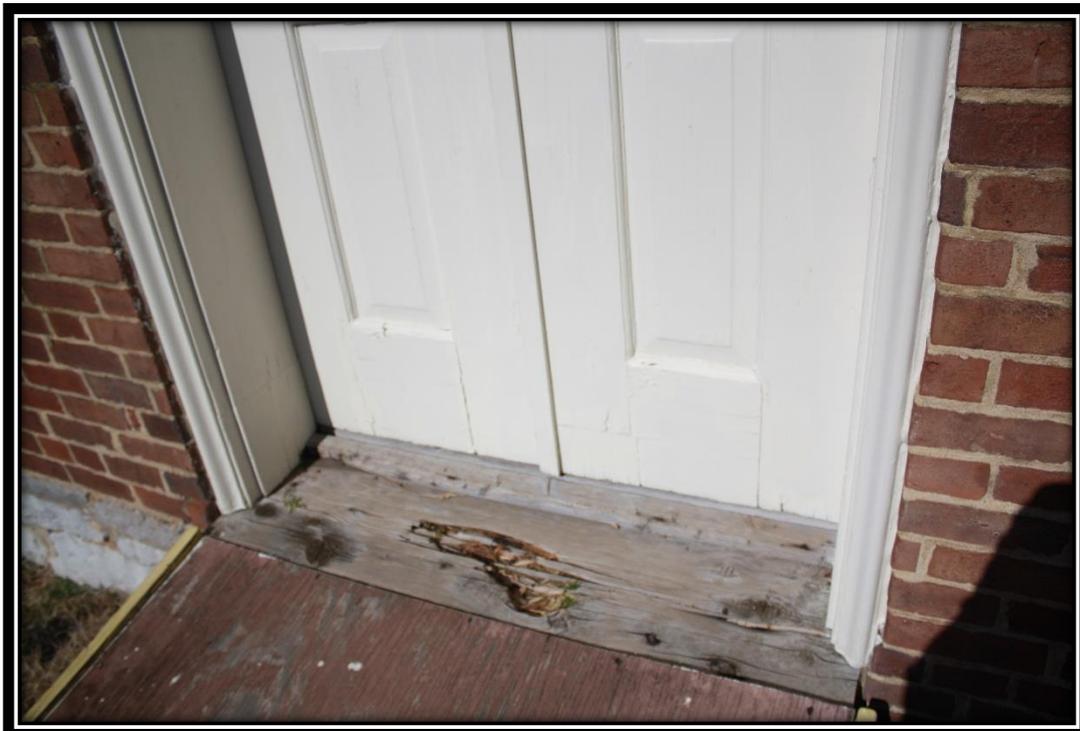
Rotting door threshold requires replacement, December 2015.

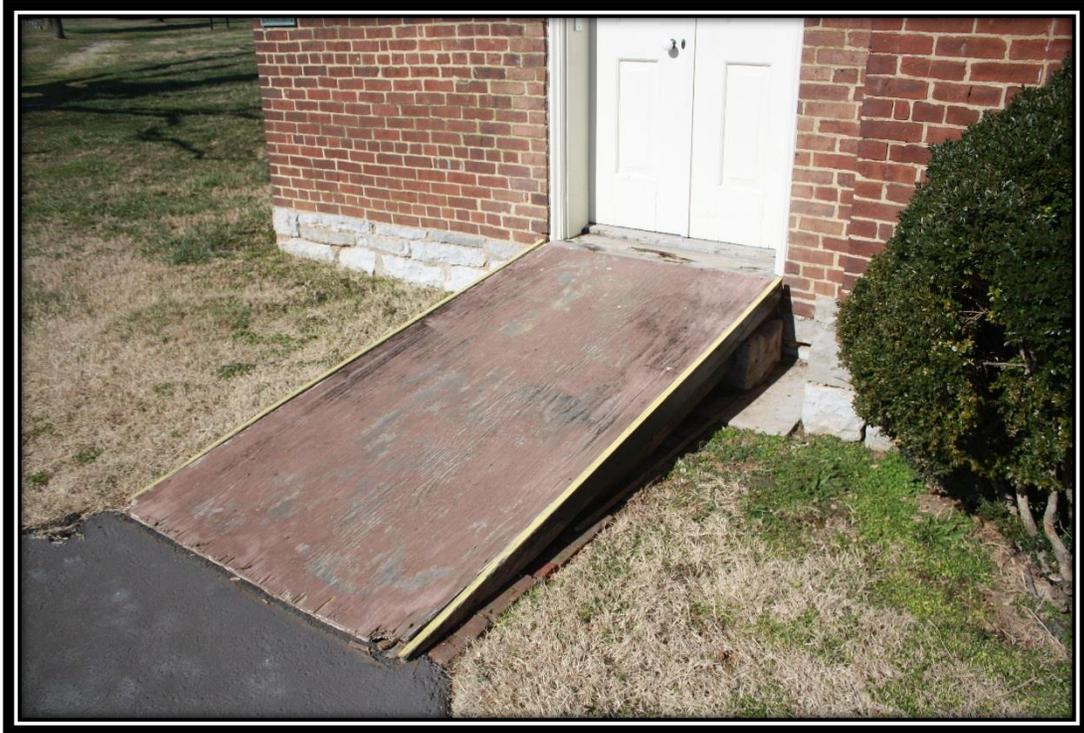
Deteriorated handicap ramp to the Hermitage Church, December 2015.

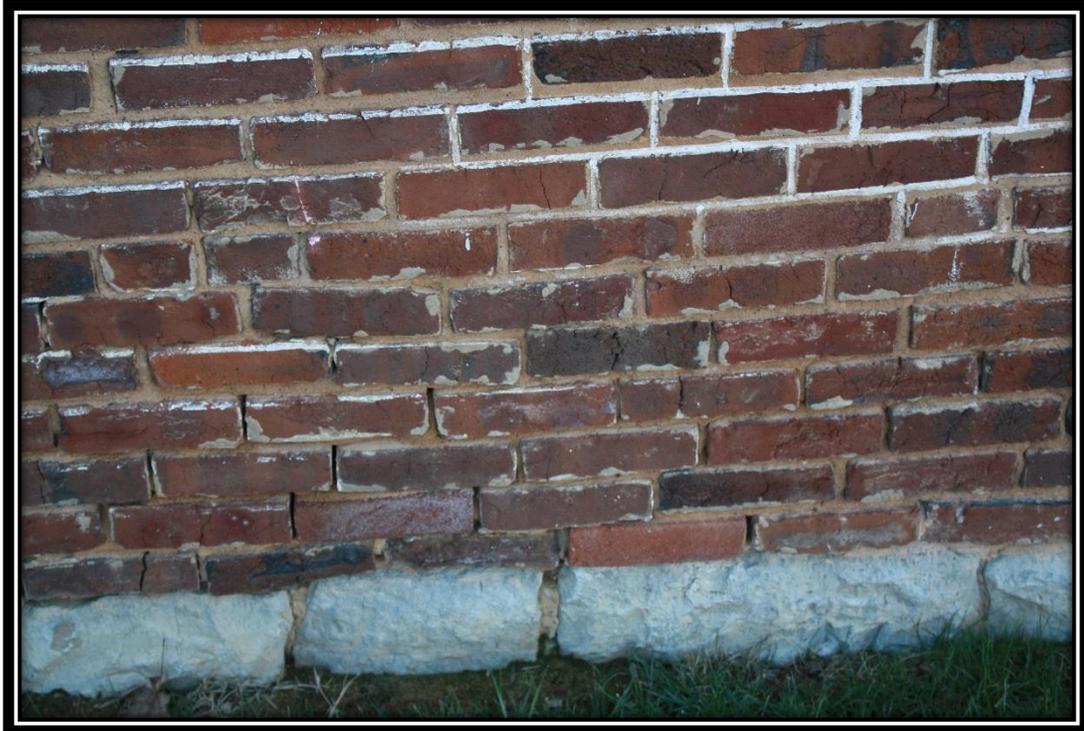
The Hermitage Smokehouse exhibits mortar deterioration of the lower 18-20 courses of brick and the stone foundation. The cause of this deterioration is salt contamination in the soil surrounding and inside the smokehouse. This is a typical problem with brick smokehouses. Andrew Jackson Foundation research on this salt problem shows that it is expensive and difficult to cure and often cures promoted as permanent, prove impermanent or detrimental to the building. Rather than attempt to cure the problem, the AJF has taken the approach of making mortar repairs as necessary. Typically, repairs are needed every five to seven years. The existing repairs are now in year six of service. Repointing of these joints will cost \$20,000 to \$30,000. The AJF is actively seeking funds to repoint the Hermitage Smokehouse and will complete the work in 2016 if funding becomes available.

Mortar joint deterioration at the smokehouse due to salt and rising damp, December 2015.
