2015 ANNUAL REPORT

TENNESSEE STATE BUILDING COMMISSION

This Annual Report describes preservation and significant maintenance and management work completed on historic and cultural resources at Andrew Jackson's Hermitage by the Andrew Jackson Foundation (AJF) in calendar year 2015 and proposed work for calendar year 2016. This annual report submission to the State Building Commission (SBC) is required under Tennessee Code Annotated section 4.13.104. The following is a brief description of proposed property acquisition, construction, demolition, alteration, restoration, or preservation works in progress. Projects involving routine maintenance and minor repairs are not included. Projects are listed in order of priority.

Hermitage Mansion

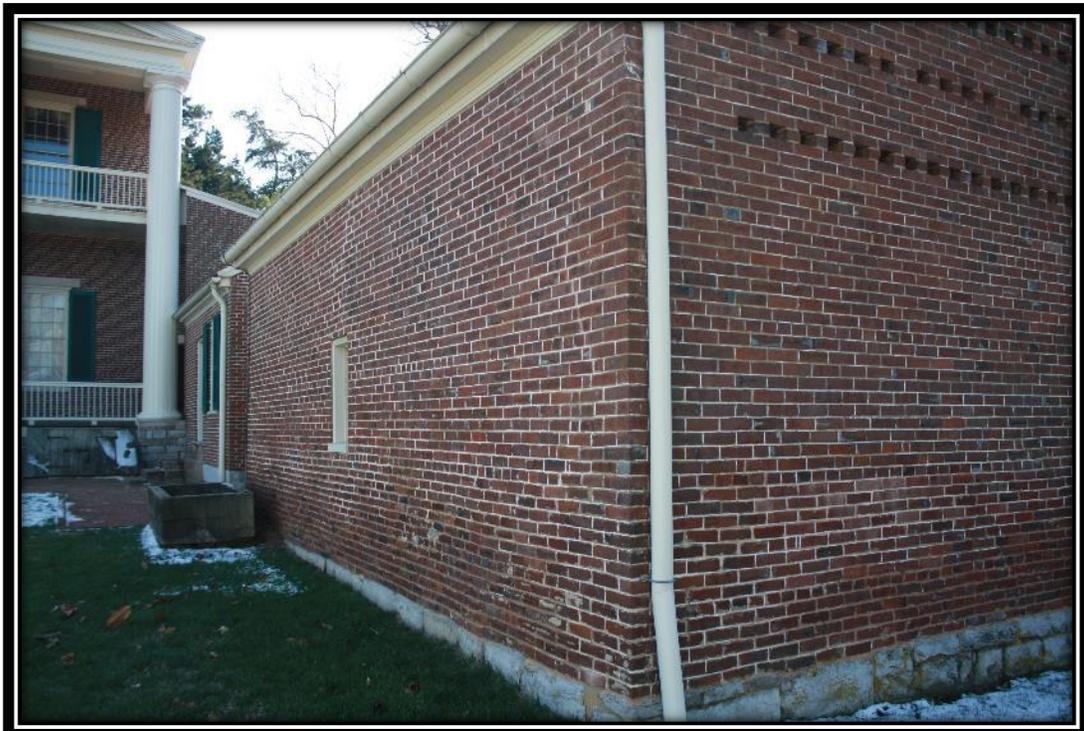
Wet and darker looking areas of walls correspond to mortar joints affected by salt and rising damp, December 2015.

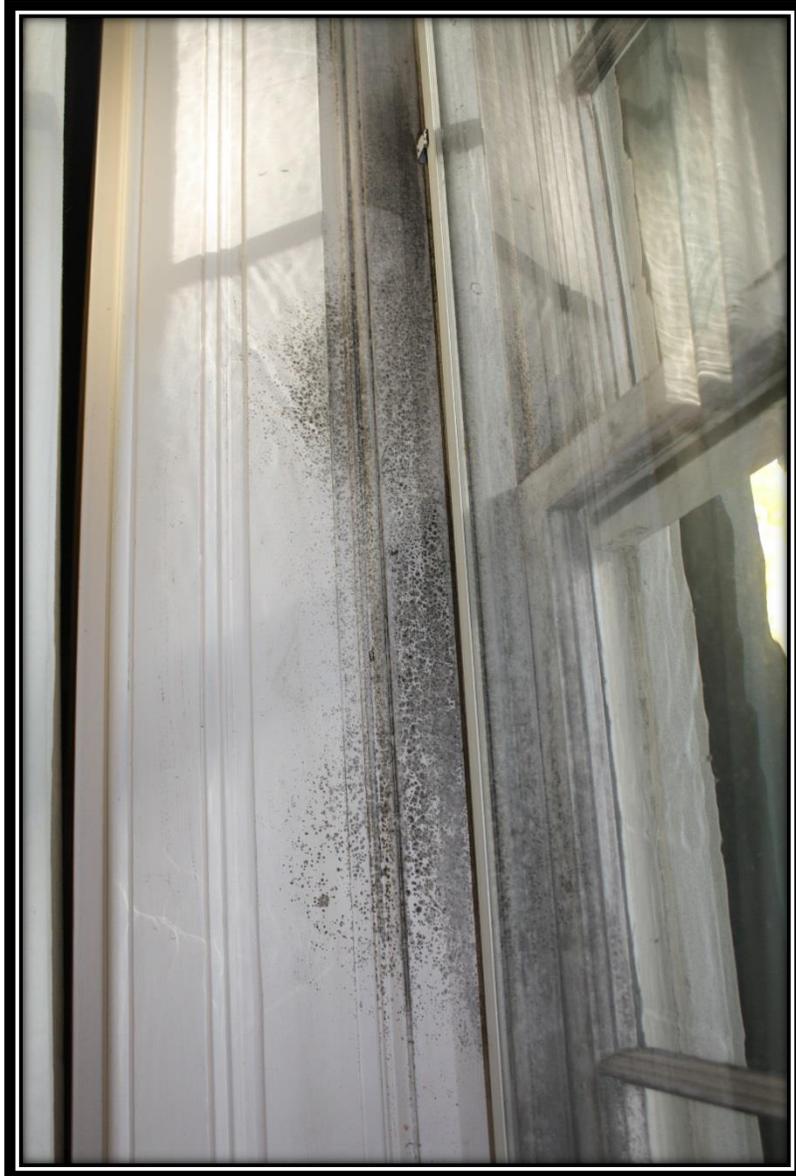
*Mold on window casing from moisture infiltration and condensation
in Andrew Jackson's Bedroom.*

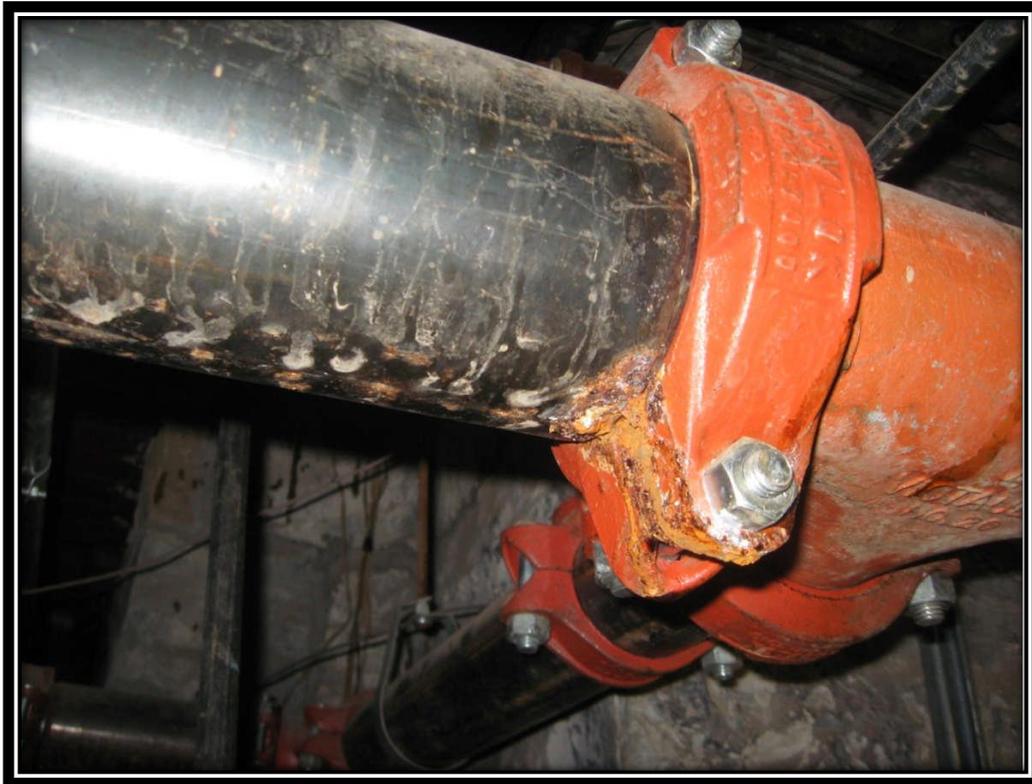
This image shows typical Hermitage mansion sprinkler pipe corrosion at a rolled joint.

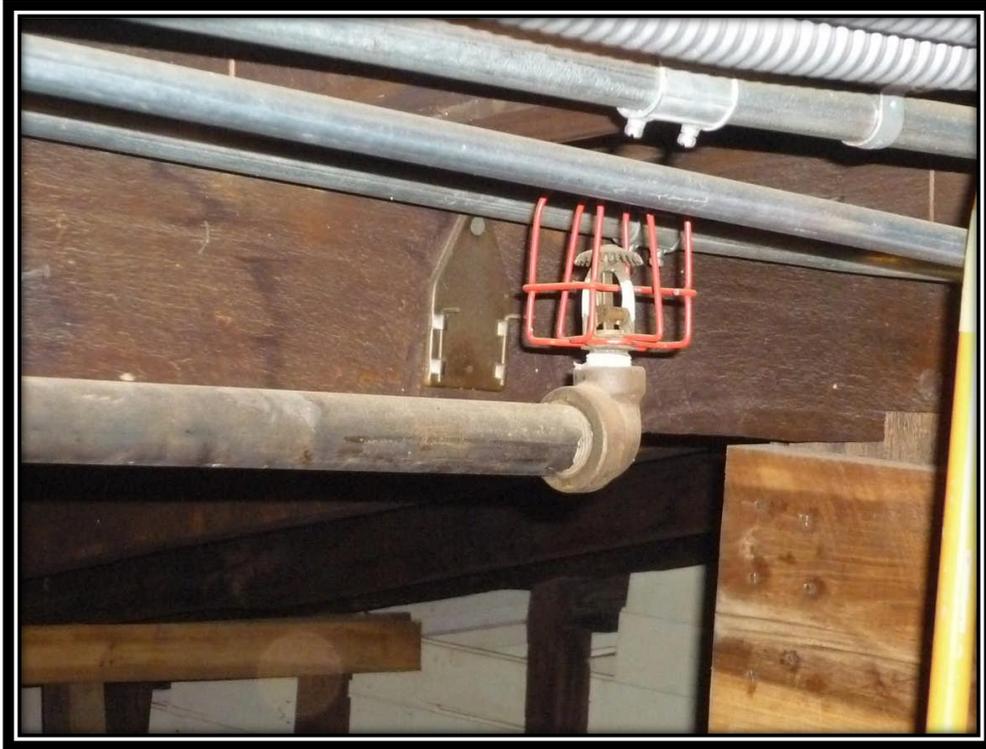
Typical obstructed sprinkler head in the Hermitage mansion attic.

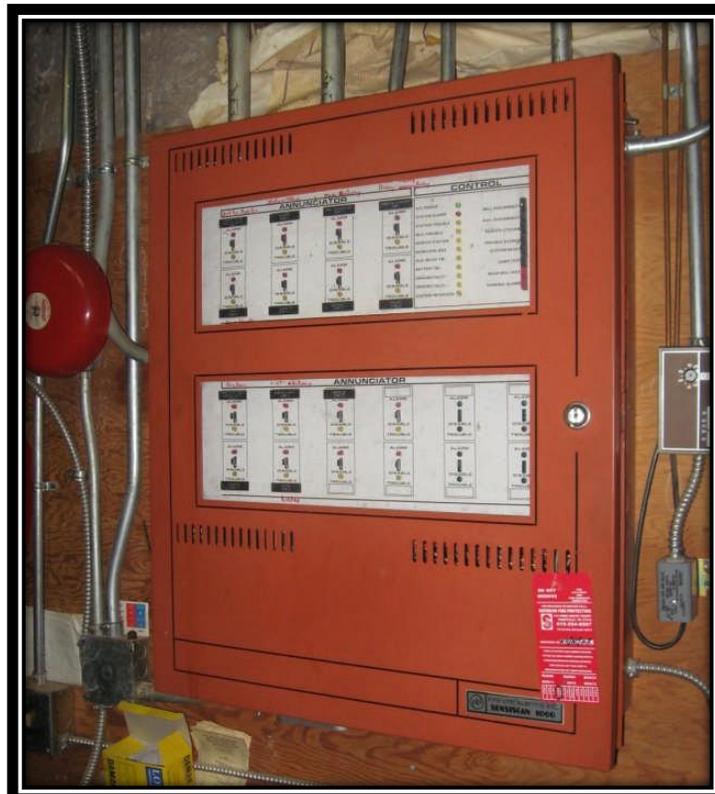
1988 Fire Alarm Control Panel in the Hermitage Basement to be replaced in 2015.

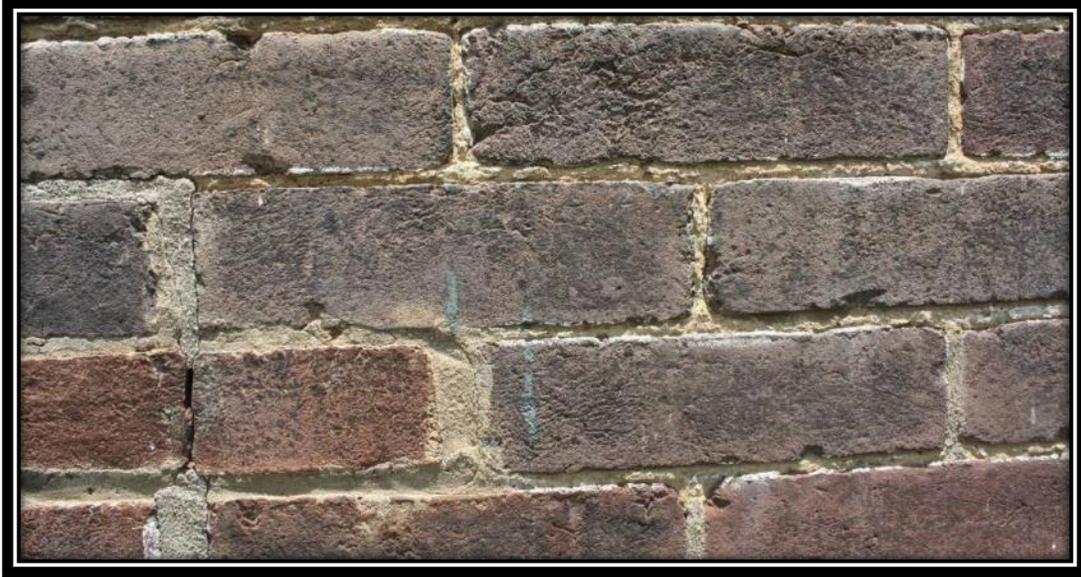
A previous repointing effort at Tulip Grove was not installed deeply enough into the joint. That repointing mortar failed and took off the face of the historic lime sand mortar underneath it. Tulip Grove requires complete repointing on all elevations, May 2010.

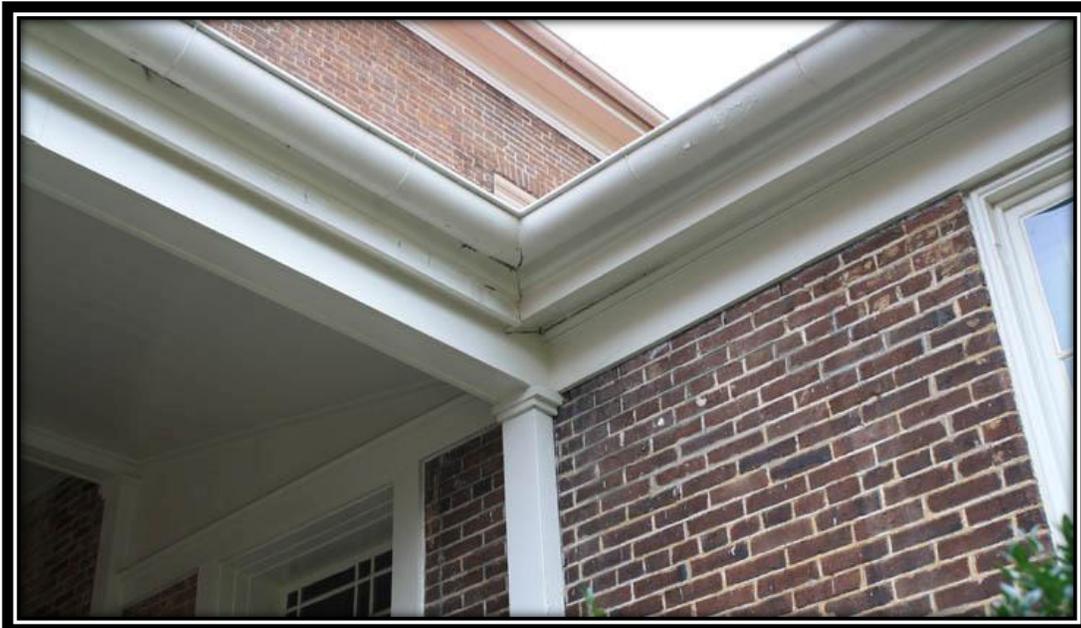
Failed mitered corners in Tulip Grove's gutter system have resulted in wood deterioration underneath, May 2010.

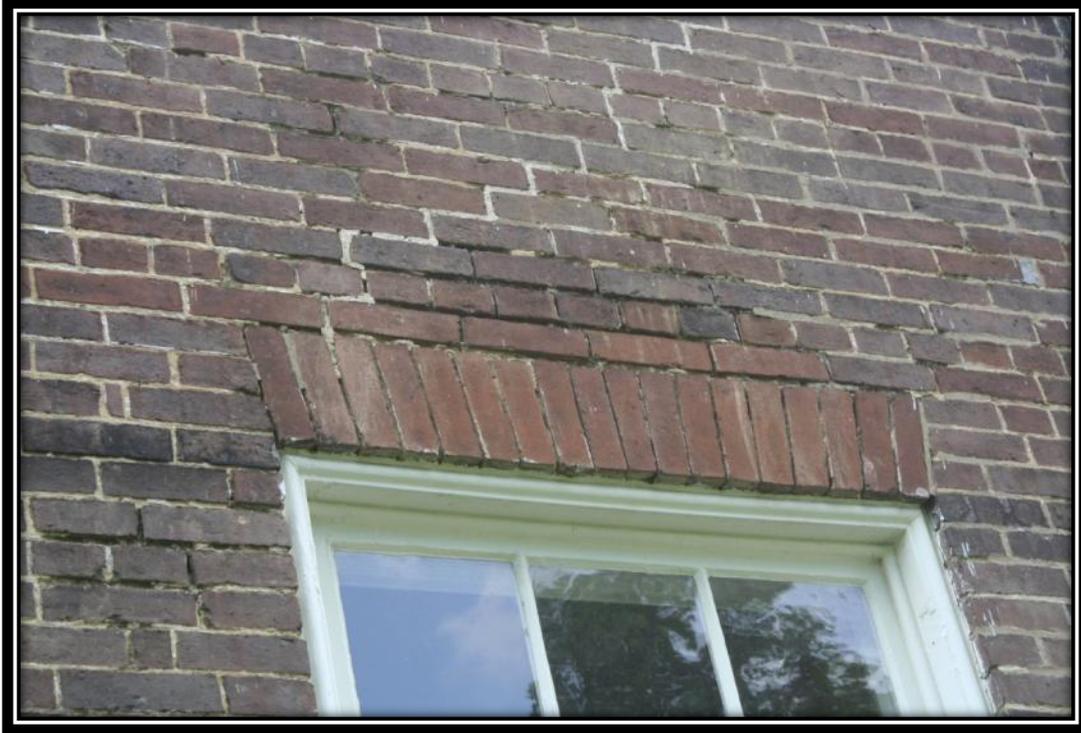
Typical mortar joint deterioration over window jack arches.

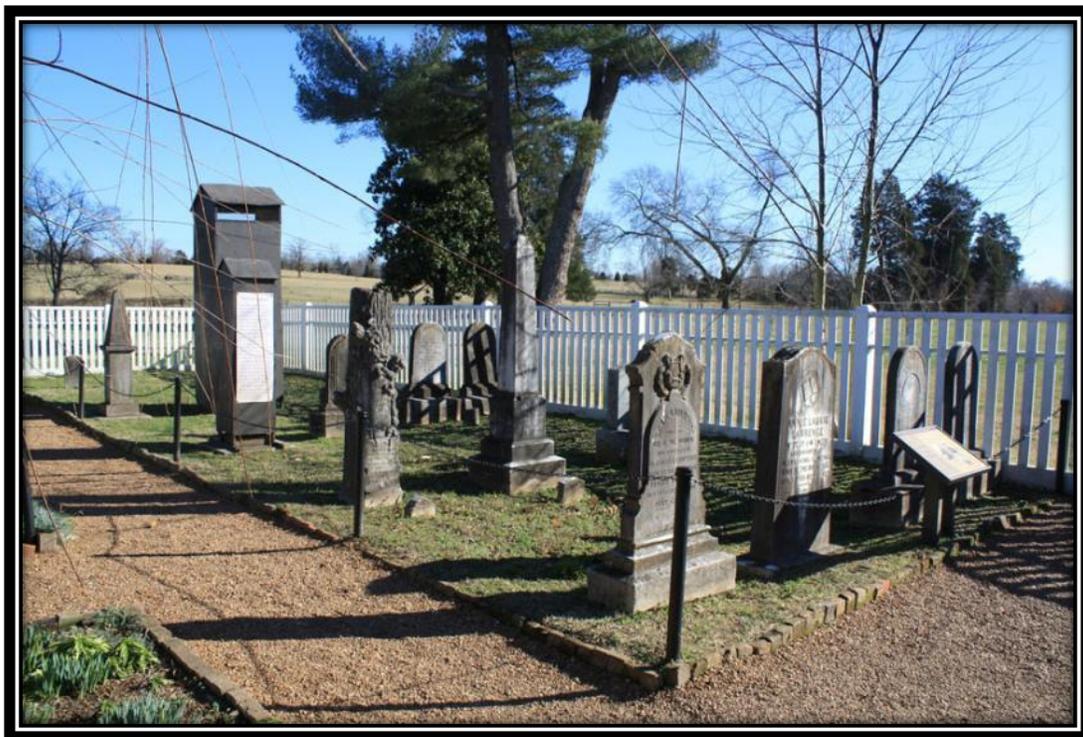
Overall image of the Jackson Family Cemetery showing darkening of stones from airborne pollutants and biological growth. The two gravestones in wood boxes are those of Sarah and Andrew Jackson, Jr. and Ralph E.W. Earl.

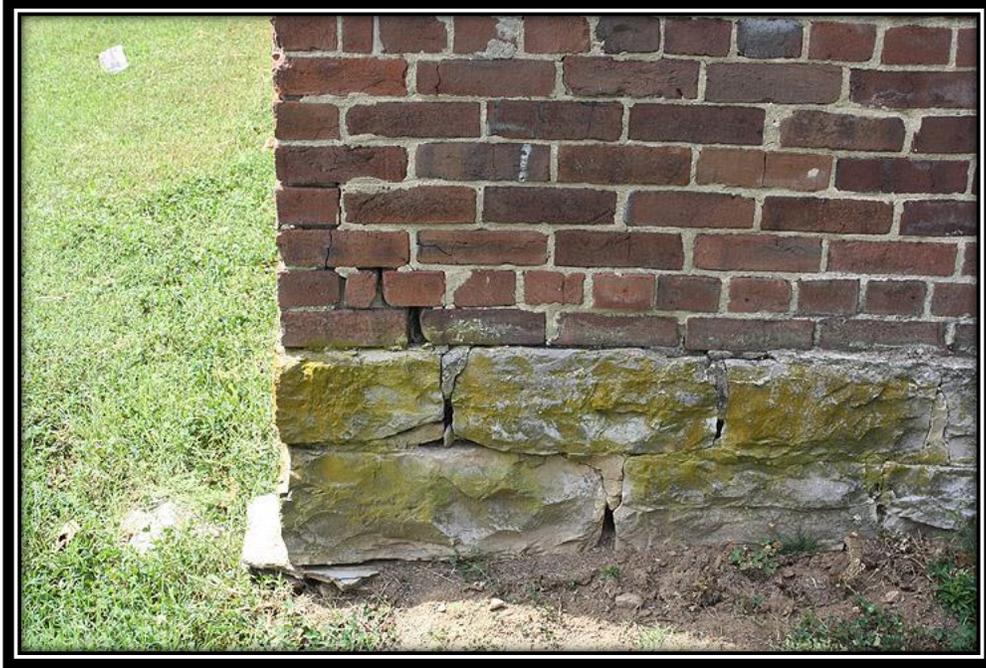
This image shows failed mortar in the Hermitage Church foundation and walls, May 2010.

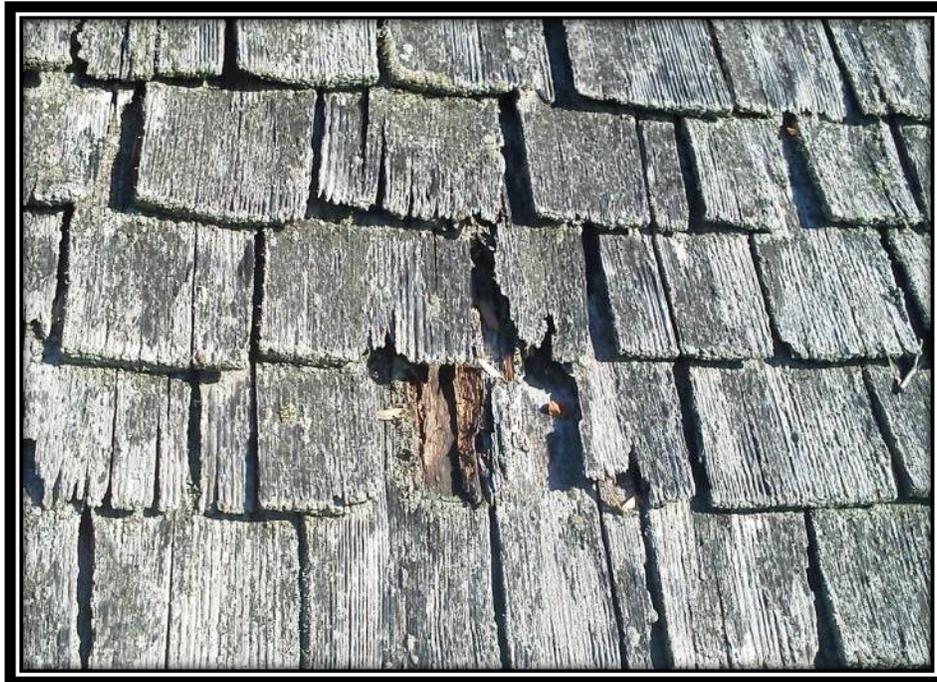
Typical condition of church roof shingles. Note split shingles and large gaps in coverage.
