21. Crushed

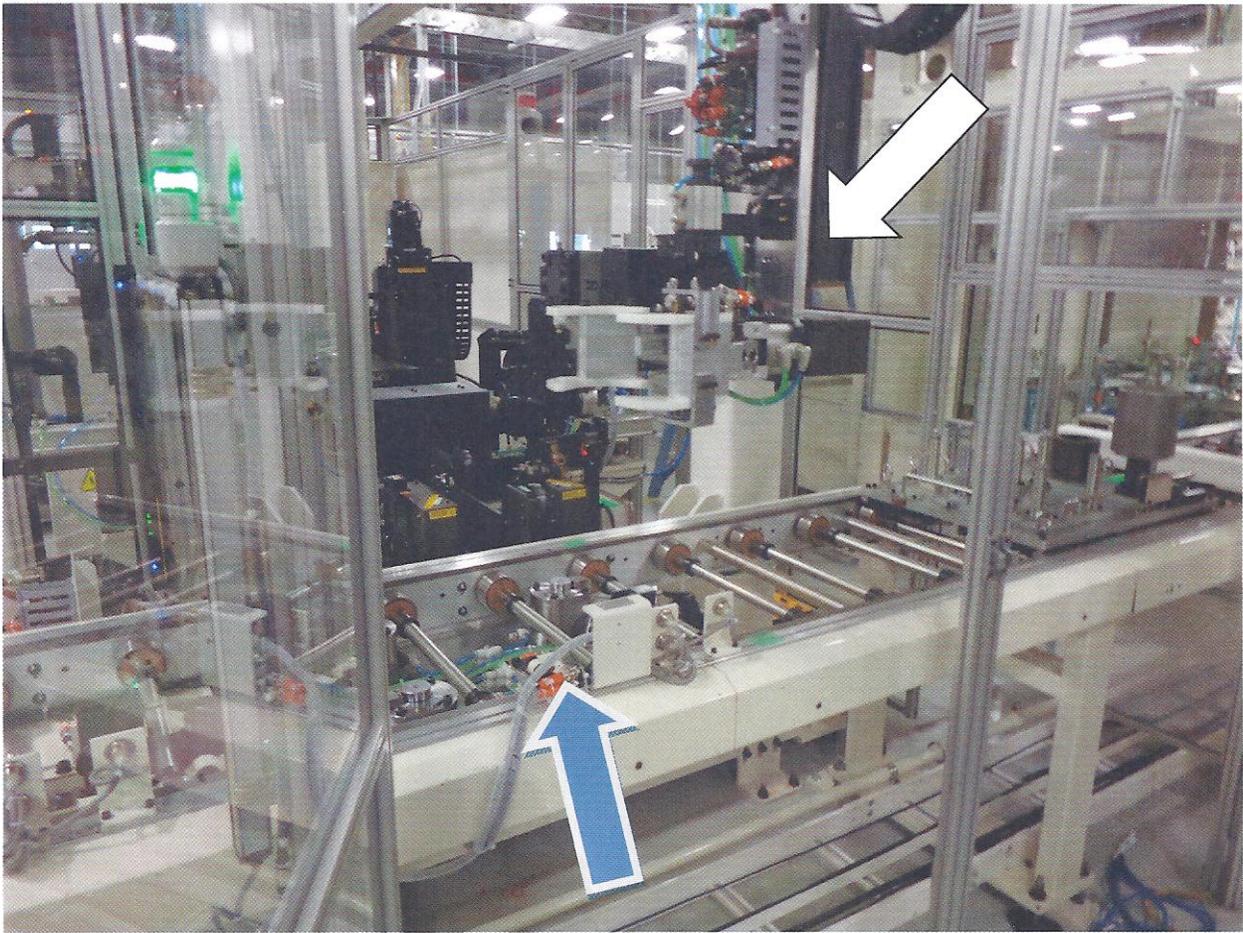
A **54-year-old** Japanese employee of a subcontractor died when he was caught between a conveyor line and a gripper on a gantry crane. The victim was working on an automated machine making adjustments while installing and programming the software for the new machine. All safety guards were in place but the victim bypassed the guards to install the machine. Part of the machine was a robotic arm (gantry gripper) which was designed to pick up the manufactured part off a pallet on a conveyor when the pallet reached a specific sensor. The victim began adjusting the machine using a dry-run mode which allows the machine to run full cycles without product or a pallet being in the machine. All interlocks were bypassed and the doors to the machine were open. He attempted to adjust the air line for the pallet sensor which, when activated, causes the gantry gripper to cycle. The gantry gripper was in the “home” position directly above where a pallet would normally be if one were present. While adjusting the air line, he accidentally engaged the sensor causing the gantry to act as if a pallet were in place and cycle to pick up a part from the conveyor. The victim was pinned and crushed between the gantry and the conveyor. The injuries were fatal.

The white arrow indicated the gantry by which the employee was crushed. The blue arrow indicated the location of the pallet sensor and where the employee was working when he was pinned.
