8. Struck by Collapsed Wall

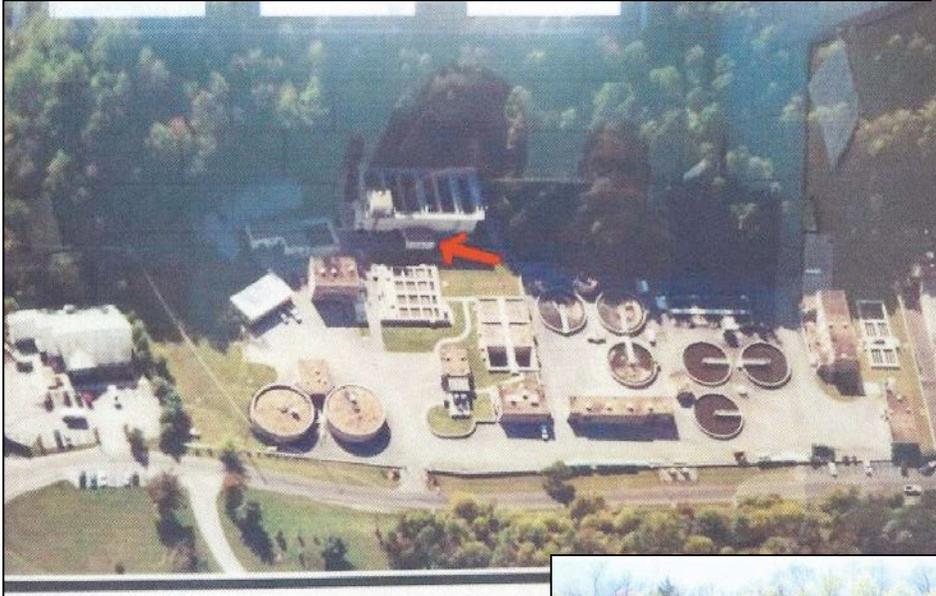
Red arrow shows flow control building in front of equalization basin before the wall collapse

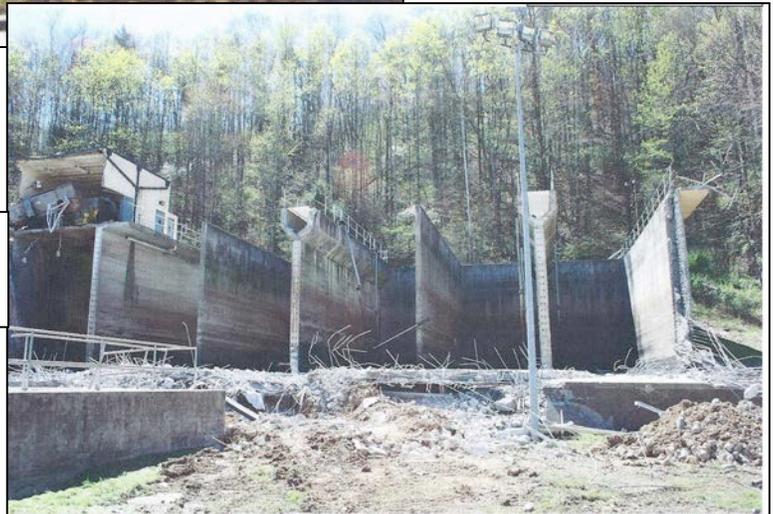
Two employees, a 53-year-old and a 44-year-old, of a wastewater treatment plant were killed when a basin wall collapsed onto them. The two plant operators were inside the flow control building located on ground level approximately eight feet in front of the East wall of the equalization basin. They were assumed to be making adjustments to the effluent flow valve and performing other duties related to high flow levels inside the equalization basin. While they were performing their duties, the East wall of the equalization basin separated and fell onto the flow control building. Both operators were fatally injured as a result. The equalization basin was constructed of masonry materials reinforced by rebar. The Director of the Office of engineering for Federal OSHA visited the site to help determine the cause of the wall collapse. He concluded that the cause of the failure was a deficiency in the concrete wall construction.

After the collapse, the flow control building with the victims is under the rubble of the collapsed wall
