**William R. Snodgrass Tennessee Tower
3rd and 4th Floor Plaza Level Waterproofing
SBC no. 529/000-02-2019
Nashville, Davidson County, Tennessee**

Programming for Tennessee Tower Waterproofing

October 24th, 2023

Goodwyn Mills Cawood, LLC.
GMC Project No. ANAS 230036
NASHVILLE, TENNESSEE

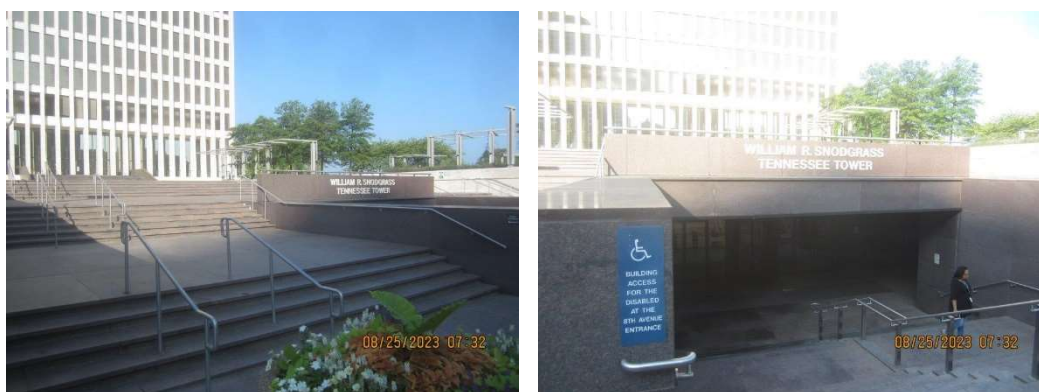
Overview of the 3rd Floor Plaza area and entrance where leakages were reported. This area would be anticipated for further destructive surveying to gain further knowledge of the conditions concealed by the exposed finishes in place.

NRC recommends further destructive observations be performed at the 3rd floor Terrace and transitions. In review of the area, the drainage components are covered and could not be observed functioning. The drainage areas are recommended to be exposed and observed for blockages at the second level drainage plane. If blockages are present, the blockages may be hindering proper relief of moisture and backing up waterproofing levels. If the waterproofing levels are not draining, moisture could be forced to the perimeters for overflow purposes. NRC recommends an area of destructive surveying be considered to promote more understanding of the drainage components, waterproofing components, and possible waterproofing protections anticipated to be in place. Once these items are understood, small selective areas of

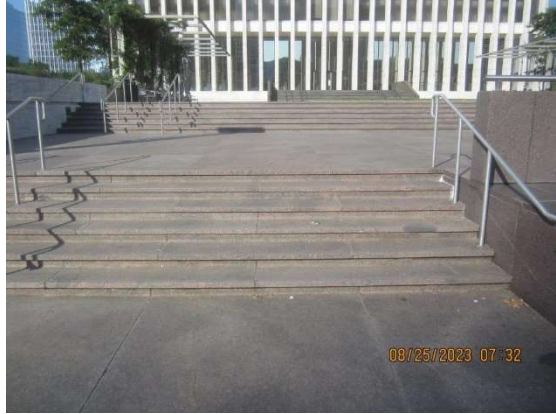
Overview of the stair where transitions are anticipated to occur in the below waterproofing system.

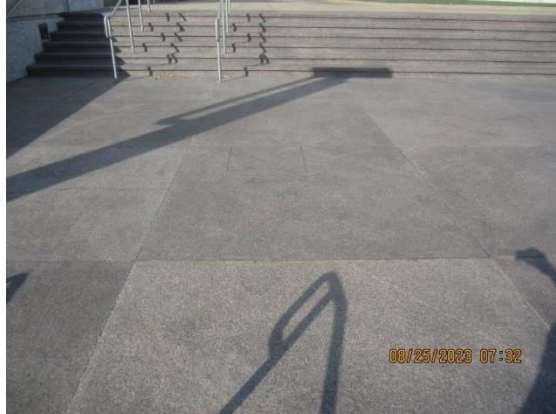
Overview of the area where a drain system has been covered. NRC recommends removing the finish components above the drainage system to promote observation of the drainage relief point.

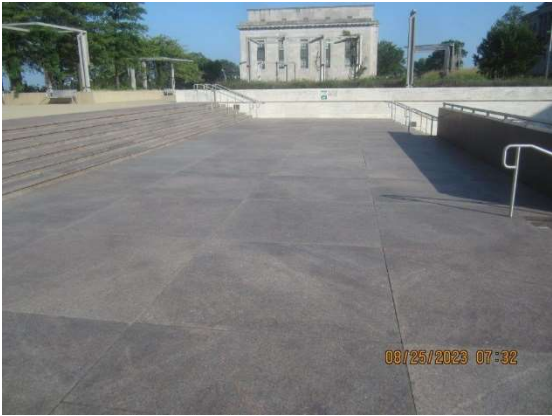
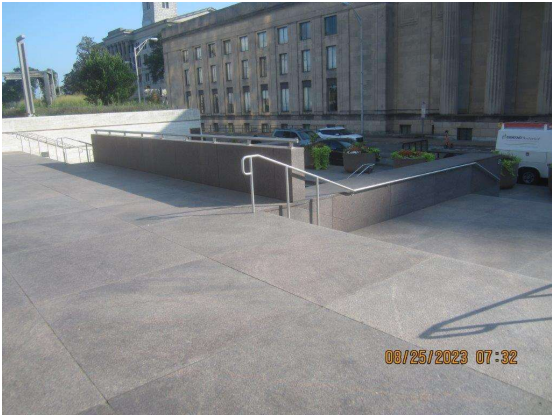
Overview of the 3rd Floor Plaza above the entrance area. NRC anticipates a waterproofing to be installed below the finish surface. Drainage locations are recommended to be observed closely.

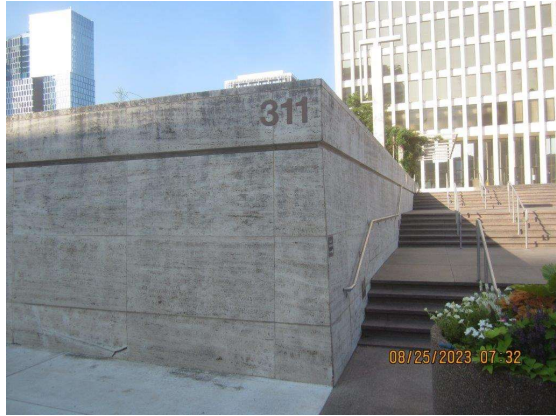
Overview of a planter structure where leakages were reported. NRC recommends locating the drainage system for destructive surveying observations. Ensuring moisture relief is occurring is critical to the performance of the waterproofing systems below.

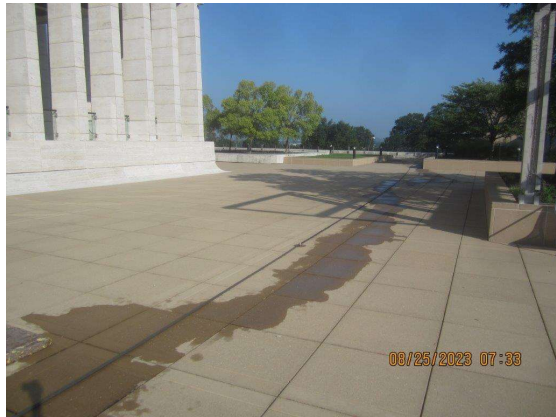
One leak was reported in the area shown above. The Team did not thoroughly observe this location. As per the other areas, ensure drainage components are functioning as designed.

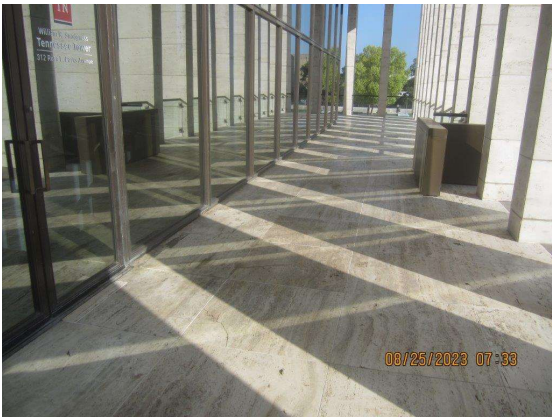
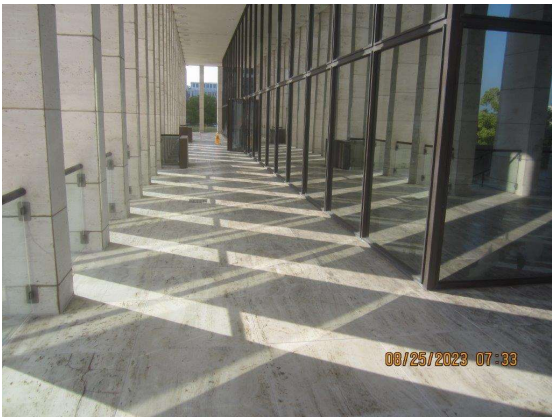
Overview of the 4th Floor Terrace Plaza where leakages were more concerning. The State’s initial program was anticipated to revolve around these waterproofing and glazing locations.

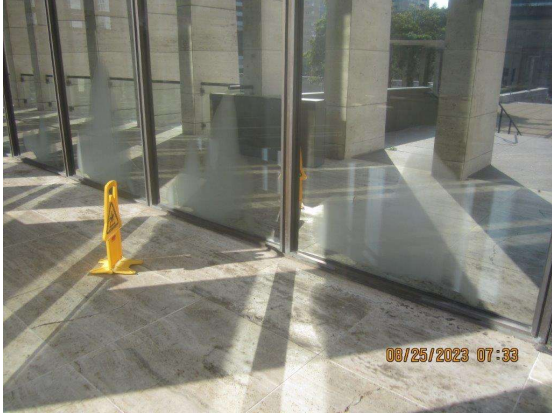
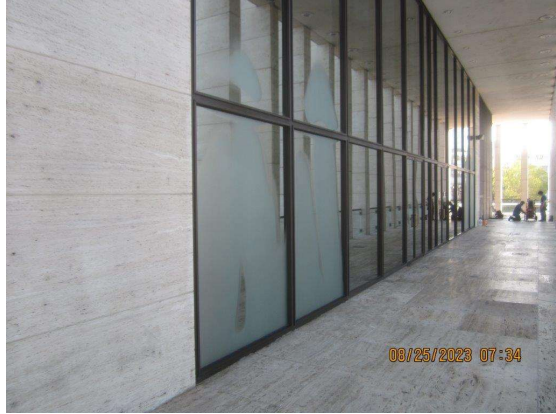
In other areas at the building connection, the glazing systems were observed condensing at the glass components. The single pane not insulated glazing appeared to be thermally voided promoting moisture build up at the Curtain Wall System. The moisture was observed traveling down the glass to the extrusion location. NRC could not observe the Curtain Wall Systems make-up or drainage plane. It appeared the drainage plane was buried within the Terrazzo finish area. Blockages to the internal drainage system may be present if the appropriate pathways are not present. These areas could not be observed in detail at any location. The interior of the Curtain Wall was not observed and the focus of the meeting was at the exterior Terrace Plaza waterproofing system location.

NRC observed significant condensation occurring on the glazing system. The drainage pathways within the Curtain Wall could not be observed. Further destructive surveying is recommended.

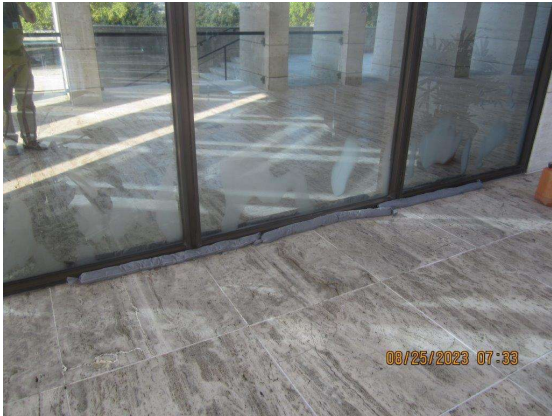
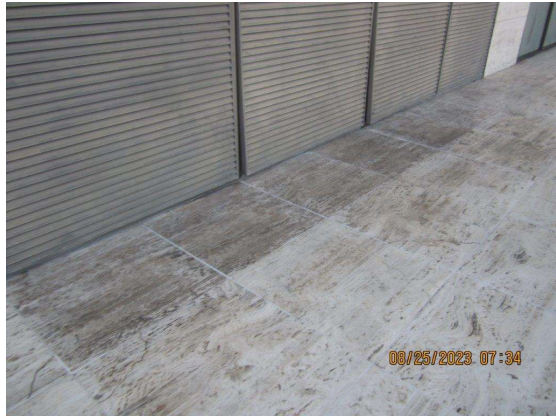
Transitions along the base of the structure are recommended to be destroyed to promote further knowledge of the waterproofing installations and drainage pathways.

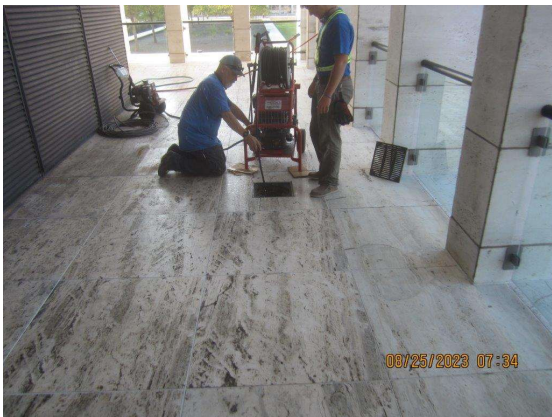
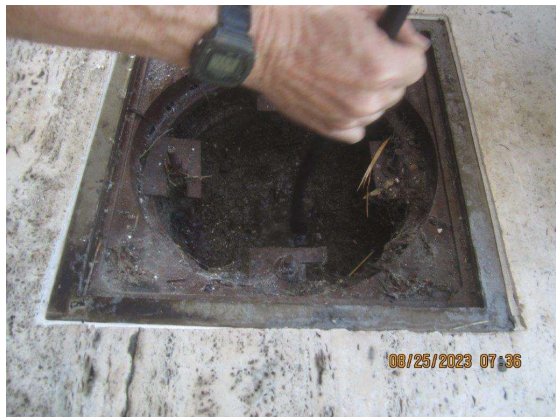
A Plumbing Contractor was present onsite upon NRC's return. The technicians were working to clean the drain line of debris. The moisture in the drain piping was observed backing while cleaning was being performed.

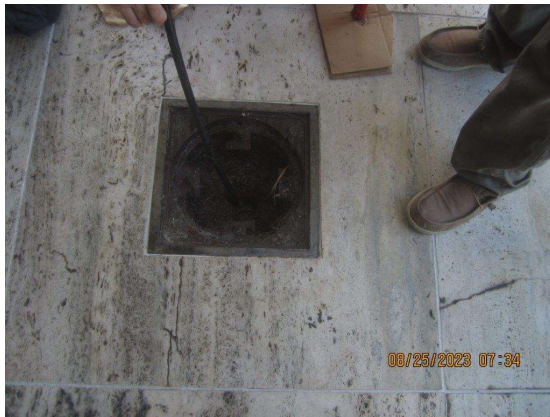
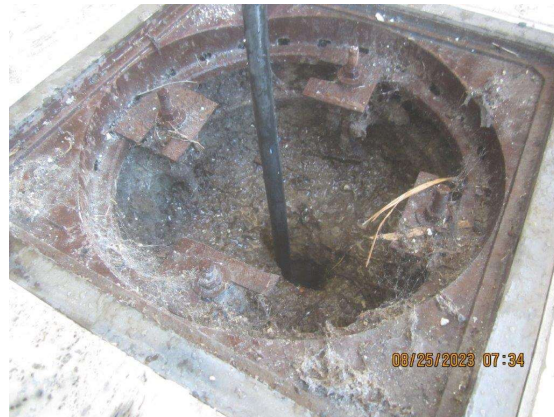
Overview of the two-part plaza style drainage component. The technicians were cleaning the plumbing lines while NRC was present. NRC recommended the technicians clean the drain bowl and second level drain strainer screen while working to clean the drainage systems.

NRC made recommendations onsite to the Team regarding the drainage systems cleaning. The drain relief points were recommended to be cleaned at the second levels drainage plane. The debris blockages appeared to clog the pathway for moisture, in which immediate recommendations were made to promote relief of the waterproofing surface moisture. As a larger scale for the project, the areas at the interior perimeter of the building should be observed more closely. NRC recommends destructive surveying be performed at a localized area where the waterproofing transitions into the structure. This destructive surveying would promote further understanding of the drainage pathways for surface moisture at the Curtain Wall and waterproofing levels. Throughout limited observations, it appeared the pathways for moisture were hindered by concrete and overburden installations. The pathways at the building connection may need to be created to promote relief of moisture from the building connection and direction of this moisture to the cleaned drainage system. Once the destructive surveying is performed, more information may be provided regarding the waterproofing system transitions. At this time, NRC can only speculate what is currently installed. The system appeared to be a hot applied asphalt but this is unknown. The drainage mat was observed inverted in one small location, in which the proper drainage pathways may be hindered below the concrete topping pour. Correction of the drainage plane and systems components may be needed to promote reduced moisture intrusion potentials. Details with the waterproofing and Curtain Wall system may need to be corrected once further knowledge is obtained.

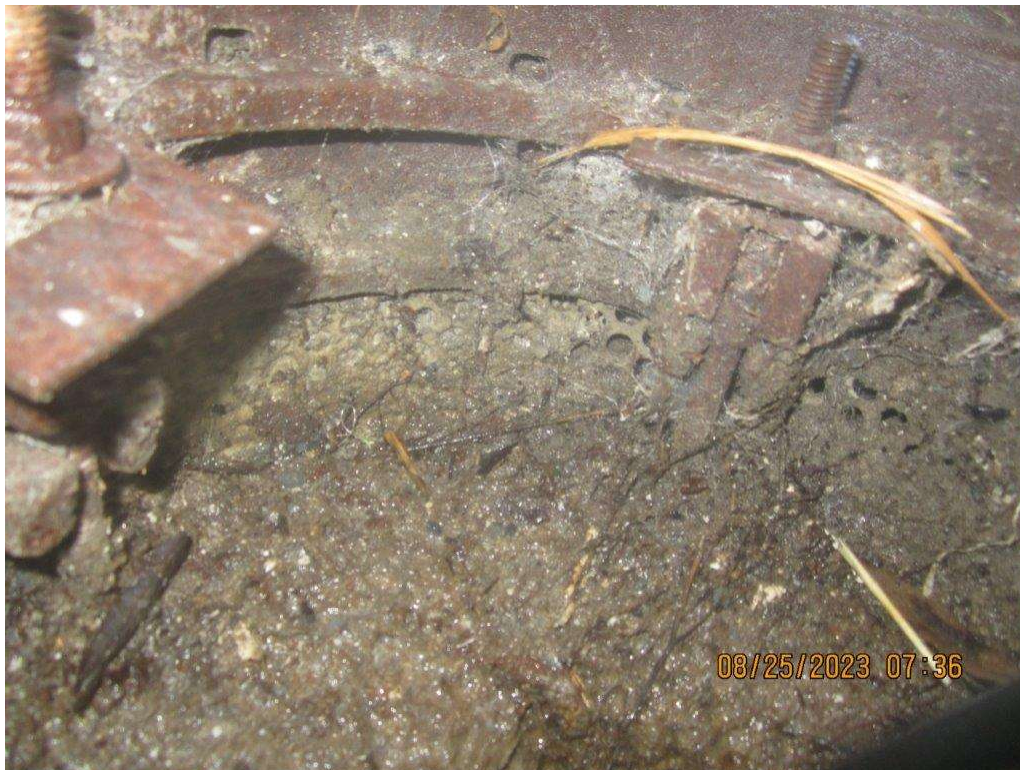
The drainage system was observed clogged with debris at the waterproofing level. NRC recommended cleaning the strainer of debris to promote relief of moisture at the waterproofing level. Once cleaned, the moisture from the waterproofing system should relieve as designed to reduce pressure on the surrounding components. Further destructive surveying is recommended to be performed to understand the construction make-up of all waterproofing components.

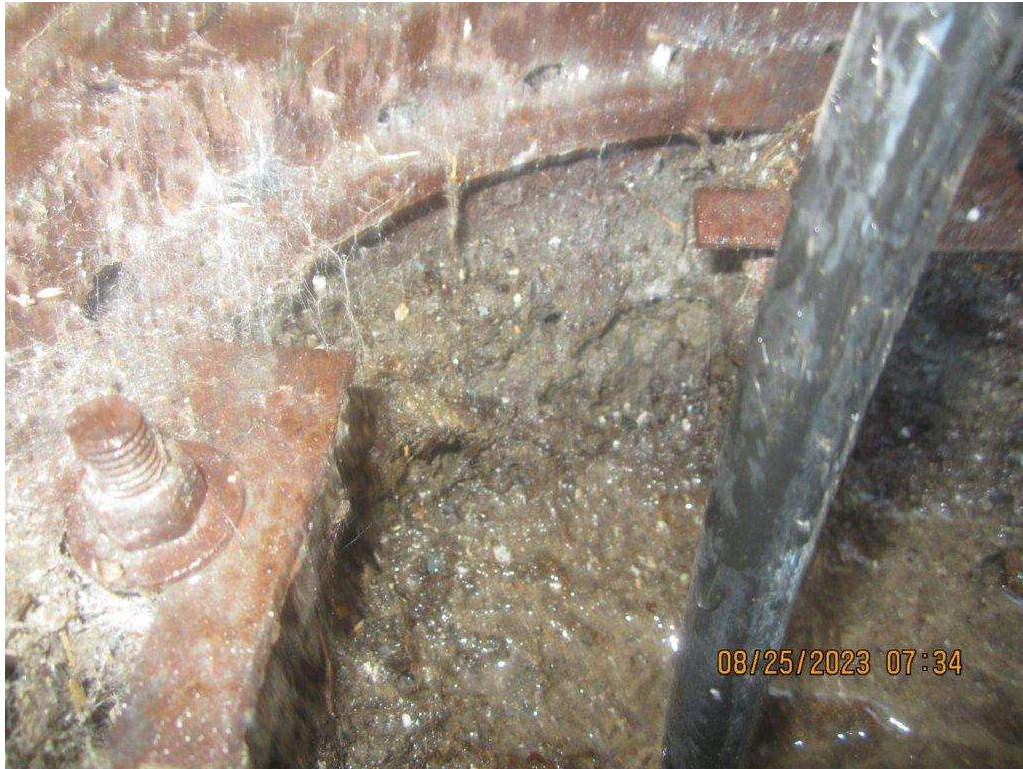
The debris blockages observed in the drainage system component was recommended for cleaning. Significant blockage was observed at multiple drain locations. The technicians were made aware of the recommendations as they were not intending to clean these areas.

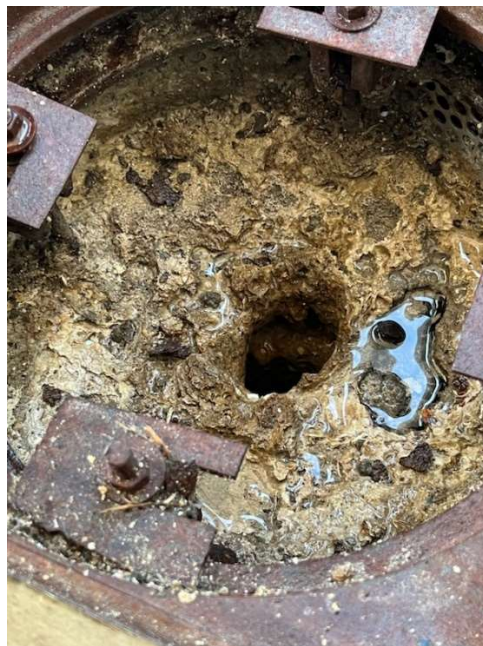
Cleaning was reported to have occurred but the strainers remained to be clogged in areas surrounding the drain bowl.
