**TOWN OF LINDEN PRELIMINARY ENGINEERING  
REPORT  
WASTEWATER SYSTEM IMPROVEMENTS  
AMERICAN RESCUE PLAN**

Perry County, Tennessee

**COLLECTION SYSTEM AND LAGOON REHABILITATION**

**PRELIMINARY ENGINEERING REPORT**

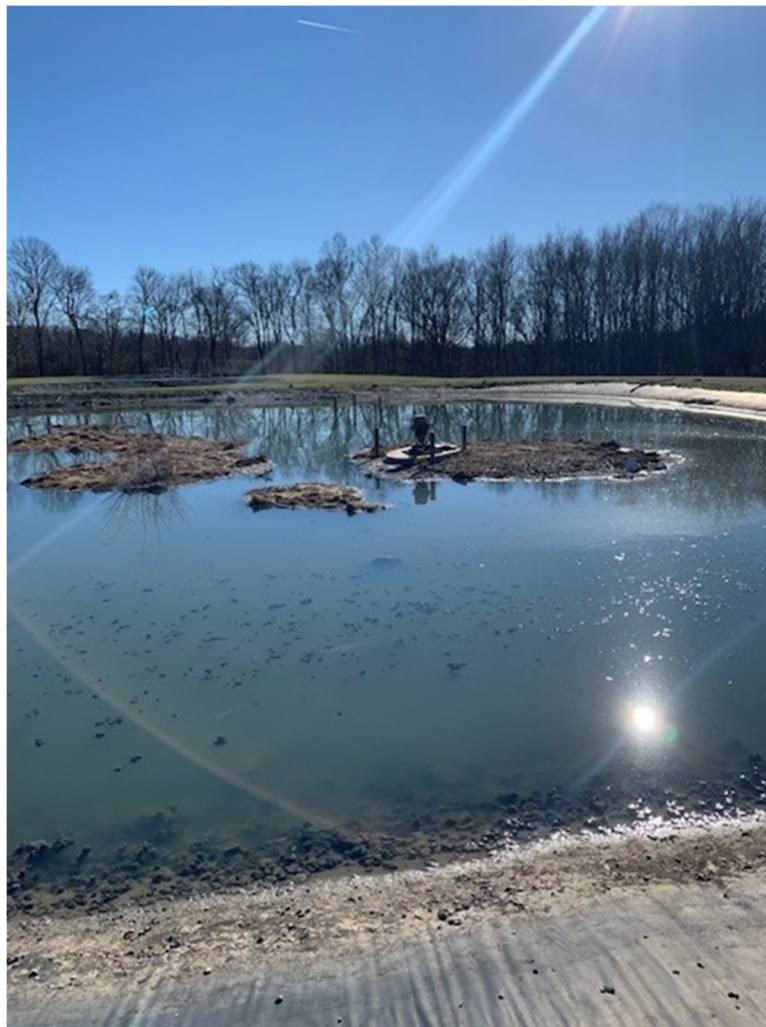
*Figure 1 - Existing Cell #1*

The lagoon is also showing an extremely high sludge level in Cell #1. If excessive accumulation of sludge in wastewater lagoons is not removed, it can disrupt the treatment process by reducing the lagoon's water holding capacity, thus decreasing the amount of time available for proper treatment. As a result, there can be an increase in the concentrations of BOD and TSS in the effluent. In certain cases, the anaerobic digestion of sludge can even result in the release of ammonia into the lagoon's water column. This can lead to a situation where the concentration of ammonia in the effluent is higher than that in the influent.

The purpose of this report is to address the issues with inflow and infiltration and excessive sludge in the initial lagoon cell. The I&I issue is a critical need issue for the collection system and affects the treatment process. The sludge accumulation has made cell #1 aerators near inoperable due to the depth.

- B. Sludge removal – The project proposed will pump and remove the excess sludge from cell #1. Linden’s wastewater treatment plant utilizes a lagoon system that is over 30 years old. Sludge removal is needed to maintain a state of good repair for the treatment plant and to remain in compliance with state wastewater regulations. This need has been identified by TDEC inspections and the immediate need is evident by the photo below shown previously in this report.

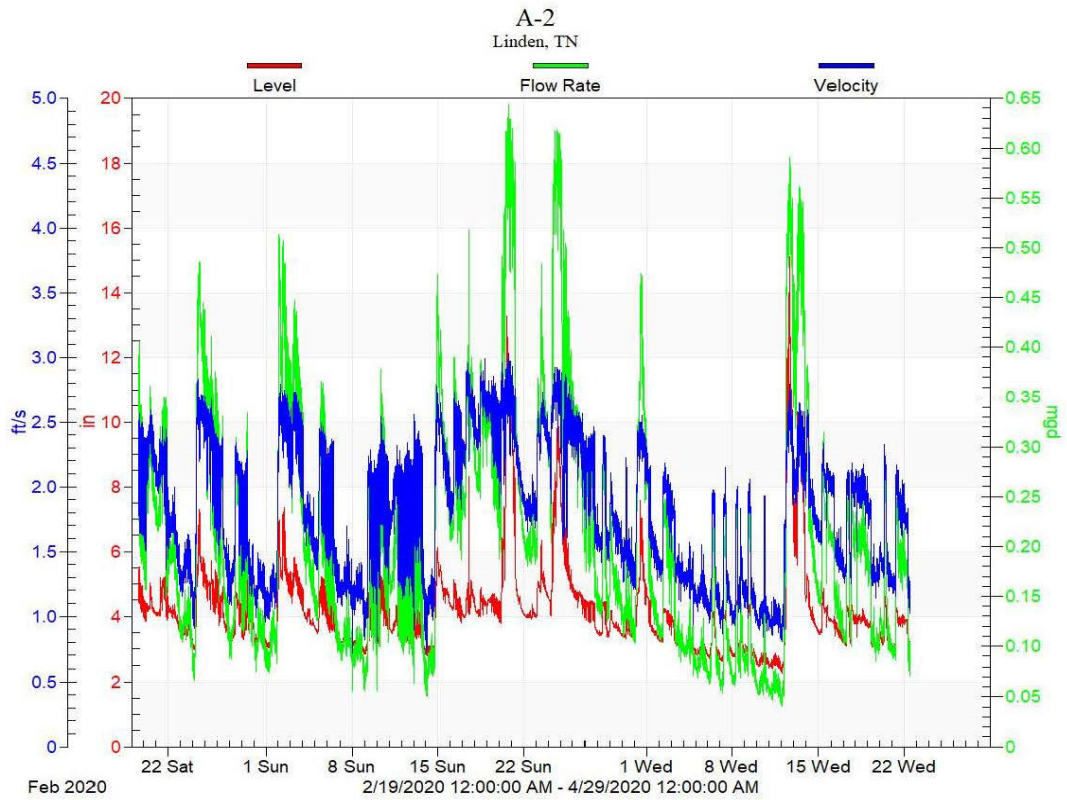
**Manhole Number:** A-2

Site A-2 measured flows from the southern-most portion of the Town and was one of two monitors measuring flow to the Elm Lane PS (a third tributary to the PS was not monitored). Flow rates near 0.094 MGD increased to over 0.600 MGD during peak wet weather conditions. Dry weather depths and velocities averaged 3.0 inches at 1.0 fps in an 8-inch pipe; peak recorded depths were 15 inches.

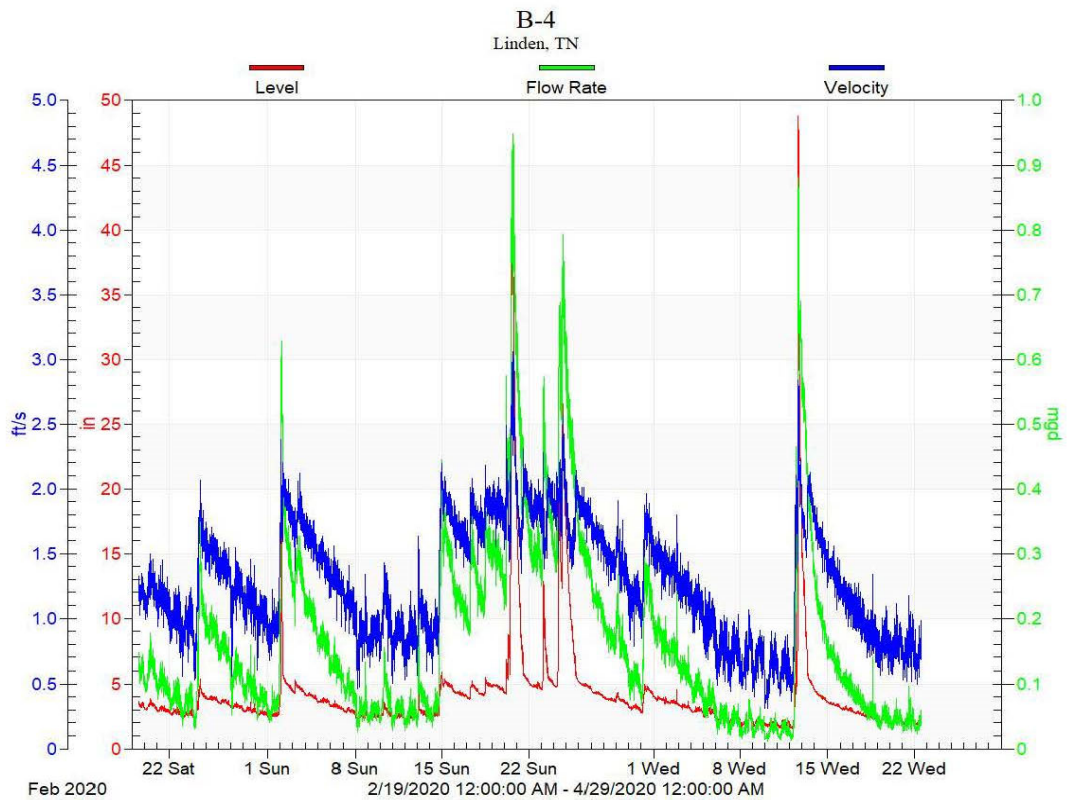
**Manhole Number:** B-4

Site B-4 measured flows from the Shelton St/Brookside Dr area and was one of two monitors measuring flow to the Elm Lane PS (a third tributary to the PS was not monitored). Flow rates near 0.035 MGD increased to over 0.900 MGD during peak wet weather conditions. Dry weather depths and velocities averaged 2.10 inches at 0.7 fps in a 10-inch pipe; peak recorded depths were 49 inches.

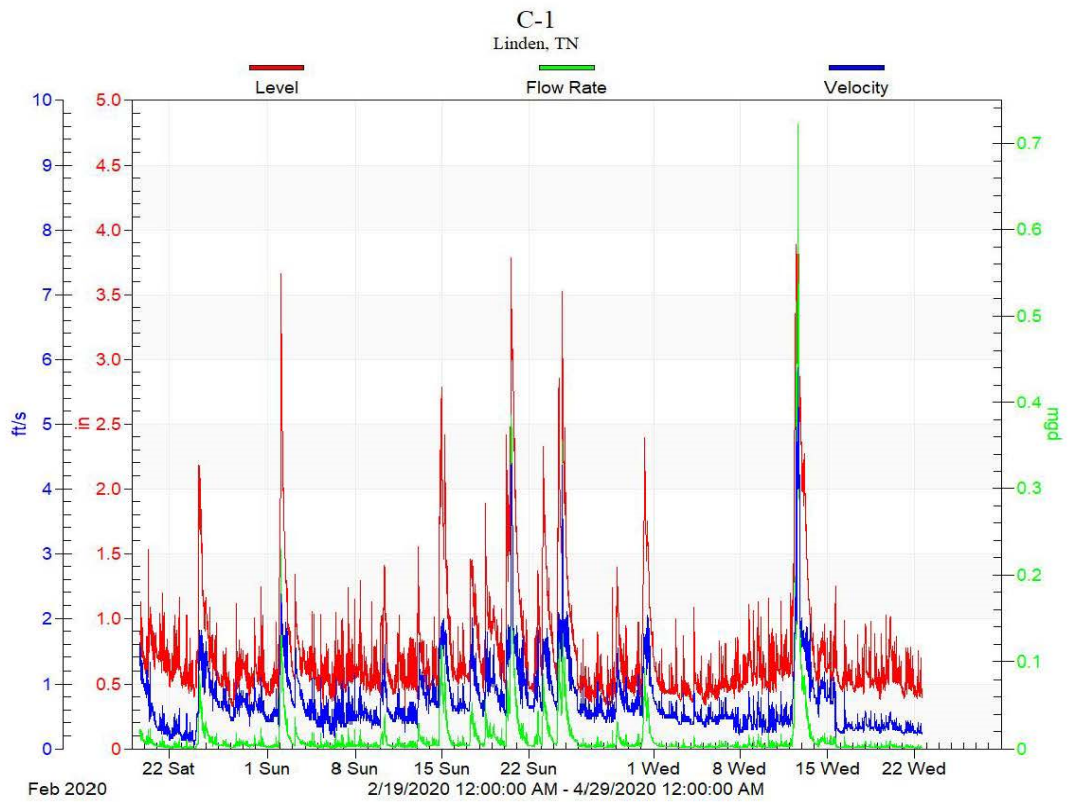
**Manhole Number:** C-1

Site C-1 measured flows tributary to the River Street PS. Very low flow rates near 0.003 MGD increased to over 0.700 MGD during peak wet weather conditions. Dry weather depths and velocities averaged 0.5 inches at 0.5 fps in an 8-inch pipe; peak recorded depths were 4.5 inches.

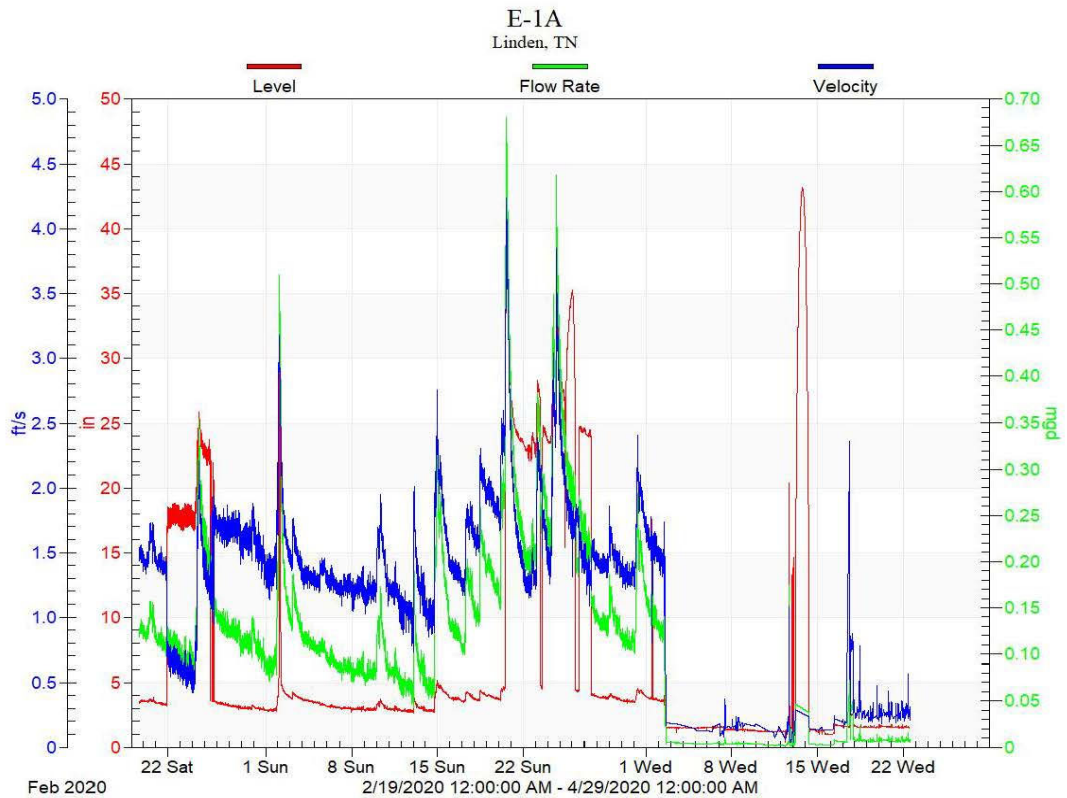
**Manhole Number:** E-1A

Site E-1A measured flows from the downtown/School St portion of the Town and was one of two monitors measuring flow to the Treatment Plant PS. Flow rates near 0.072 MGD increased to almost 0.700 MGD during peak wet weather conditions. Drier weather depths and velocities averaged 2.7 inches at 1.1 fps in an 8-inch pipe; peak recorded depths were near 43 inches.

Site E-1A's flows abruptly fell from near 0.120 MGD to near zero on April 2, 2020 and never returned to normal for the remainder of the study period (it surcharged during the April 12-13 rain event due to backwater from the Treatment Plant PS). This latter portion of the study period contained both the lowest and highest flows at other locations, so the above-stated dry and peak flow rates may not be totally comparable with other locations.

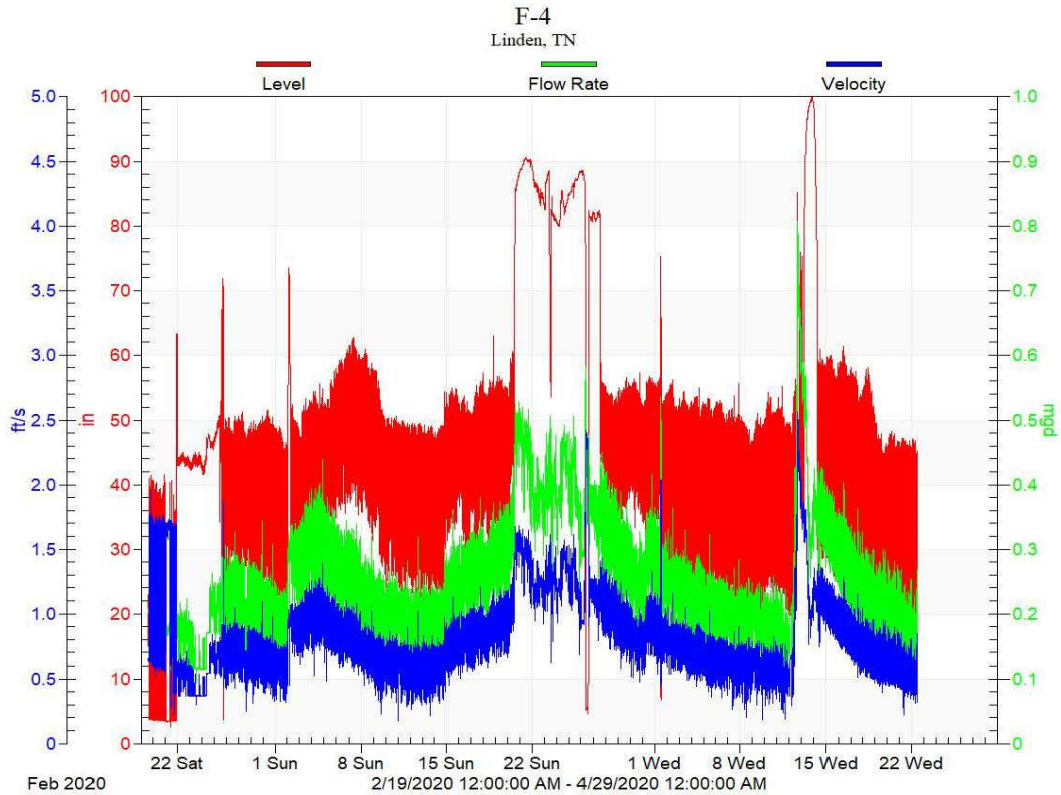
**Manhole Number:** F-4

Site F-4 measured flows from the northern-most portion of the Town and was one of two monitors measuring flow to the Treatment Plant PS. Flow rates near 0.164 MGD increased to near 0.800 MGD during peak wet weather conditions. Dry weather depths and velocities averaged 31 inches (surcharged) at 0.5 fps in a 10-inch pipe; peak recorded depths were 100 inches (the manhole is only 61 inches deep).

Depths at Site F-4 were only 3.5 inches deep during installation and first round data collect. Late April 21, however, the site surcharged to 45+ inches. Except for a few very brief periods, F-4 remained surcharged for the rest of the study. The surcharged depths are likely due to raised pumping elevations at the downstream Treatment Plant PS.
