**STRUCTURAL INSPECTION OF  
FORD HOUSE AT CEDARS OF  
LEBANON STATE PARK**

**HR # 194-1432**

**STATE OF TENNESSEE  
REAL ESTATE ASSET MANAGEMENT  
TENNESSEE TOWER, 24<sup>TH</sup> FLOOR  
312 ROSA L PARKS AVE.  
NASHVILLE, TENNESSEE 37243**

**JUNE 10, 2022**

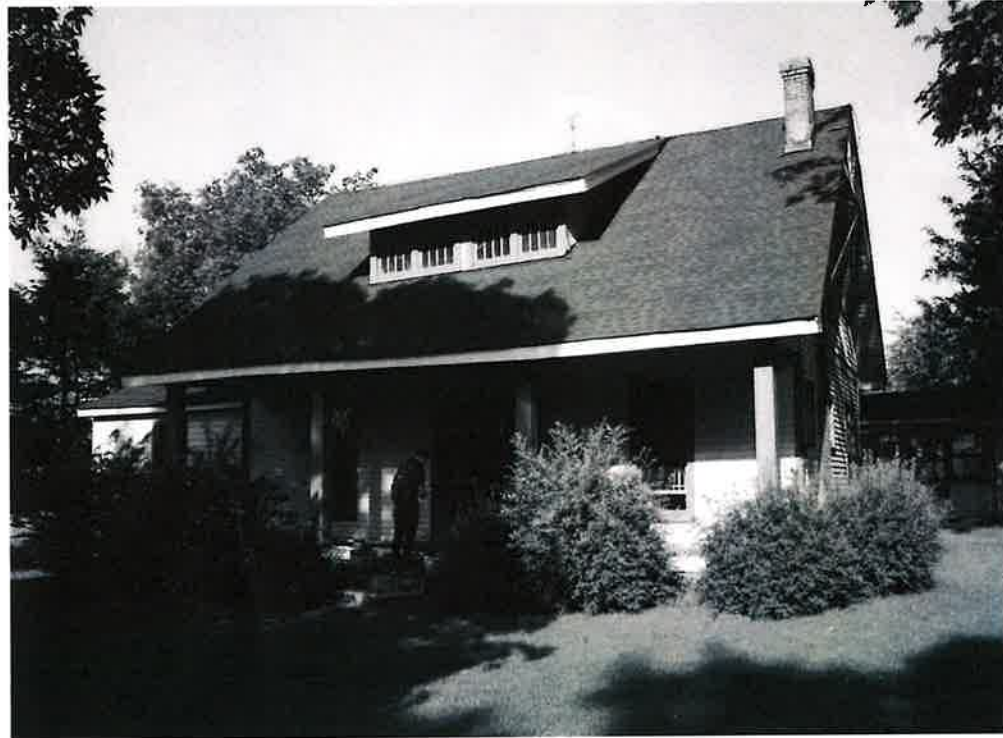
Photo No. 1. Overall building.

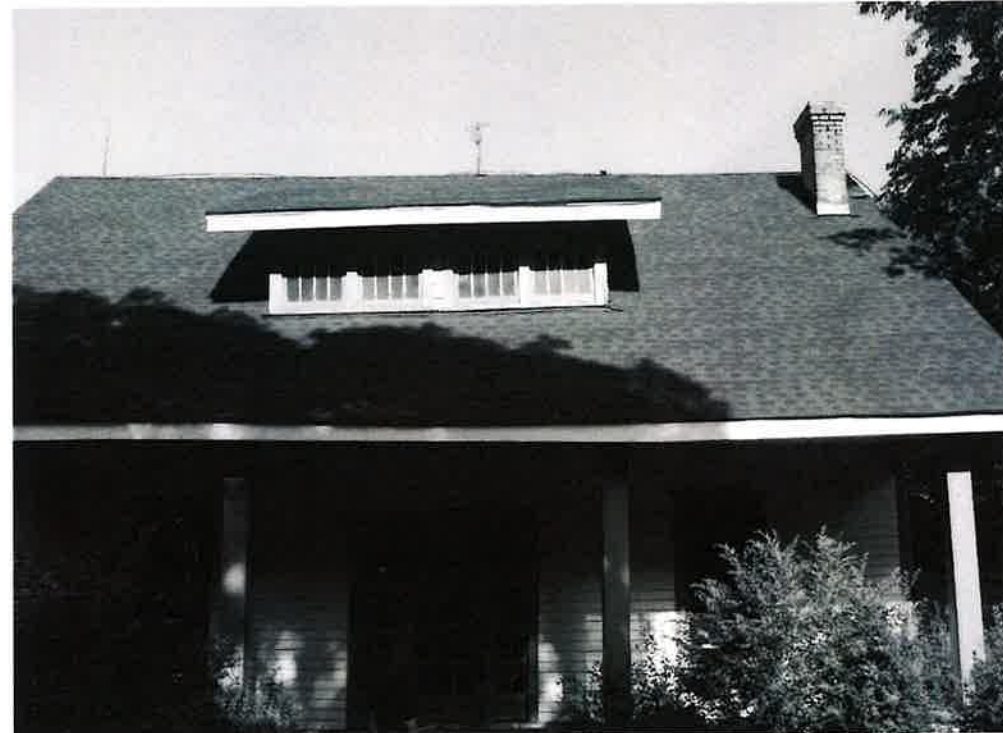
Photo No. 2. Exterior east elevation.

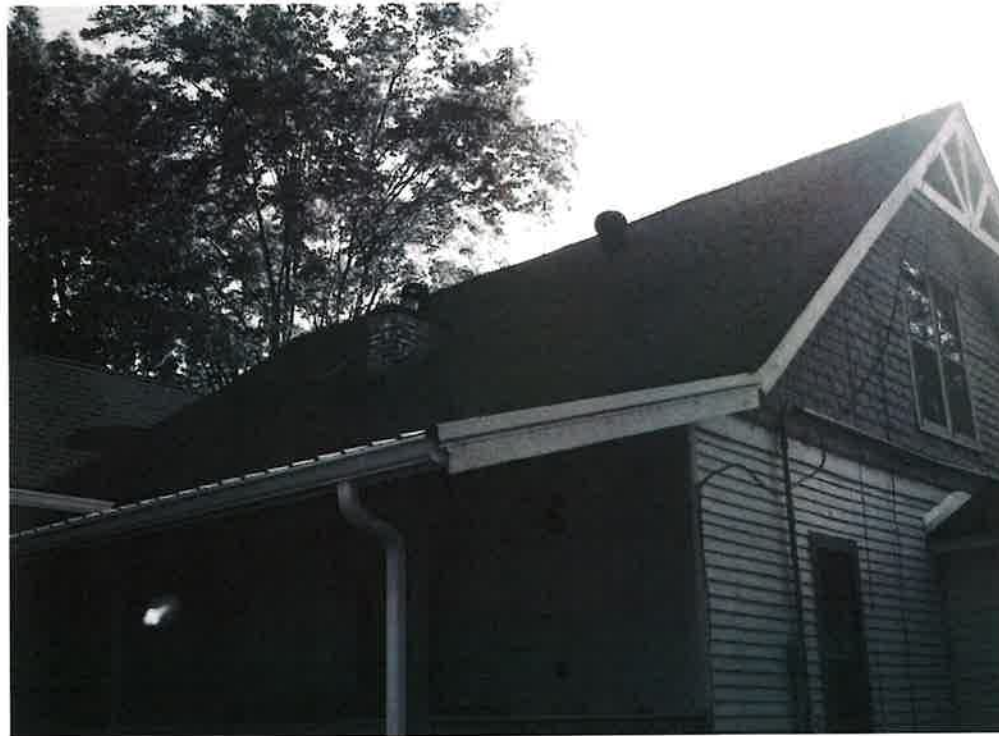
Photo No. 3. Northwest elevation.

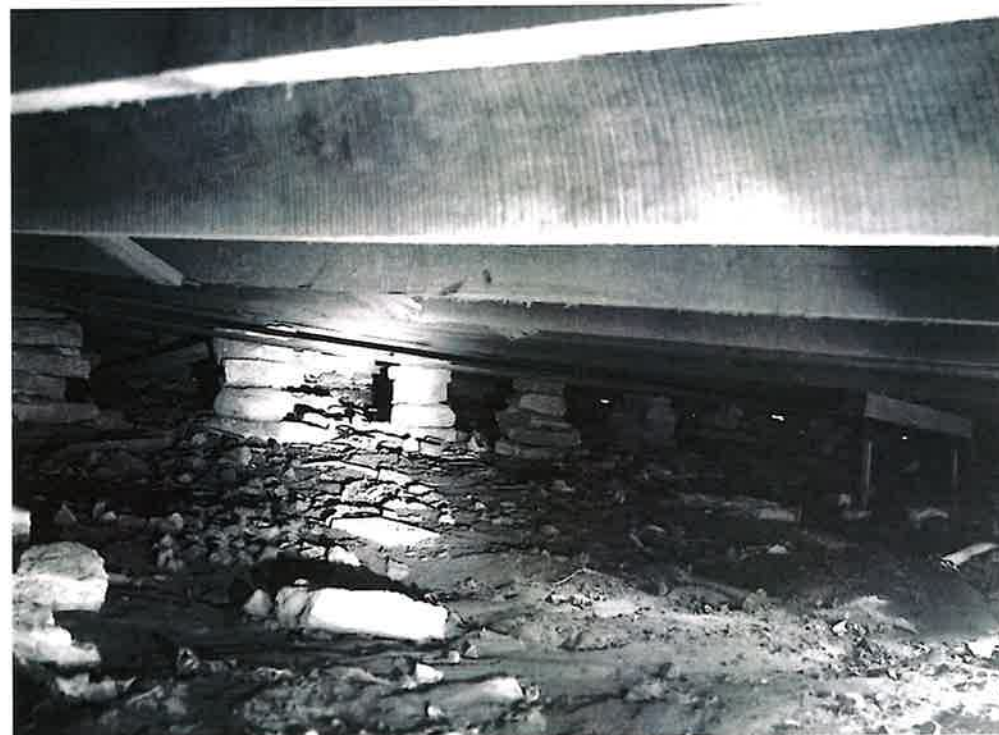
The single stone foundation was observed to be small in size and without a positive connection. No positive connections between the support framing and stone piers were observed nor between individual stones in the same pier indicating a friction connection.

Photo No. 4. Individual stone piers at interior support.

- Individual stone piers shall be replaced with load bearing CMU pier. This may include leaving the stone pier in place with adding fully grouted CMU pier in between existing piers.
- Replace wood sill on the east side of the main building. Align joists to proper bearing heights with new CMU supports prior to replacement of wood sill.
- Add positive properly designed connections from the building structure to the foundation to allow for proper transfer of lateral loads.
- Replace the porch joist framing.
- Replace the southern most exterior column support. In addition, provide proper bearing connections for all four columns to the foundation. The main girder and 3 northern most columns shall be exposed for further assessment. Prior to installation, the attic framing shall be set back to the proper bearing height.
- The masonry chimney shall be repointed above the roof line.

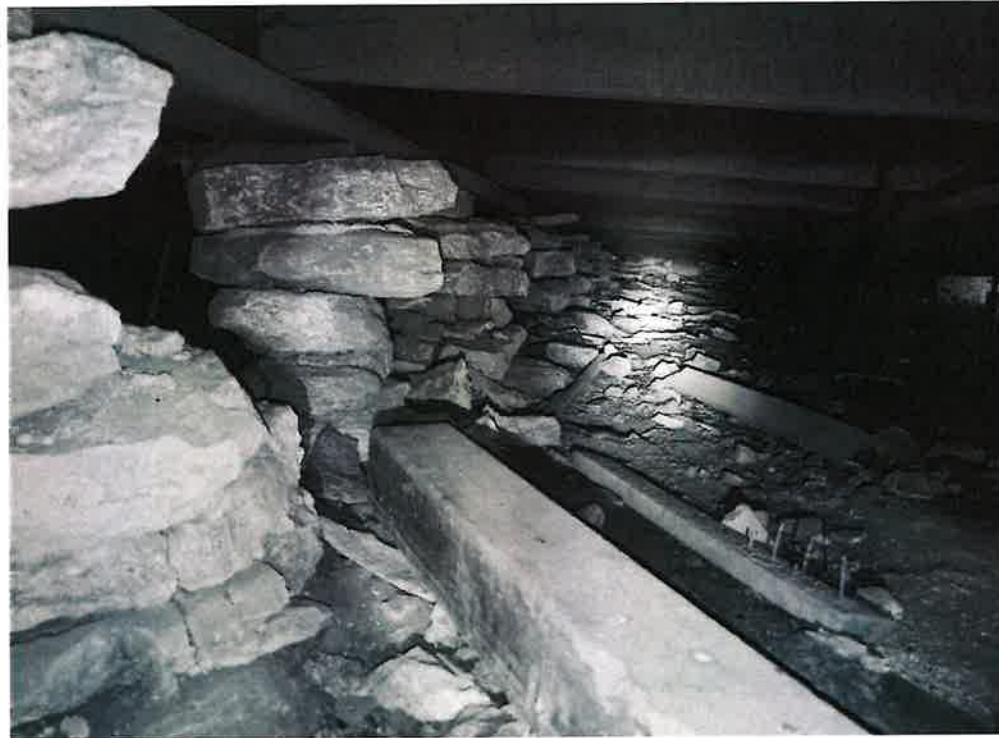
Photo No. 5. Individual stone pier foundation at interior support.

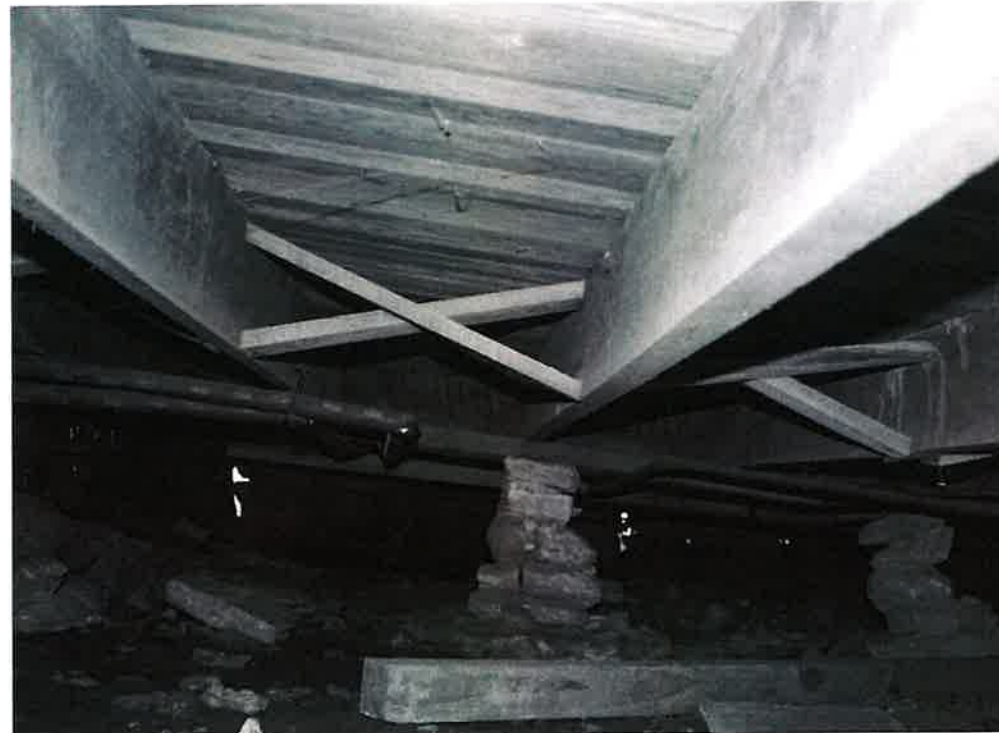
Photo No. 6. Stone pier with crack.

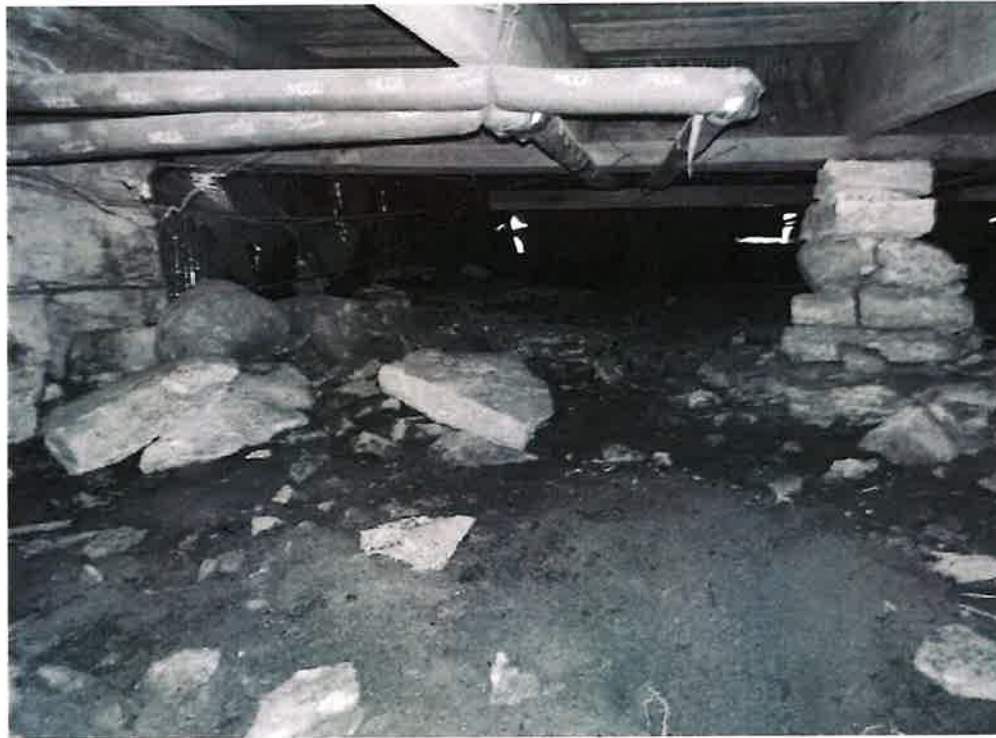
Photo No. 7. Stone pier that has fallen over.

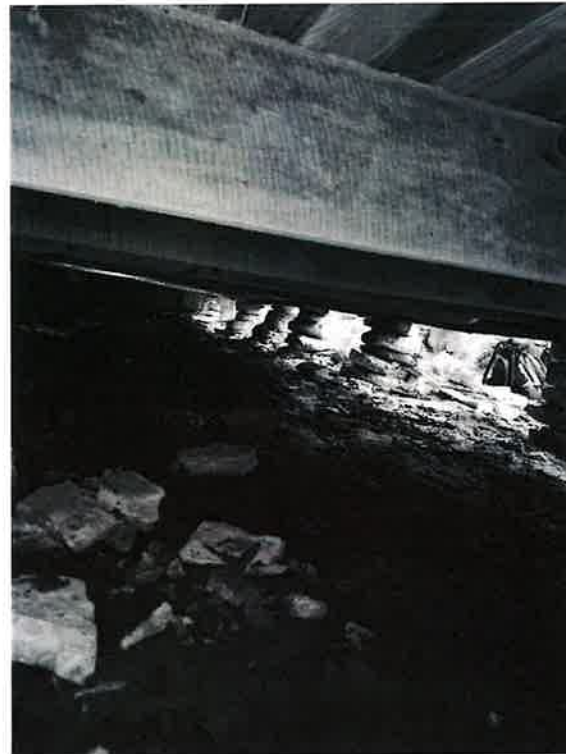
Photo No. 8. Individual stone piers on east portion of building.

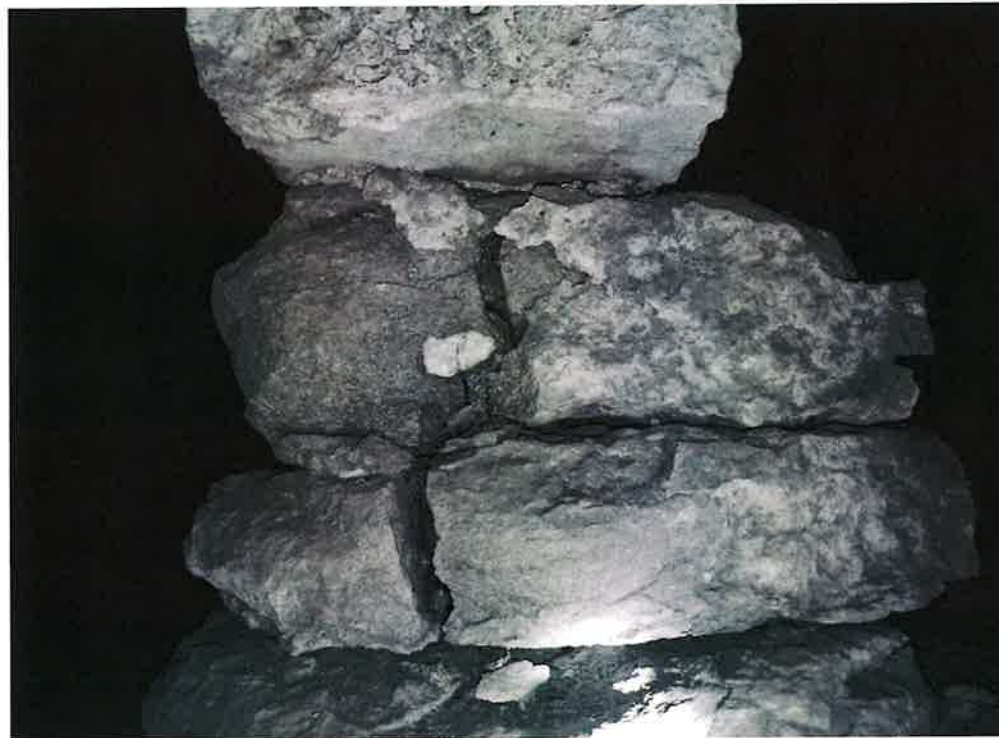
Photo No. 9. Cracks developed in stone pier.

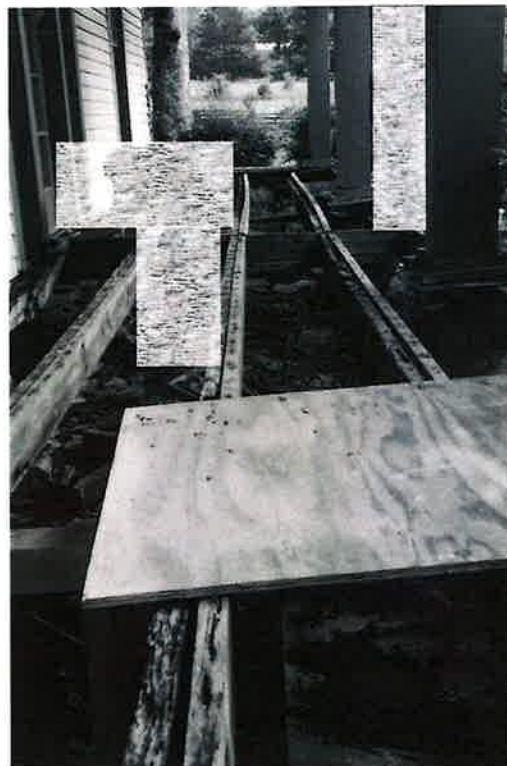
Without the wood decking, the porch framing was observed to be in poor condition. The floor joists spanning approximately 18' were rehabbed at some point, but both members were observed with section loss due to deterioration. The original joists were observed to have as much as 80% section loss, leaving the 2x6 reinforcing joists to carry most of the load. The reinforced member added to the original joist was observed to have as much as 50% section loss. The main girder spanning 6' supporting the floor joists at the center of the porch was observed to have as much as 25% section loss. Both termite and water damage were visible on the wood framing as probable cause of the deterioration. Deflection of approximately 1.5" was observed at the wood sill member of the east entrance near the front door of the building. The wood sill member spans approximately 3' between the stone piers. With removal of the porch deck, it was observed that most of the contact area for the bearing support of the four exterior columns have been reduced. The southern most column was observed with significant section loss at the base of its column. The amount of deterioration of this column at its base has even created a loose connection at its base. Based on this deteriorated supported, the main girder running over the top of the exterior columns that also supports the roof framing has deflected significantly.

Photo No. 10. Porch joist framing.

The floor joists have deteriorated to a condition that full designed replacement would solve a lot of structural deficiencies in the floor framing. Proper positive connection and full size loading contact area between the column base and stone foundation shall be installed to maintain structural stability of the structure and maintain a direct load path. In addition, the southern most column has deteriorated to a condition that requires replacement. With the deterioration of the southern most canopy, the main girder support over the columns and the three remaining columns have increased their load from original construction. In the instance of the main girder, it has exhibited extreme deflections on the south end. It would be important to expose this girder and the remaining columns to ensure of their structural integrity. Prior to replacement, it would be important to raise the attic structure to an adequate bearing height to account for the deflection/sag that has occurred due to this structural deficiency.

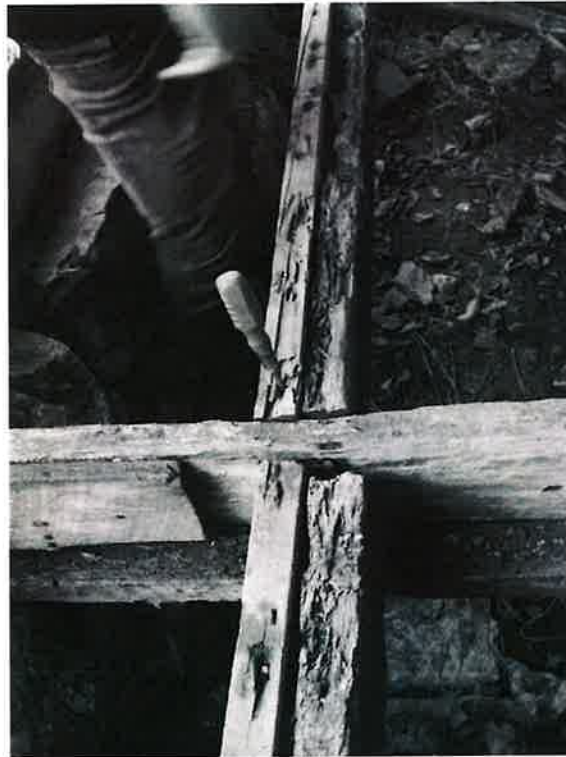
Photo No. 11. Section loss in front porch framing.

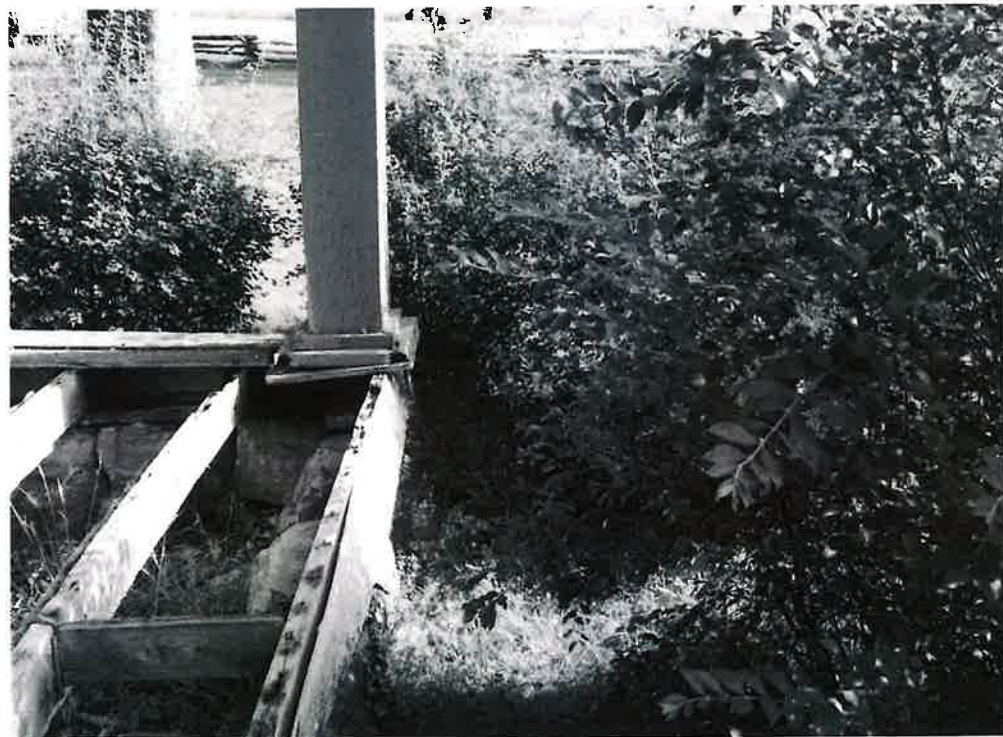
Photo No. 12. Improper supported column base.

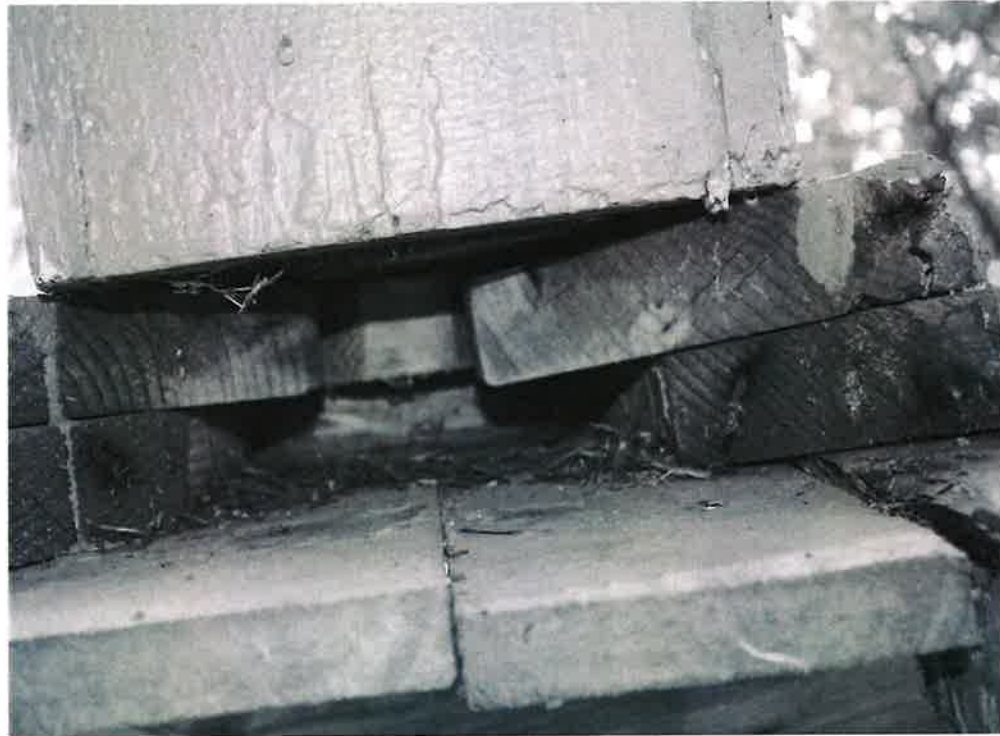
Photo No. 13. Closeup of column base.

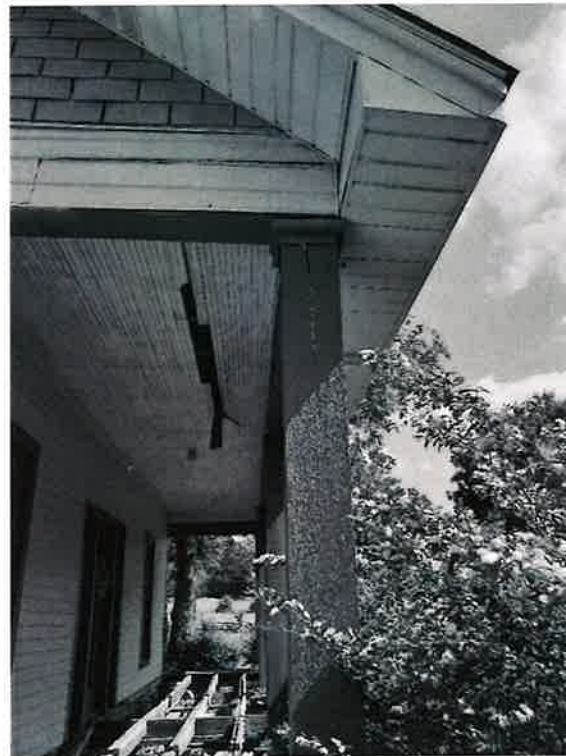
Photo No. 14. South column of porch framing.

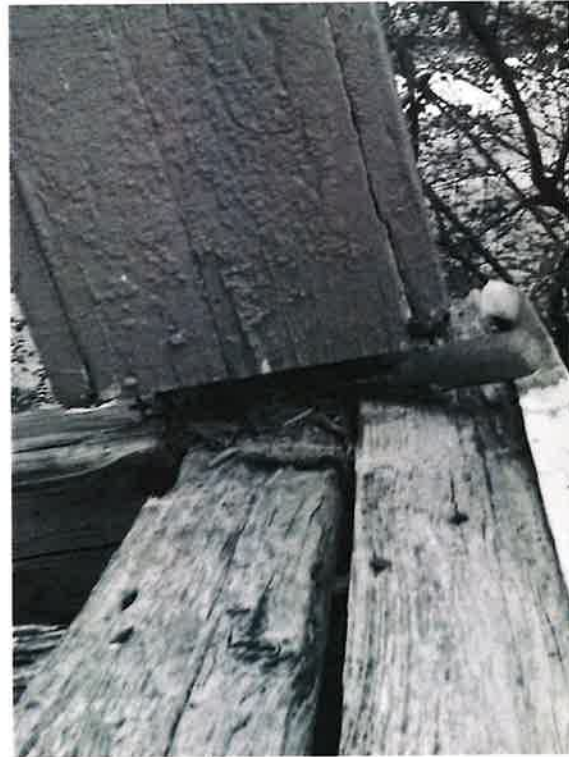
Photo No. 15. Base at south column of porch framing.

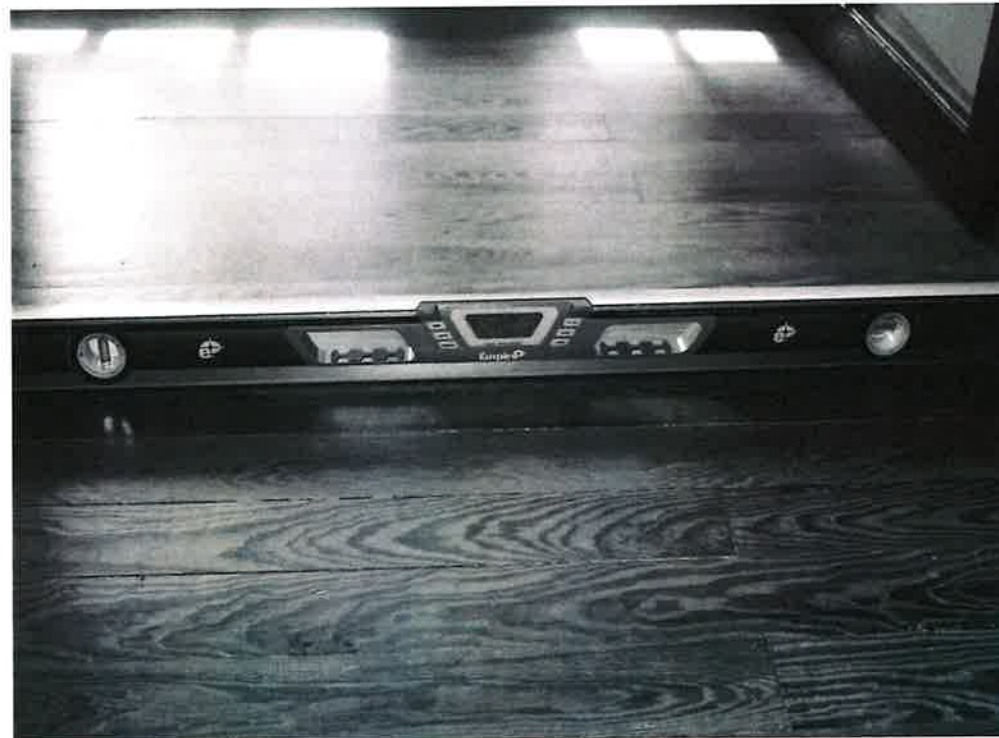
Floor joists beneath the main building were observed to be in fair condition. Floor deflection was measured from above in varying degrees from 1.2° to 2° over a 4' level perpendicular to the joist span throughout the building. Based on observations, these deflections appear to be based on their supports more than the joist itself. The east wood sill plate between the porch and main building has deteriorated with major section loss and developed major deflections between individual piers. Section loss of an estimated 20% of the joists was observed from probing on the wood joists. It shall be noted that some areas were inaccessible under the 1<sup>st</sup> floor access. Rehabilitated framing consisting of steel circular jack posts and 4x4 wood member supporting the midspan of the floor joists were observed to be in good condition; it is unknown why they were installed. At the southwest location only one steel column support is used, and the support frame utilizes a cantilever beam action to aid in the load transfer.

Photo No. 17. 2-degree slope in first floor near east elevation running north to south.

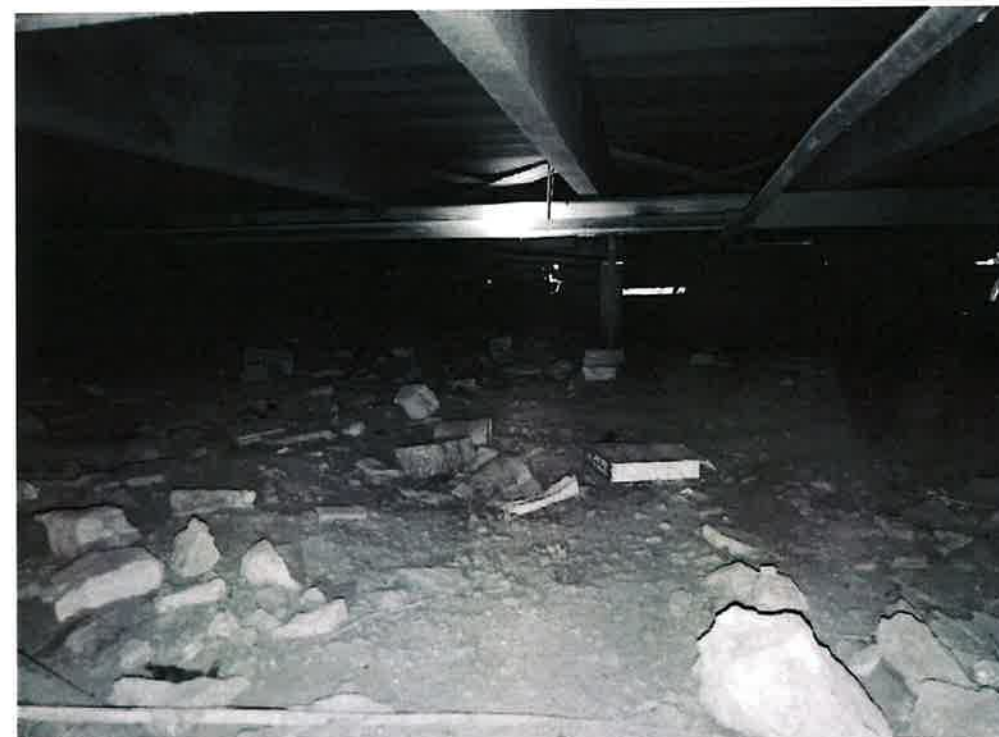
Photo. No. 18. Cantilever rehabilitation support with small foundation.

- Repair of cracks on the continuous exterior continuous stone foundation.
- Replacement of the foundation of the rehabilitation framing of the 1<sup>st</sup> floor joists that are properly designed and anchored.
- 1<sup>st</sup> floor joists that exhibit deterioration shall be reinforced to bridge the full section members together.
- Rehabilitation framing on the southwest portion shall install an additional column or two.

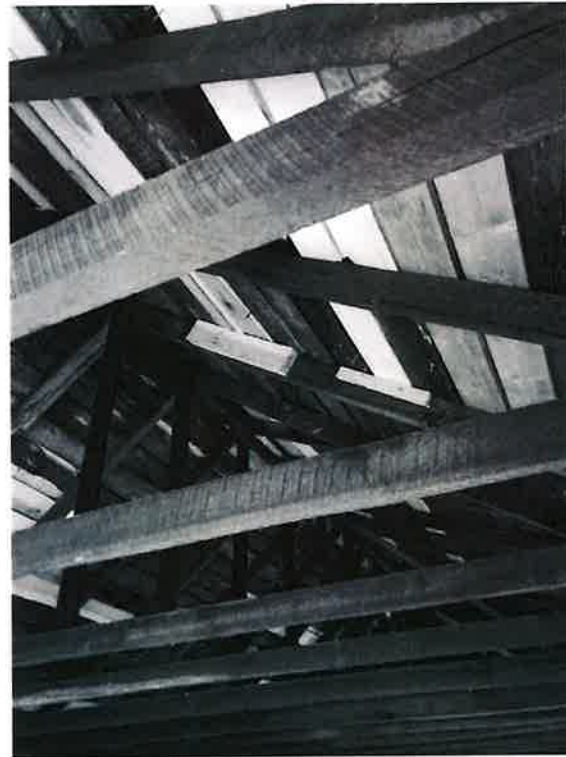
Photo No. 19. Typical truss chord rehabilitation.

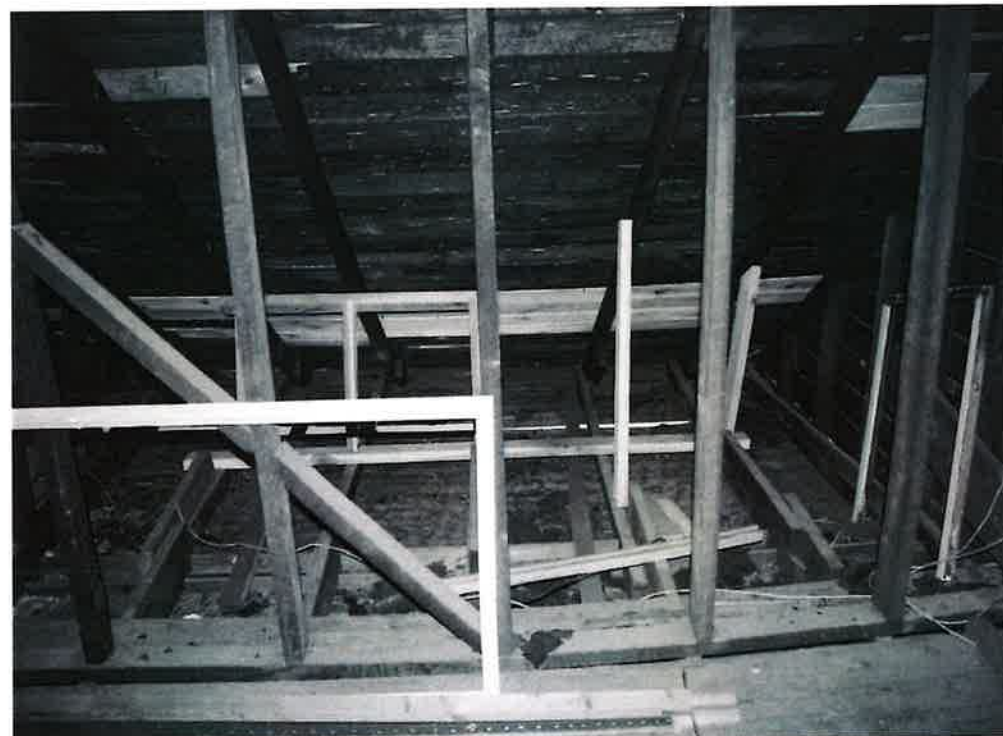
Photo No. 20. Truss rehabilitation with differential load path.

- Roof trusses with structural deficiencies shall be reinforced.
- Roof truss connections shall be attached properly.
- Rehabilitated framing in the attic shall verify its proper design or remove and reinforce structural members to maintain correct load path.
- Add caulking around openings in the building to prevent water infiltration into the building envelope.

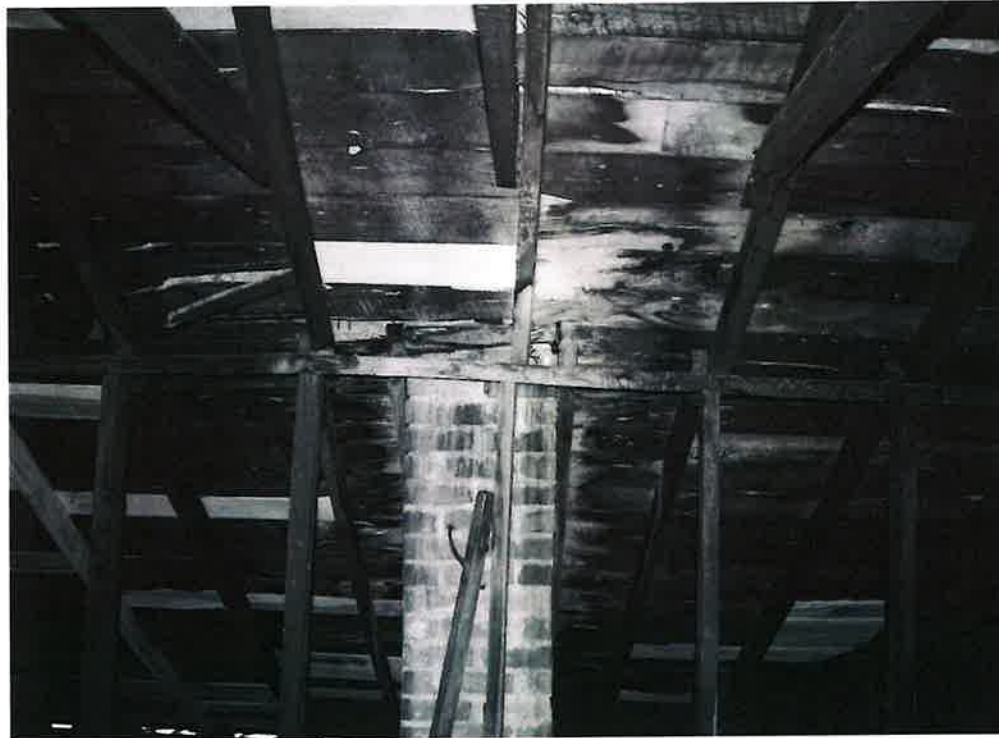
Based on observations in the attic, water has the ability to penetrate the building's envelope due to the observed gaps around window frames and chimney penetrations.

Photo No. 21. Water staining at current members with chimney penetration.

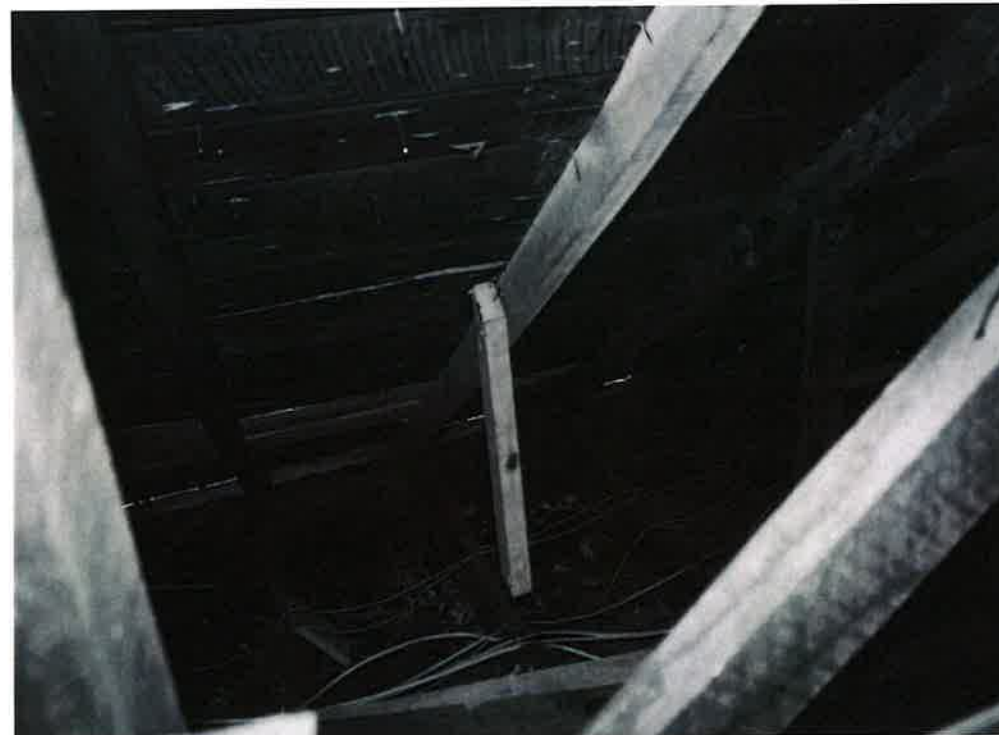
Photo No. 22. Connections at bracing with gaps.

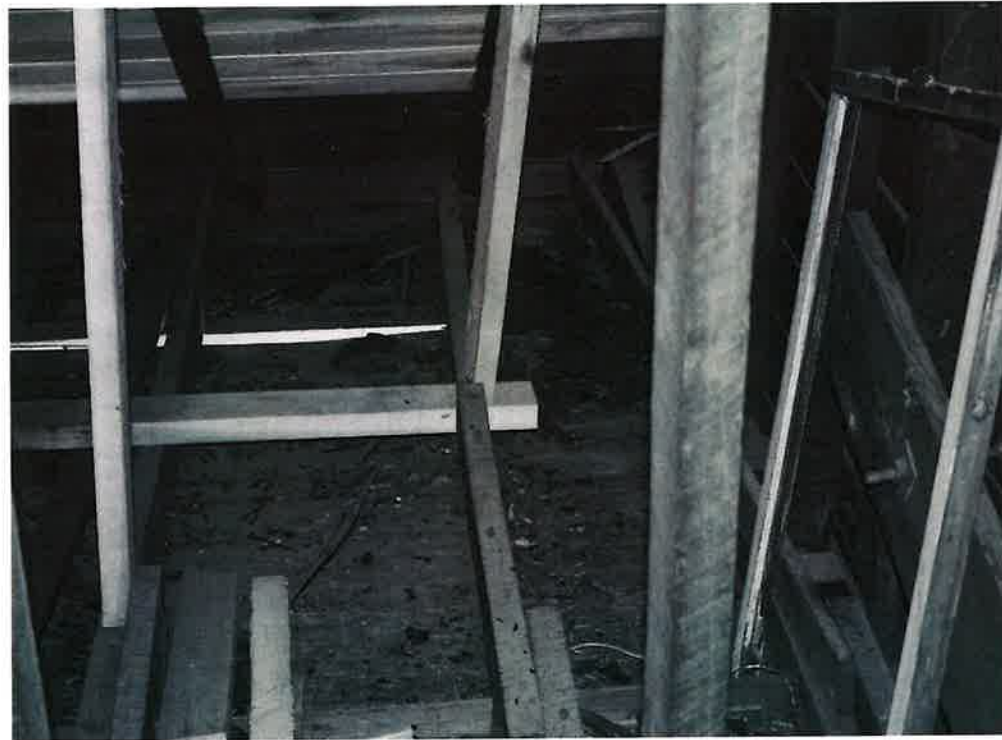
Photo No. 23. Porch ceiling framing changes size midspan.

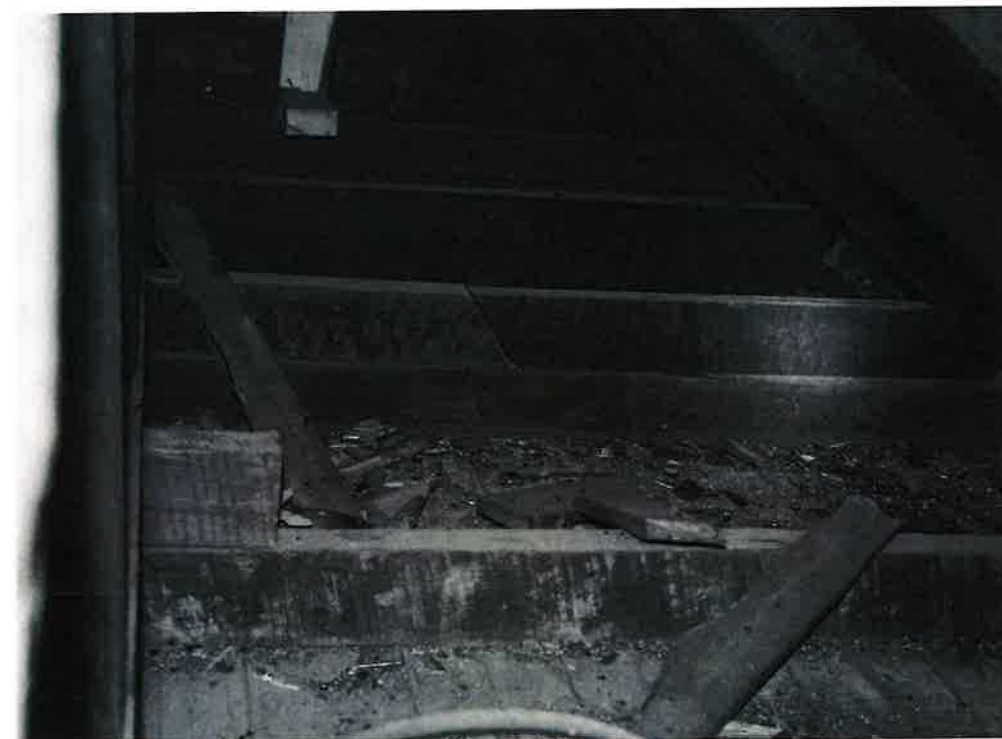
Photo No. 24. Porch ceiling framing with cracks at midspan.

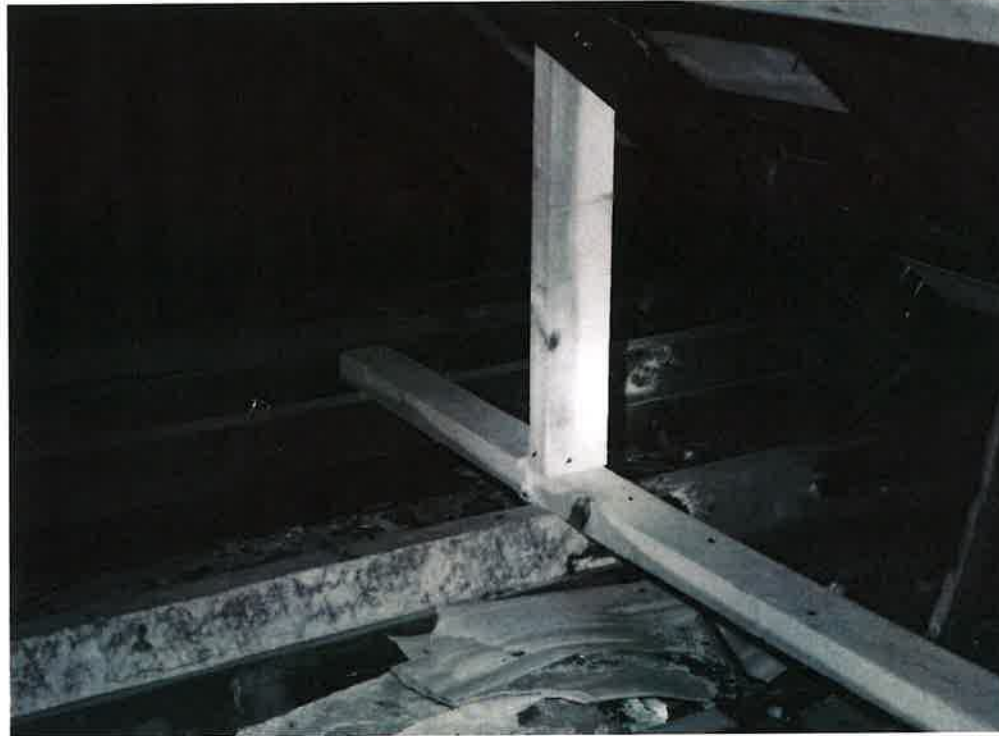
Photo No. 25. Rehabilitation framing with redistribution of load.

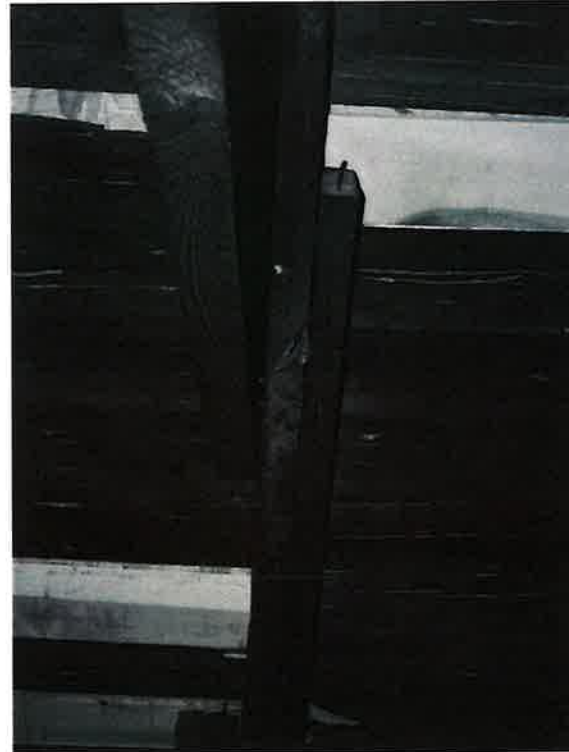
Photo No. 26. Gap at connections of roof trusses.

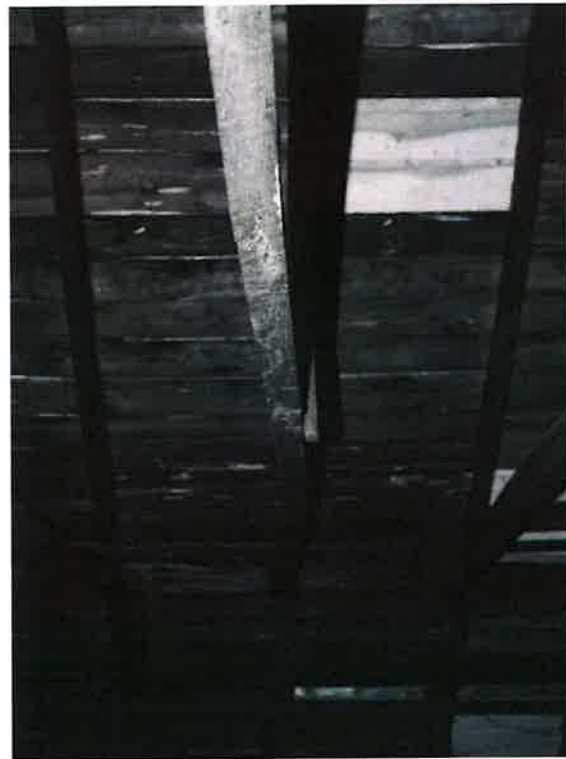
Photo No. 27. Warped bottom chord of roof trusses.

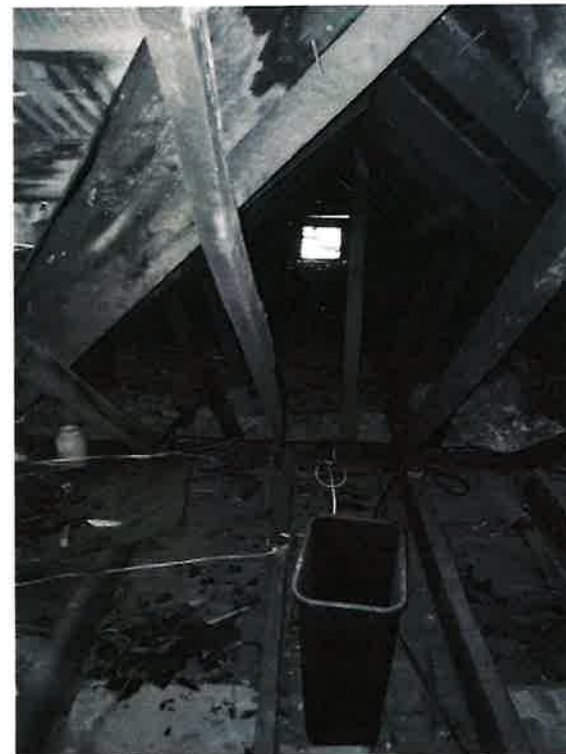
Photo No. 28. Warped top chord of roof truss near framing above kitchen.

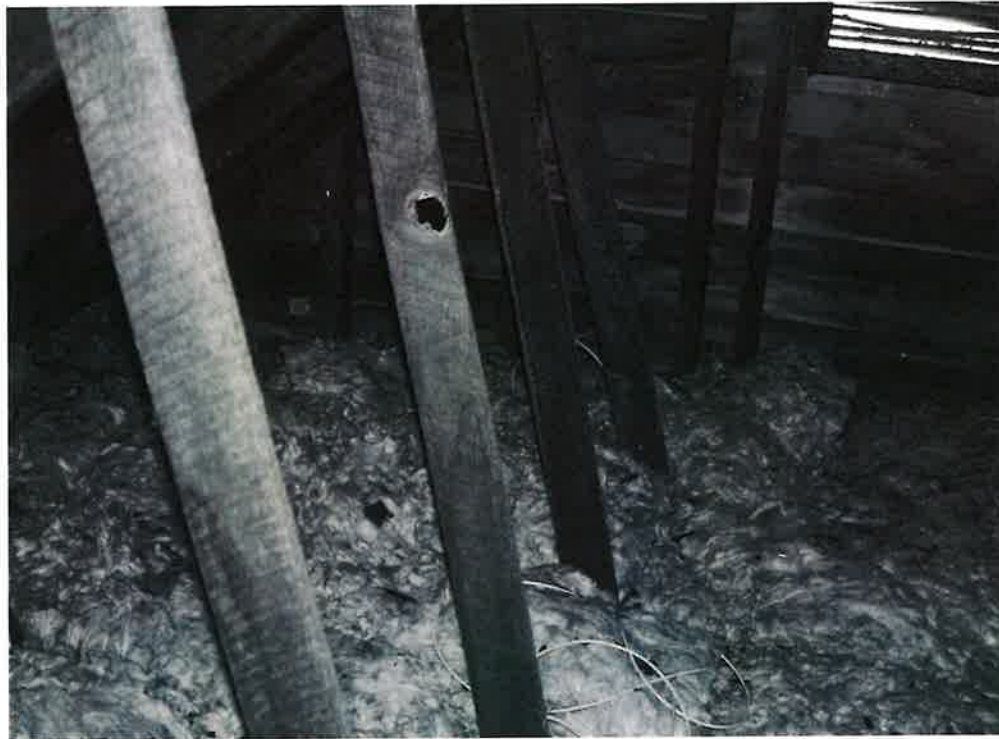
Photo No. 29. Typical warped truss webs above kitchen area.

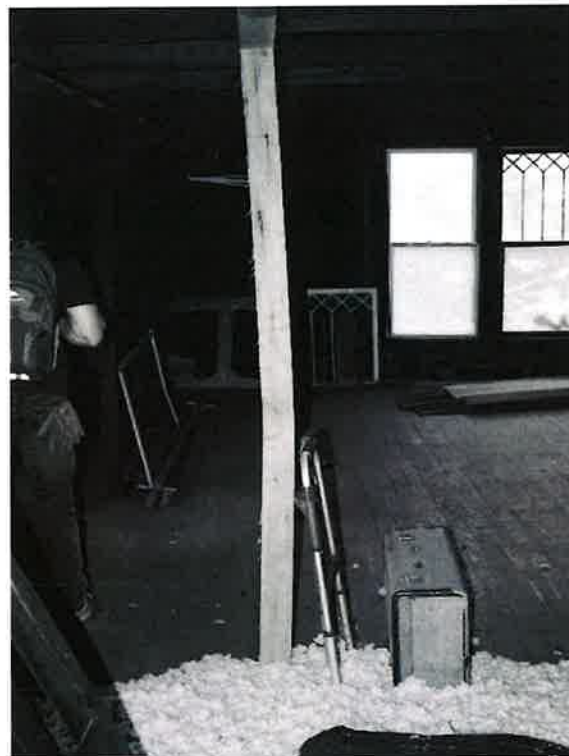
Photo No. 30. Rehabilitation frame for attic truss that redistributes load path.

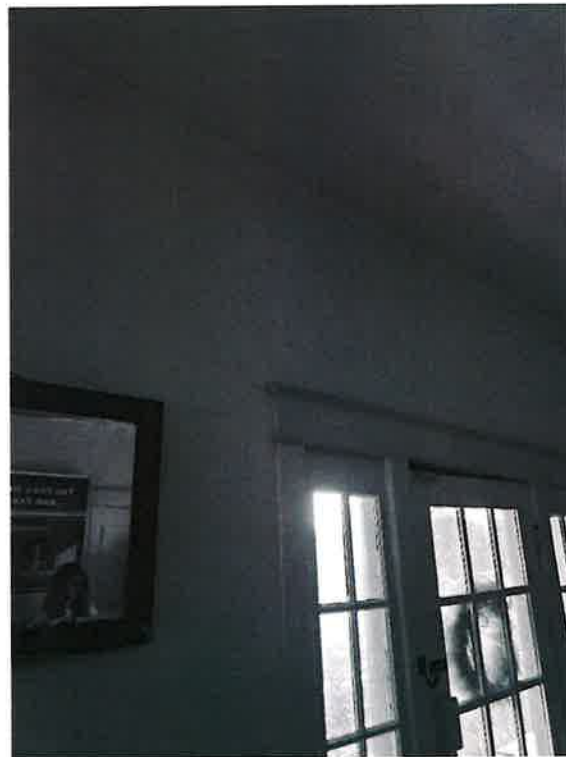
Photo No. 31. Crack in wall beneath attic.

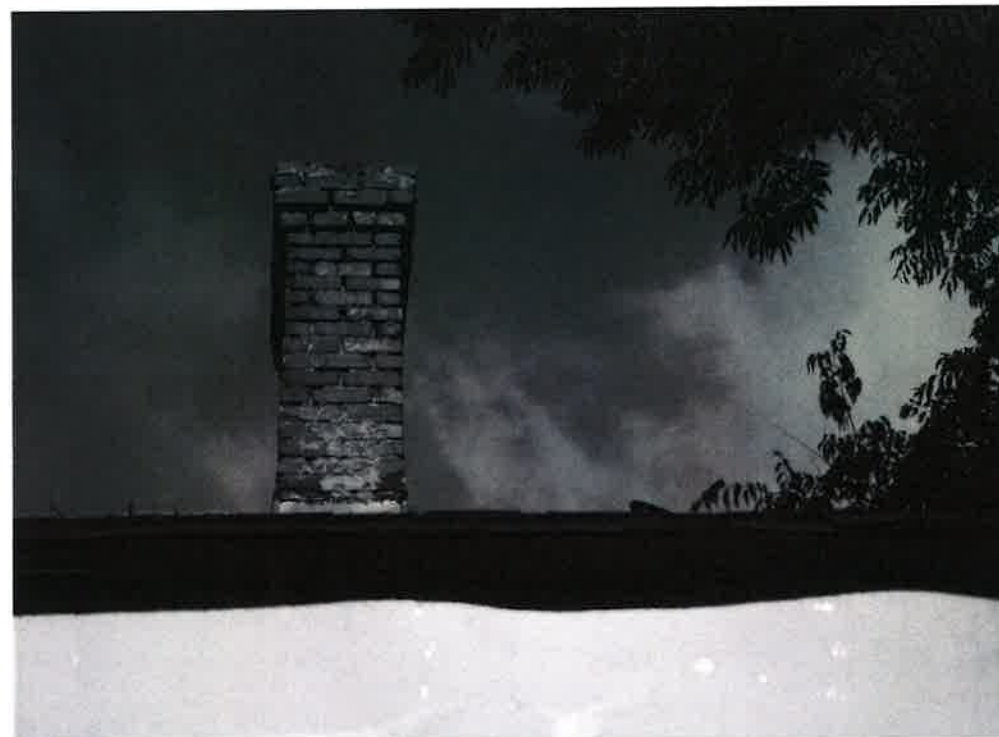
The northeast chimney was observed to have a significant amount of mortar missing above the roof line. The mortar below the roof line was observed to be in fair condition.

The masonry chimney in its current condition is a major safety hazard and requires immediate attention to repoint the brick above the roof line to prevent falling brick onto the ground. It is also important to perform building maintenance by adding caulk around openings to the entire envelope of the building to prevent water infiltration.

Photo No. 32. Brick chimney with mortar degradation.

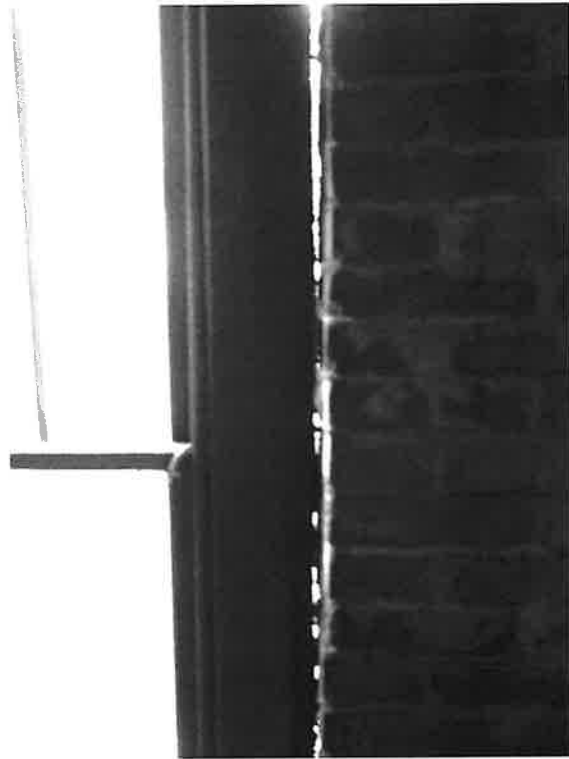
Photo No. 33. Typical gap around openings.
