Overtured Equipment—Insp #1610411 CHC Mechanical Contractors Inc.

Citation(s) as Originally Issued

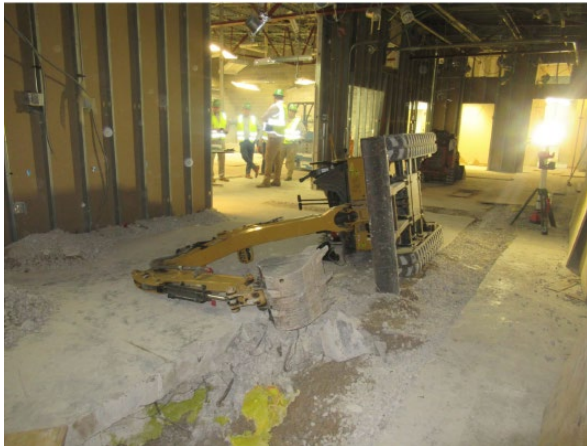
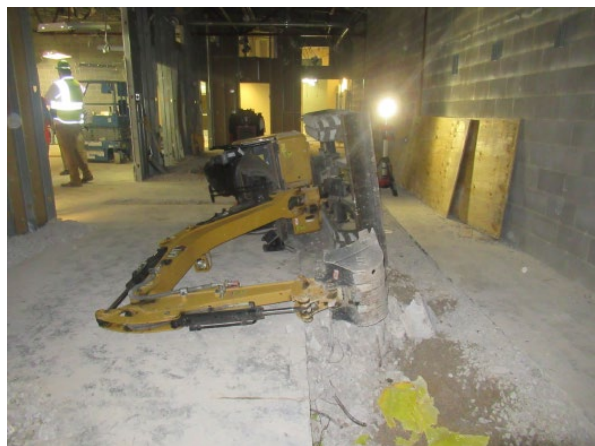
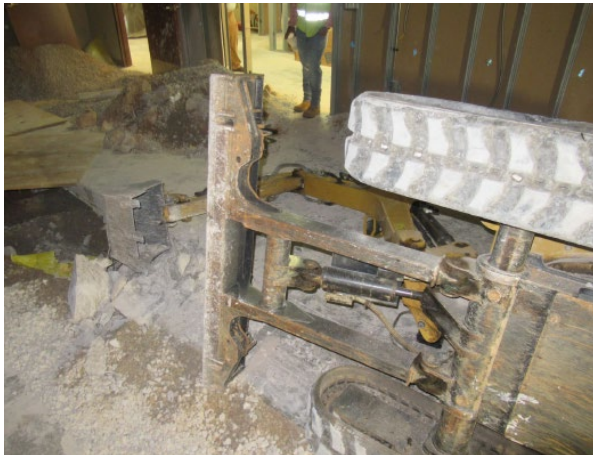
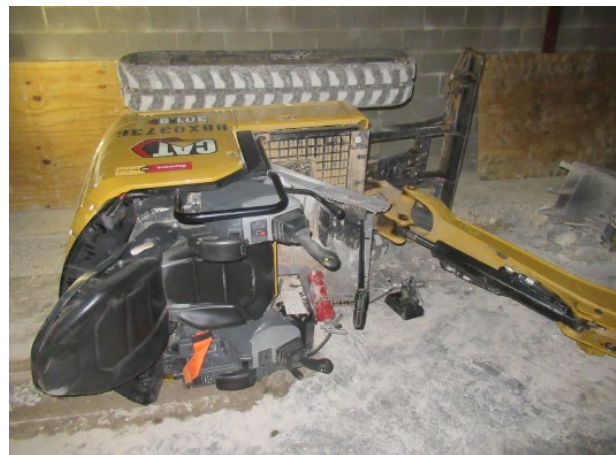
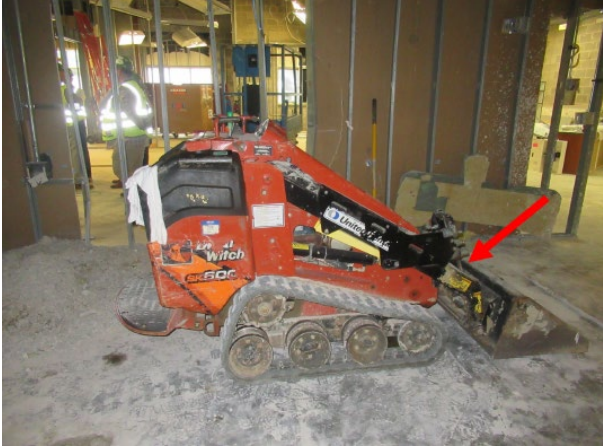
A **70 year old male** employee was operating a **mini excavator when it overturned**. The victim's torso struck another piece of equipment (skid steer) as he fell out of the excavator. He died as a result of internal trauma and bleeding.

The excavator was situated such that the tracks were parallel with the ditch. The machine was completely straddling the ditch at the time of the incident such that the tracks were entirely on the concrete. The ditch had already been backfilled as the crew was installing the sewer pipe as they went. The ditch was 2' wide and 1' deep. The distance between the tracks on the machine measured 2'10". There were several pieces of rebar in the ditch. Most of the rebar, including one that was contacting the bucket of the machine had been bent. It is presumed that some part of the excavator or its tracks may have gotten hung on a piece of rebar causing it to turn over.

An inspection of the machine determined that the roll over protection system (ROPS) which the machine had come equipped with, had been removed from the machine so that it would fit under the doorway to enter the building and additional doorways inside of the building. The ROPS was located outside of the building. The company president stated that the ROPS was not reinstalled once the machine was inside the building because they would have to remove and reinstall the ROPS every time it was necessary for the machine to be moved under a doorway.

It is not known exactly what caused the excavator to overturn, however rebar in the excavation was bent so it could have had some impact on the turnover, or possibly the excavator got off balance when it went off the edge of the concrete causing it to tip over.
