A 45 year old male employee working as a ride operator-in-training, was caught between the turntable of the Wisdom 2000 Starship ride and the stationary trailer on which the turntable sits while greasing the tandem.

Crushed Between parts of an amusement ride—Insp # 1681434 James Gang Amusements LLC

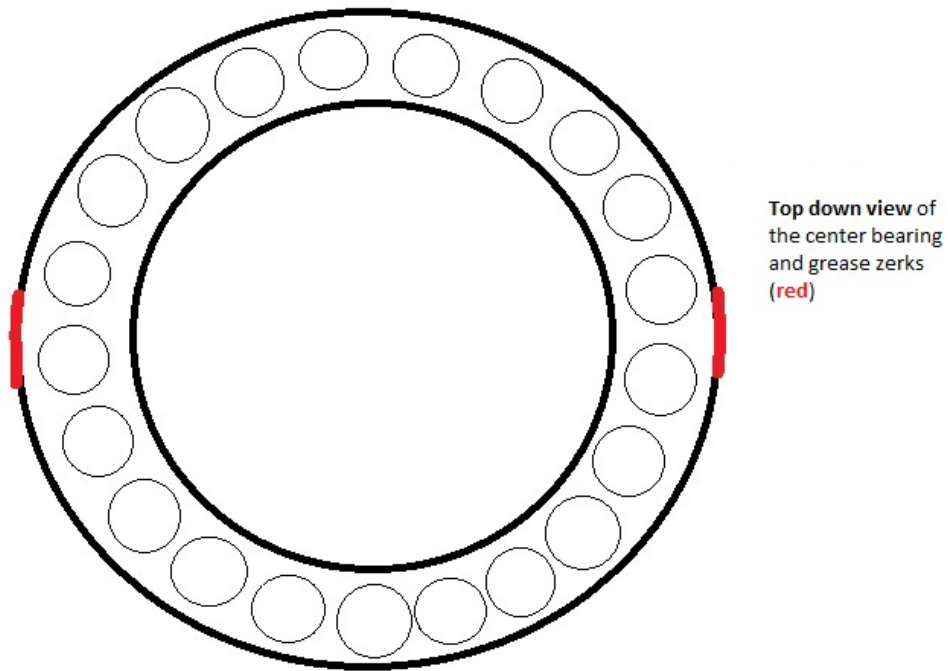
The center bearing (Fig. 1) has two grease fittings (alternately referred to as “zerks” or “alemites”), located directly opposite each other. The center bearing is made of an inner and outer ring containing several small ball bearings in the space between the rings. The space between these rings needs to be greased regularly.

Fig. 1 (top): A diagram showing the position of the two grease fittings (alternatively referred to as alemites or zerks) on the central bearing. The two fittings were located directly opposite each other. The space greased via the fittings contained ball bearings (shown for illustrative purposes only – not numerically or positionally accurate).

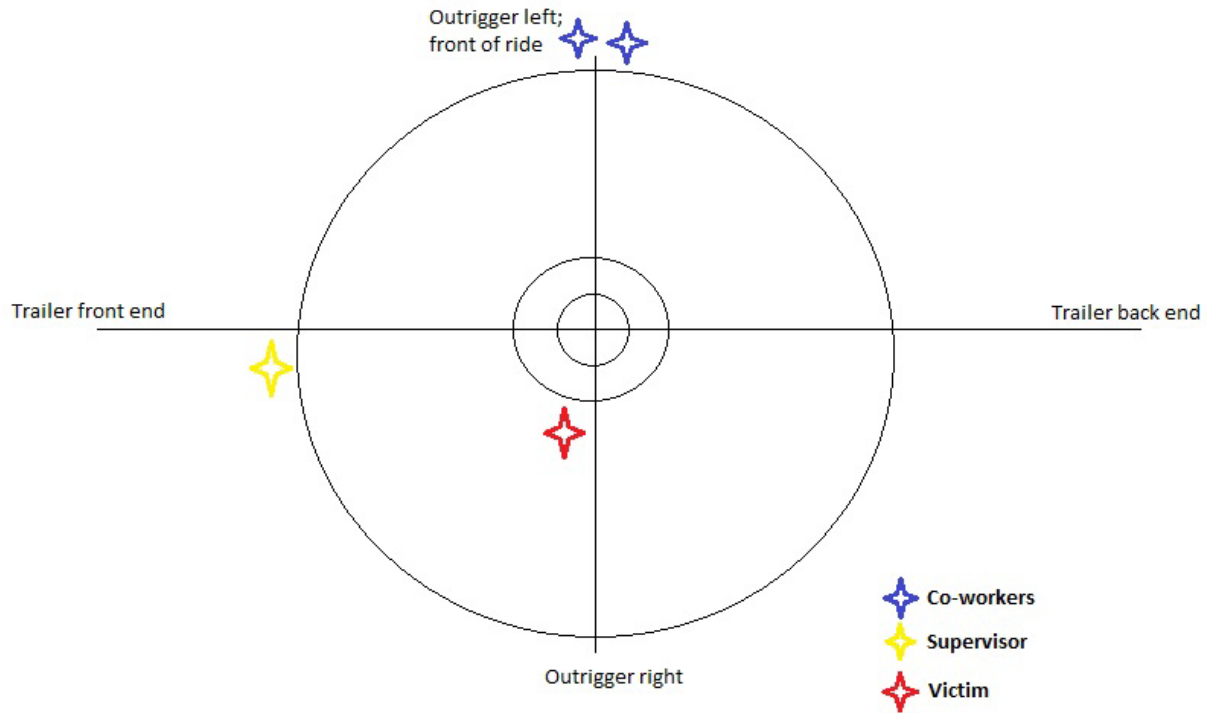
The two coworkers of the victim were positioned at the lefthand outrigger/front of the ride, and the victim’s supervisor was positioned at the front end of the trailer (Fig. 2). The supervisor had a clear line of sight to both other coworkers and the victim due to the removal of the white panel. The two co-workers were not able to clearly see the victim.

Fig. 2 (top): A diagram showing the relational positions of the victim, supervisor, and two co-workers at the time of the incident. The ends of the trailer and outriggers are denoted. The two, smaller concentric circles in the middle of the diagram indicate the center bearing (see Fig. 2). Sizes are not to scale.
