TOTAL MAXIMUM DAILY LOAD (TMDL)
For
Siltation & Habitat Alteration
In The
Caney Fork River Watershed (HUC 05130108)
Bledsoe, Cannon, Cumberland, DeKalb, Putnam, Sequatchie,
Smith, Van Buren, Warren, White and Wilson Counties,
Tennessee

Tennessee Department of Environment and Conservation
Division of Water Pollution Control
6th Floor L & C Tower
401 Church Street
Nashville, TN 37243-1534

August 1, 2005

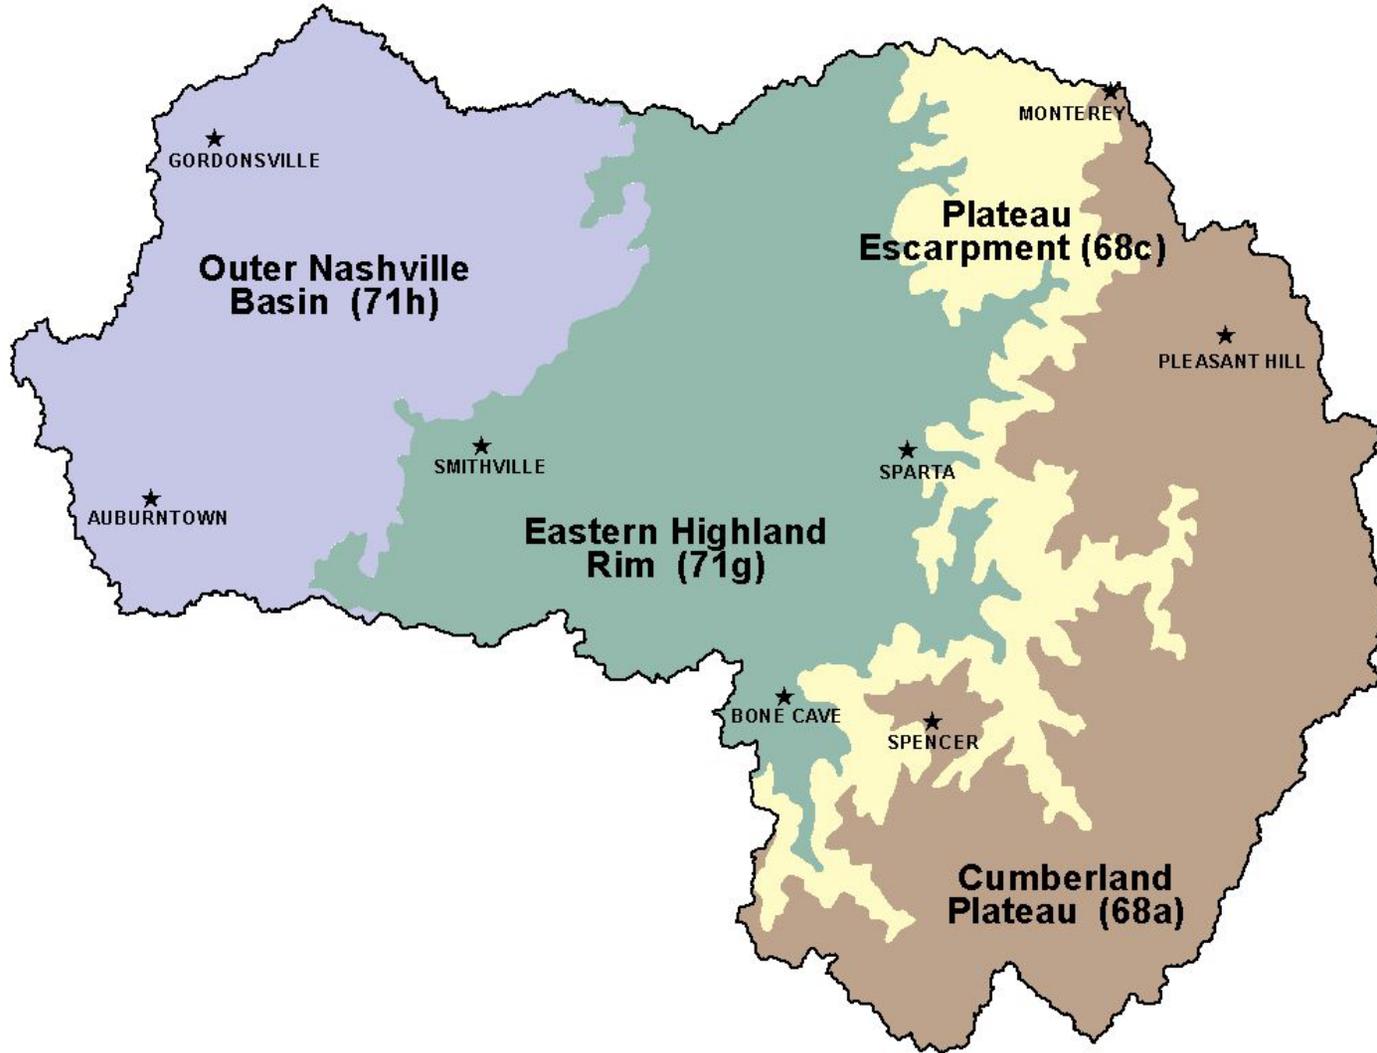
Figure 2 Level IV Ecoregions in the Caney Fork River Watershed

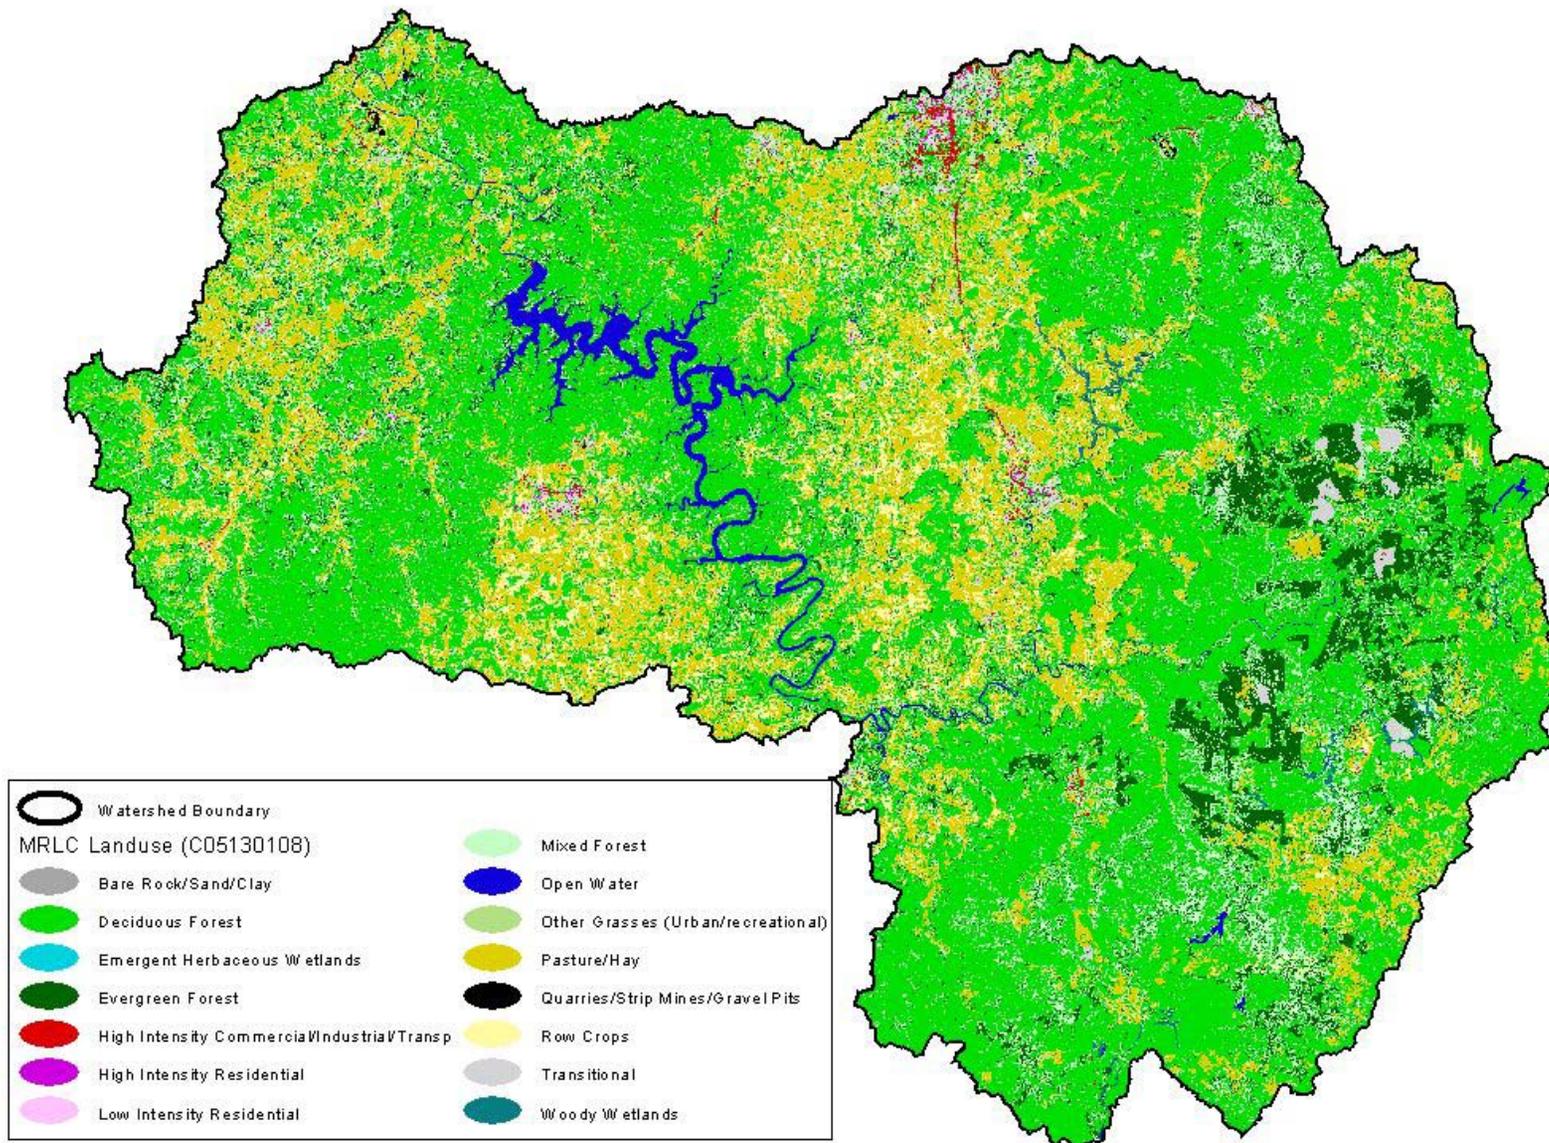
Figure 3 MRLC Land Use in the Caney Fork River Watershed

The Caney Fork River Watershed has approximately 25,887 lake acres, 2041.5 miles of streams (Rf3) and drains a total area of 1796.8 square miles. Watershed land use distribution is based on Multi-Resolution Land Characteristic (MRLC) databases derived from Landsat Thematic Mapper digital images from the period 1990-1993. Land use for the Caney Fork River Watershed is summarized in Table 1 and shown in Figure 3.

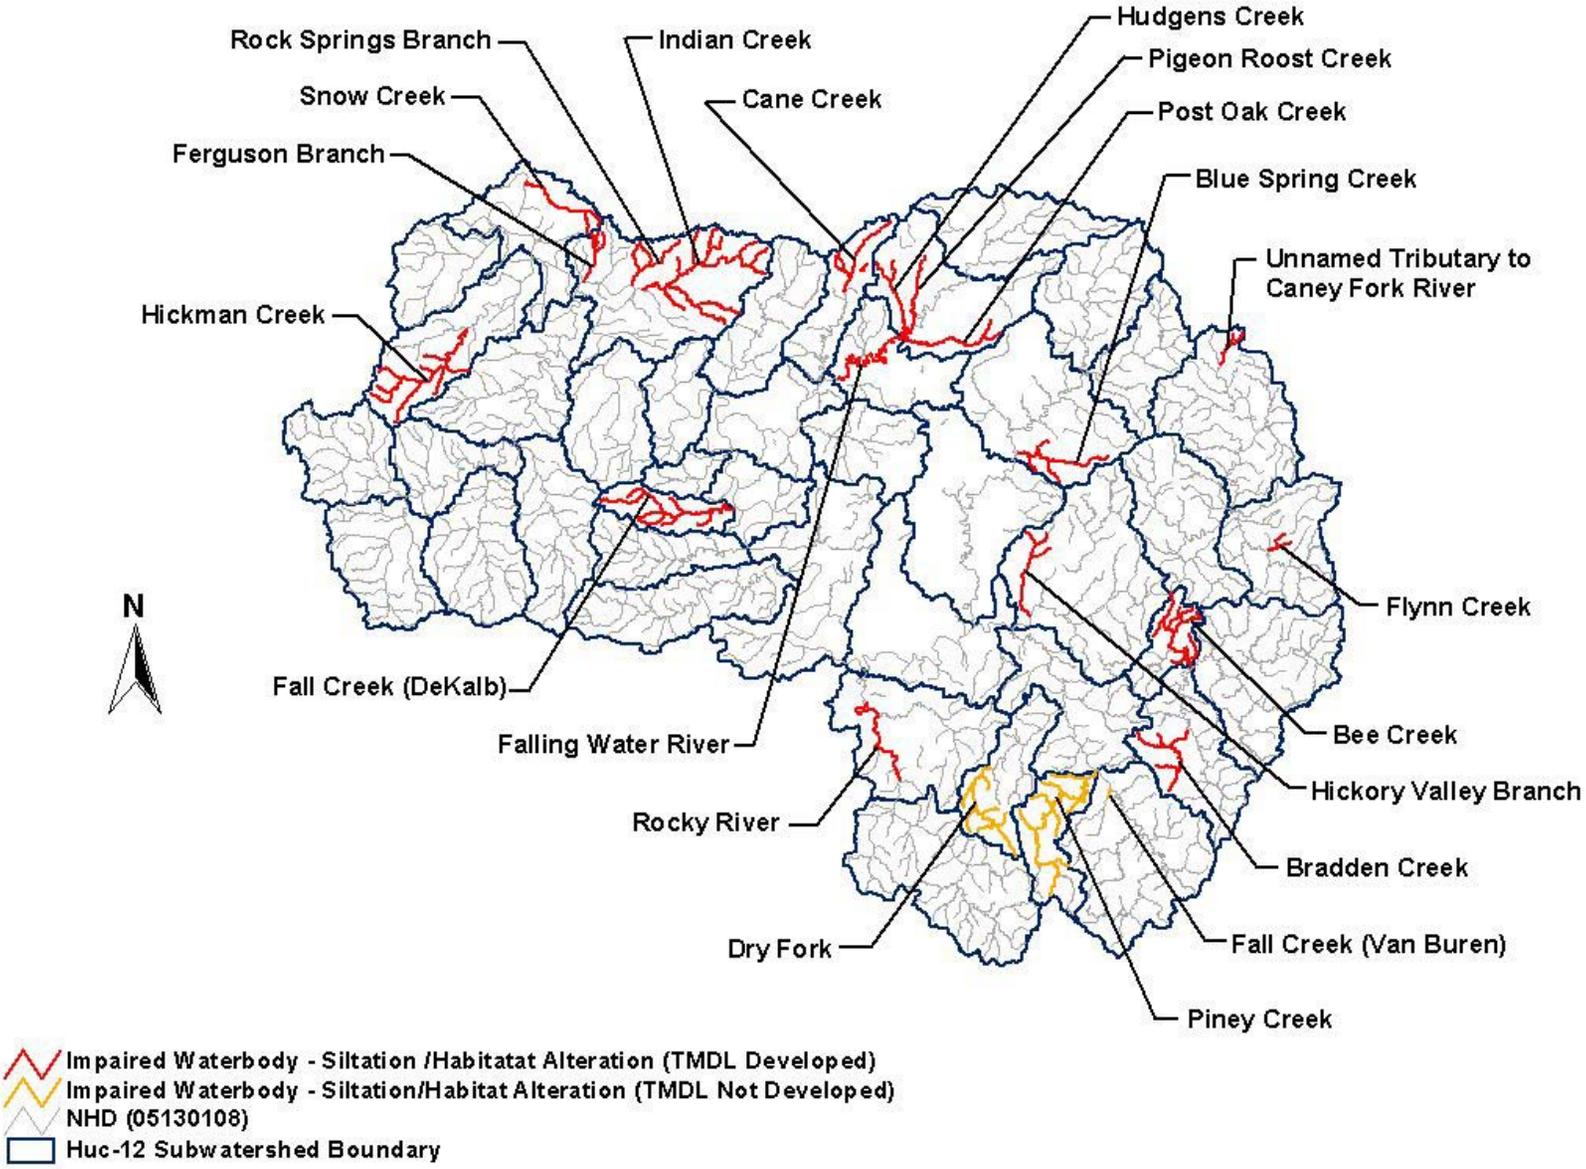
Figure 4 Waterbodies Impaired Due to Siltation/Habitat Alteration (Documented on the 2002 303(d) List)

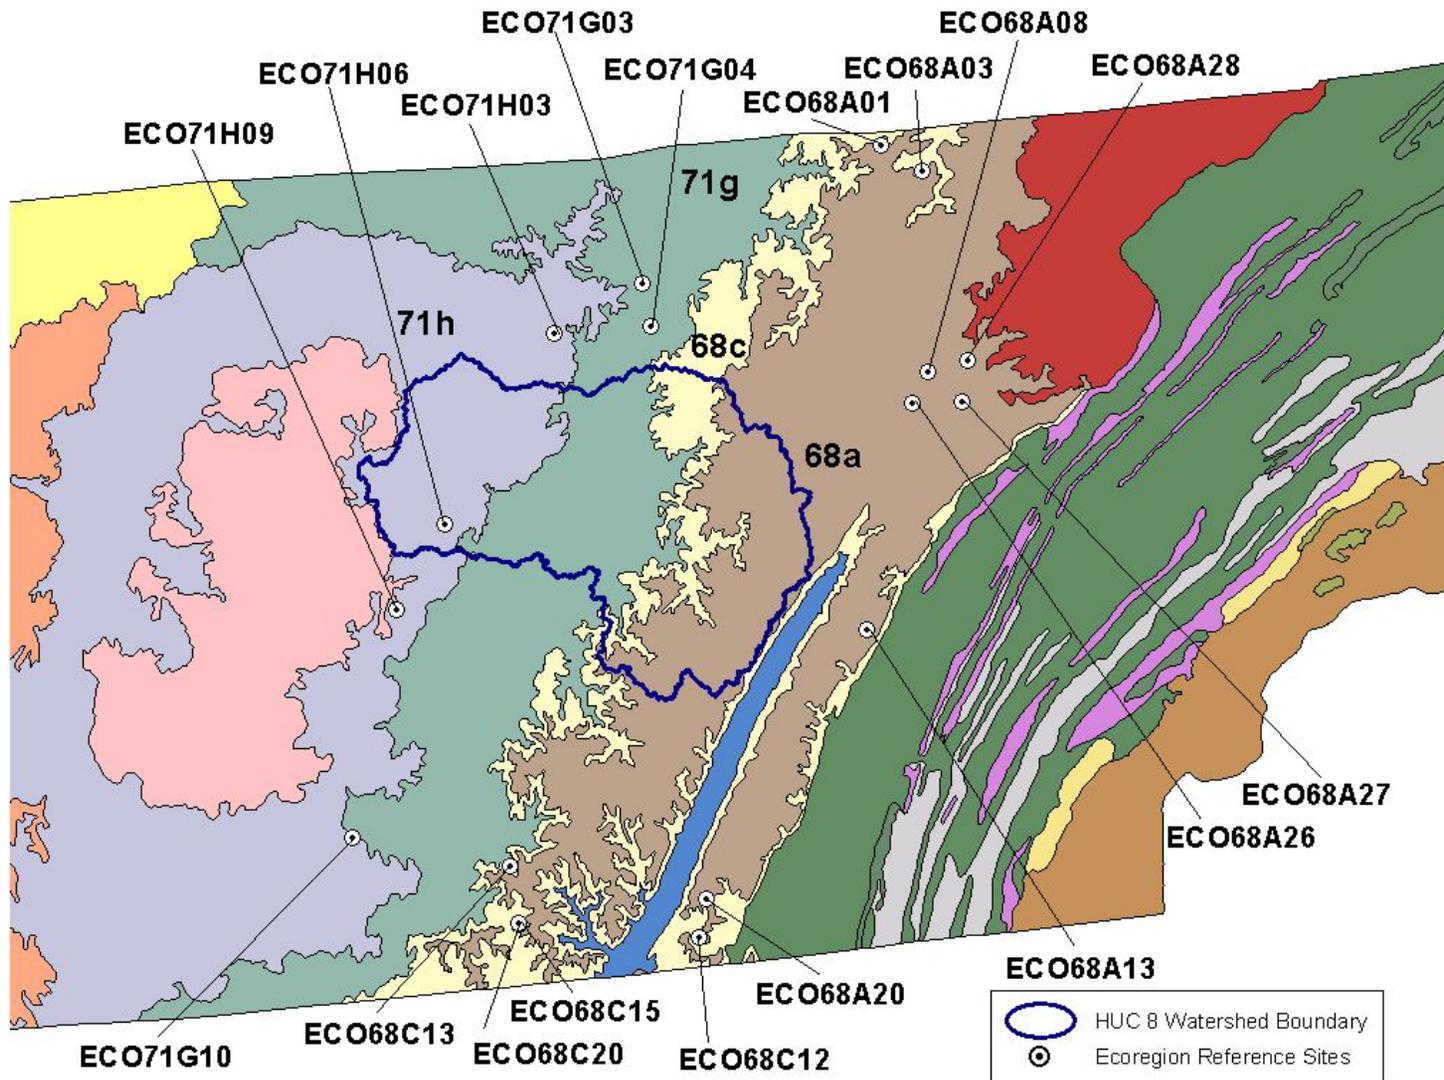
Figure 5 Reference Sites in Level IV Ecoregions 68a, 68c, 71g, & 71h

Note: Ecoregion reference sites are continually reviewed, with sites added or deleted as circumstances warrant. The stations shown were determined as ecoregion reference sites as of June 3, 2003.

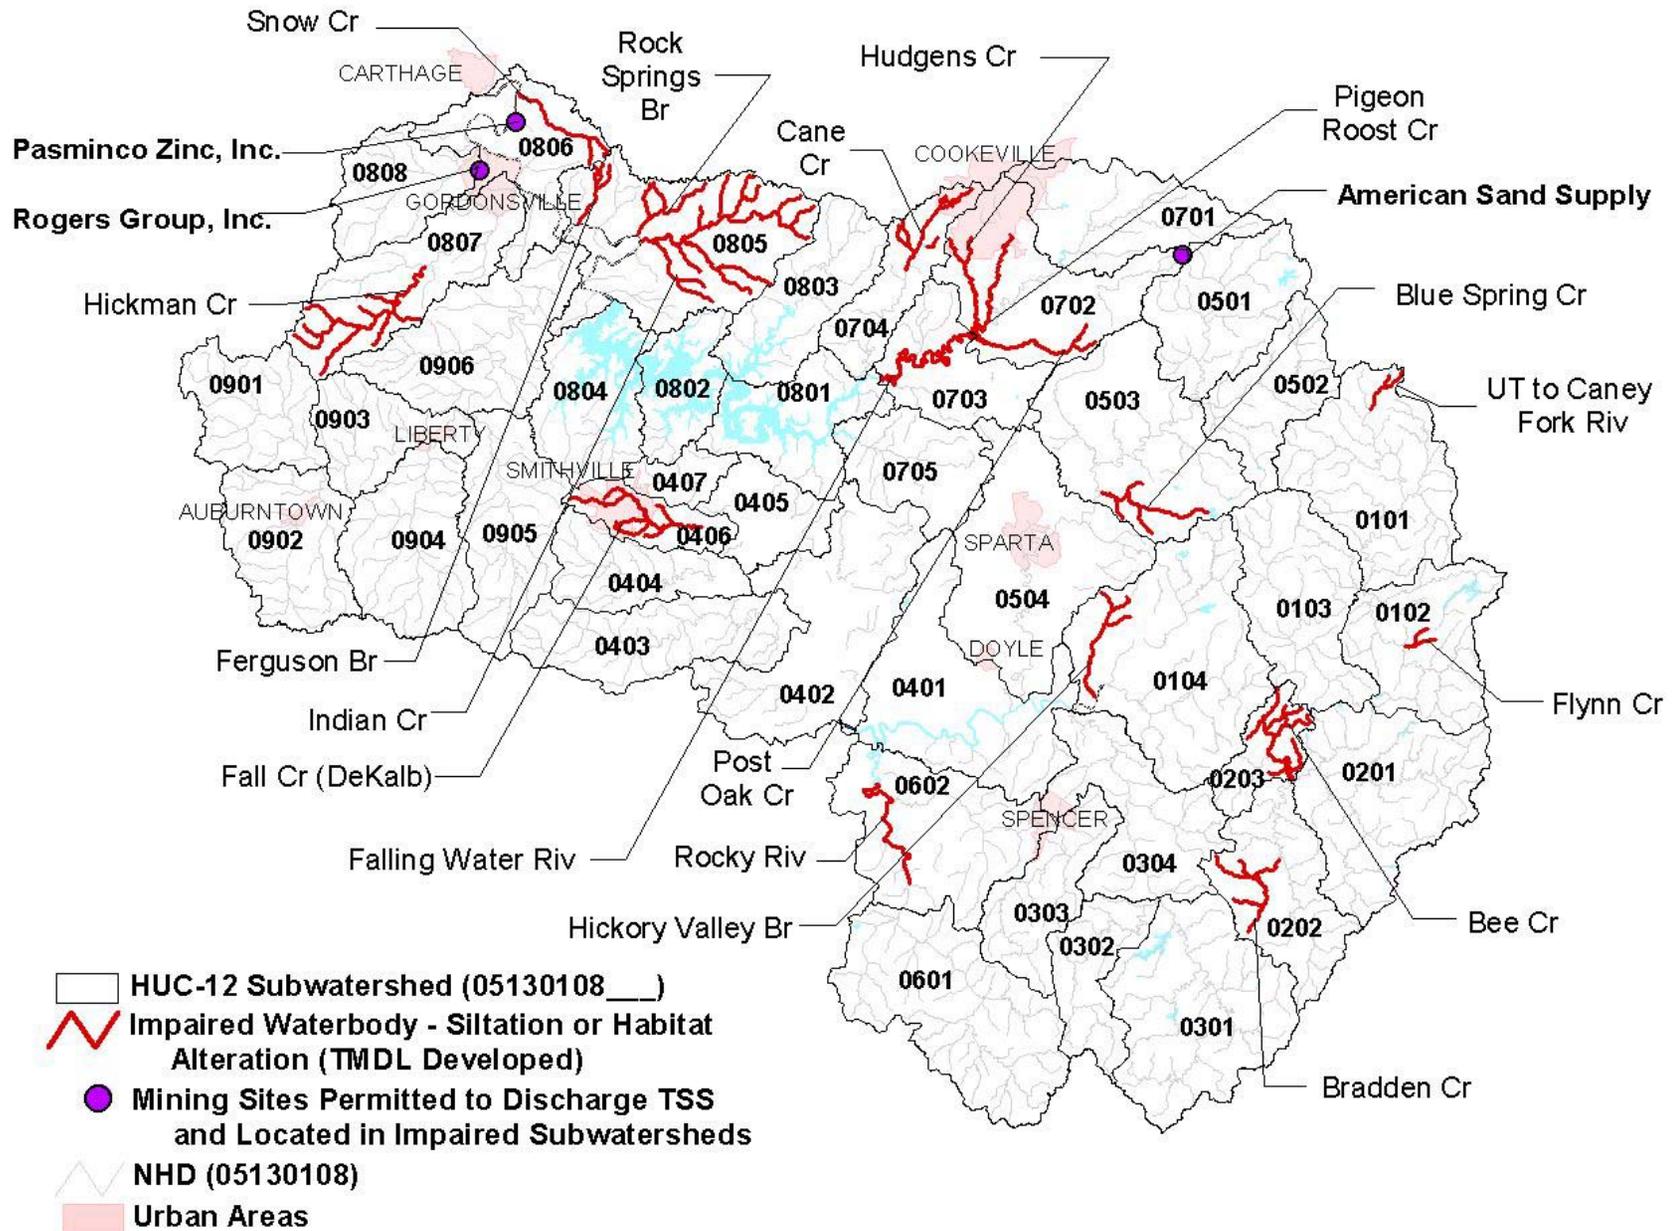
Figure 7 NPDES Regulated Mining Sites Permitted to Discharge TSS and Located in Impaired Subwatersheds

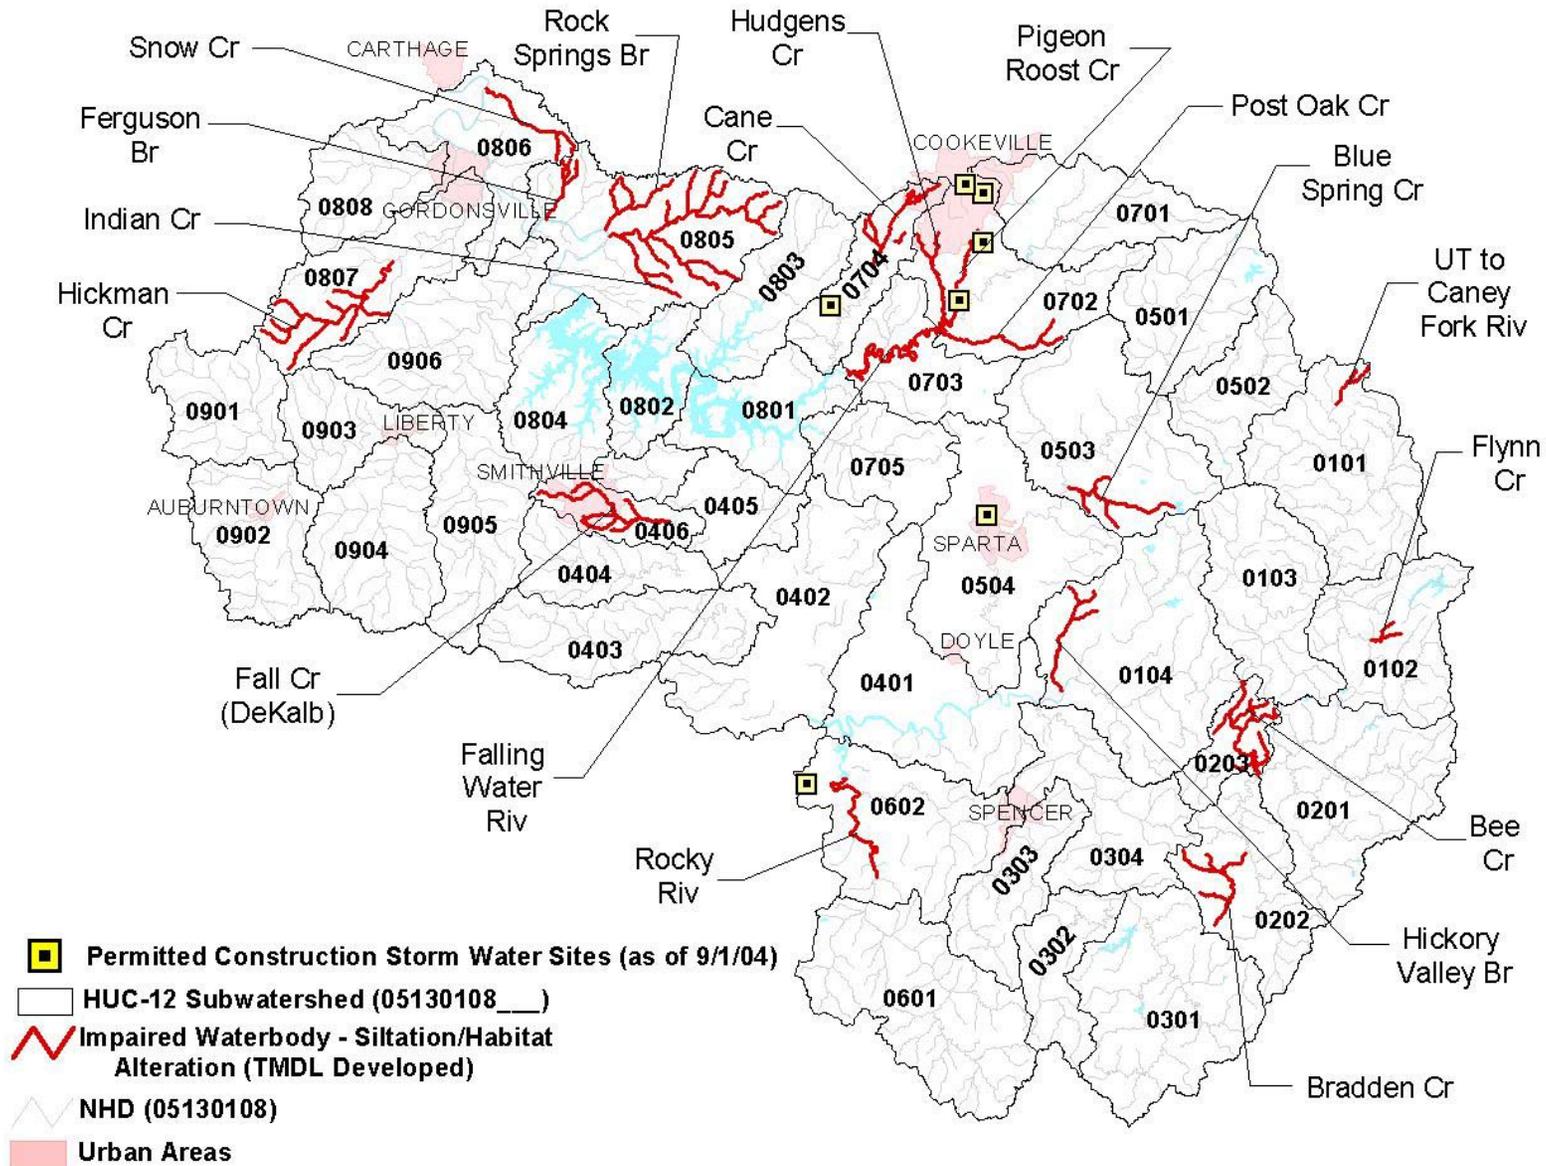
Figure 8 Location of NPDES Permitted Construction Sites in the Caney Fork River Watershed

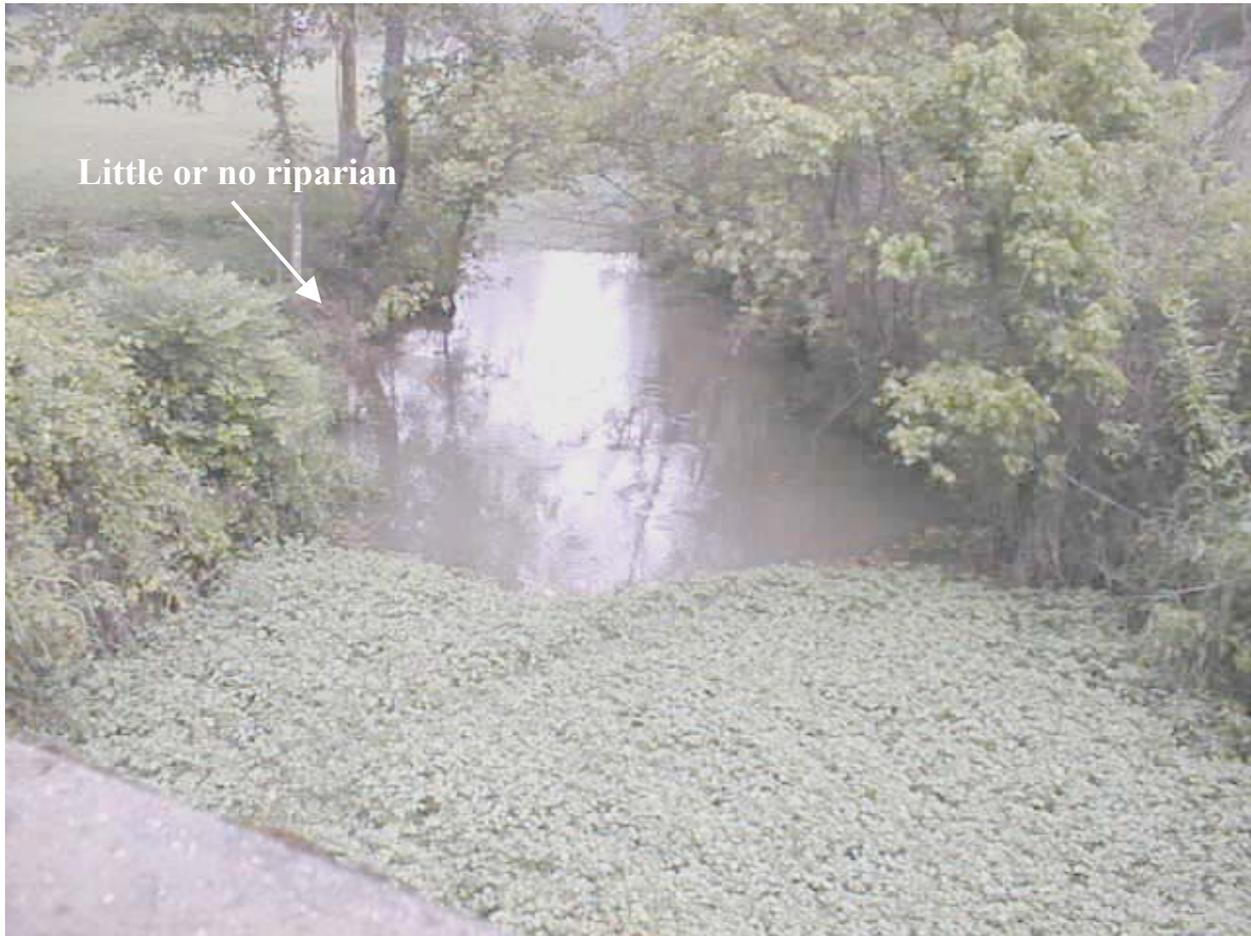
Figure F-3 Ferguson Branch - August 22, 2002

Ferguson Branch was monitored again in 2002 by the NEFO. A biorecon at RM 0.8 showed the stream was partially supporting at this location and looked similar to what it had at the previous visit except that during the last visit it was noted that the stream was clear. The stream had biological scores of 7 EPT, 3 intolerant, and 22 total families and was assessed as partially supporting due to sediment load and habitat alteration (Figure F-2). During this visit, there were opaque pools with blanketing sediment and riffle kicks producing thick red mud plumes. Notes show evidence of thinned riparian (ref.: Figure F-3).

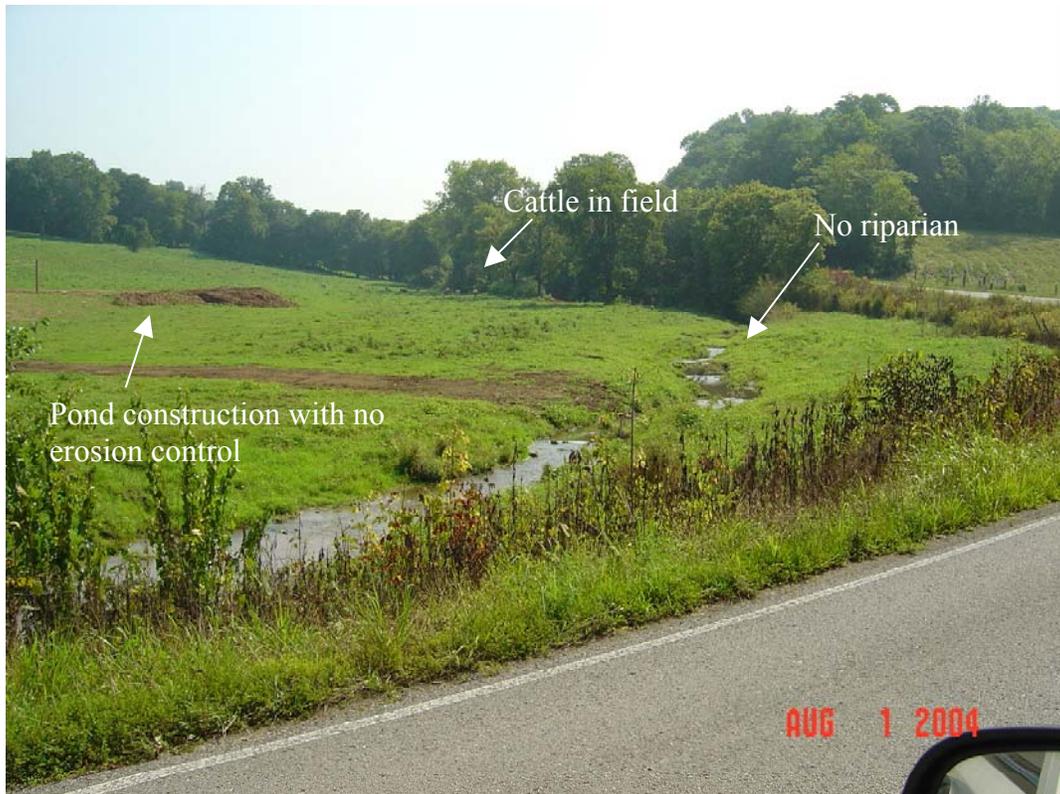
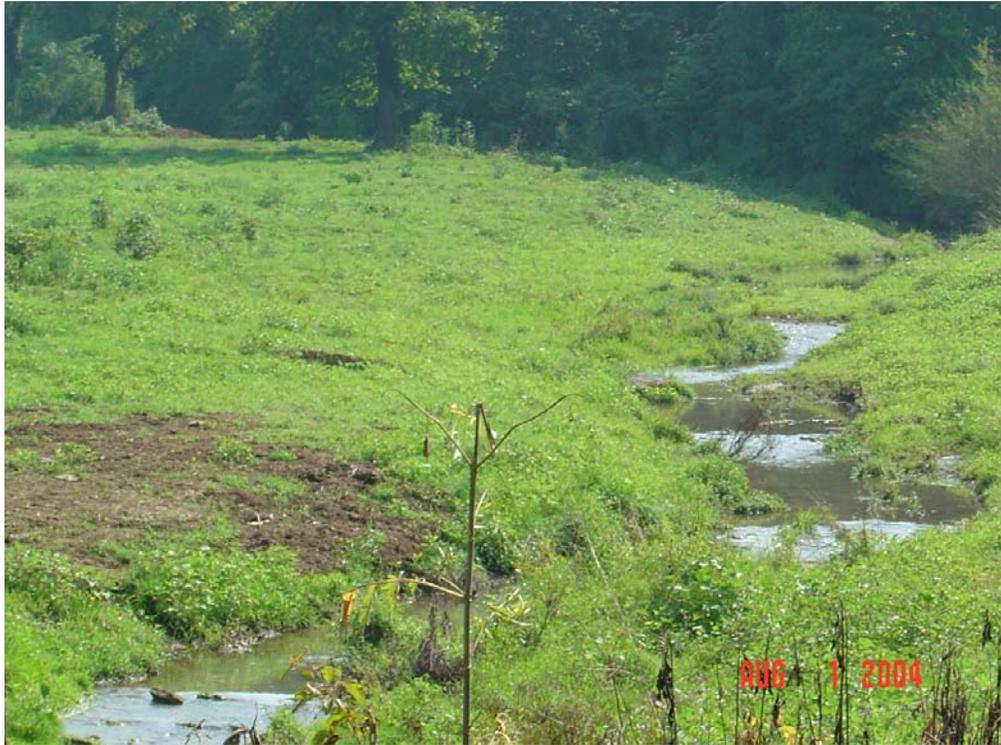
Figure F-6 Rock Springs Branch (RM 1.3) - Upstream

Figure F-7 Rock Springs Branch (RM 1.3) Upstream

Central office staff returned to Rock Springs Branch on August 1, 2004 to conduct site reconnaissance and photo document any site-specific sediment sources in the watershed. Cattle were seen in the area with free access to the stream. There was no riparian zone present. This particular site also had some recent land disturbance that appeared to be associated with the creation of two ponds (Figures F-6 through F-9). The upper headwater portions of the watershed were more agricultural use with pasture and some row crops.

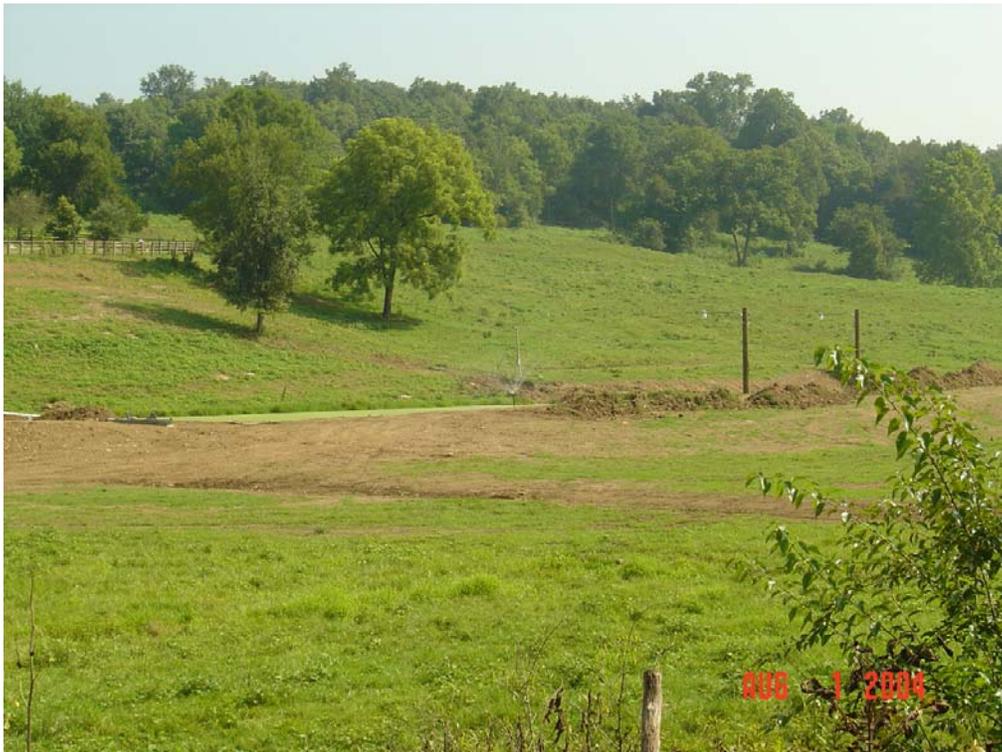
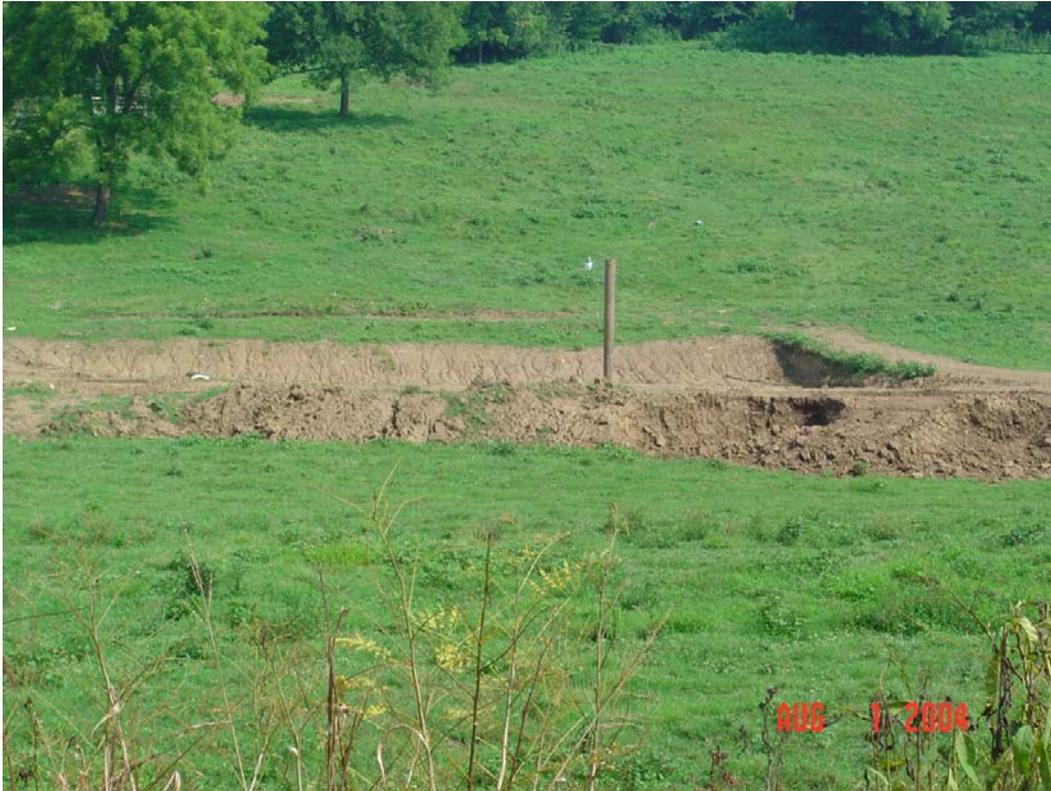
Figure F-8 Rock Springs Branch (RM 1.3) Pond Construction With No Erosion Control

Figure F-9 Rock Springs Branch (RM 1.3) Pond Construction With No Erosion Control

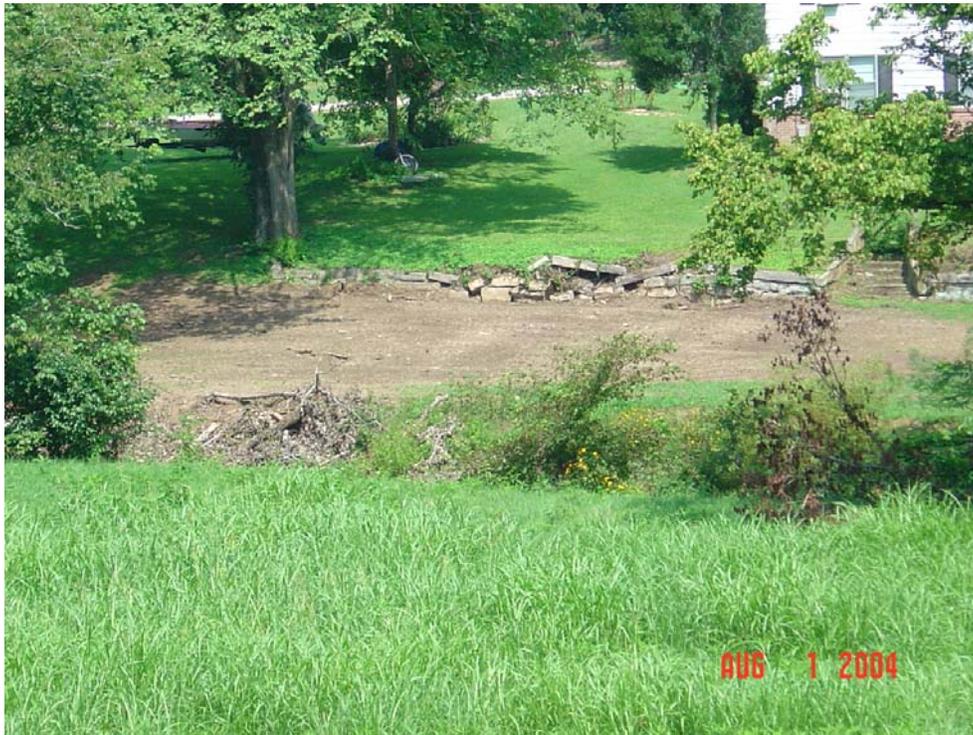
Figure F-14 Indian Creek Riparian Removal and Bank Grading

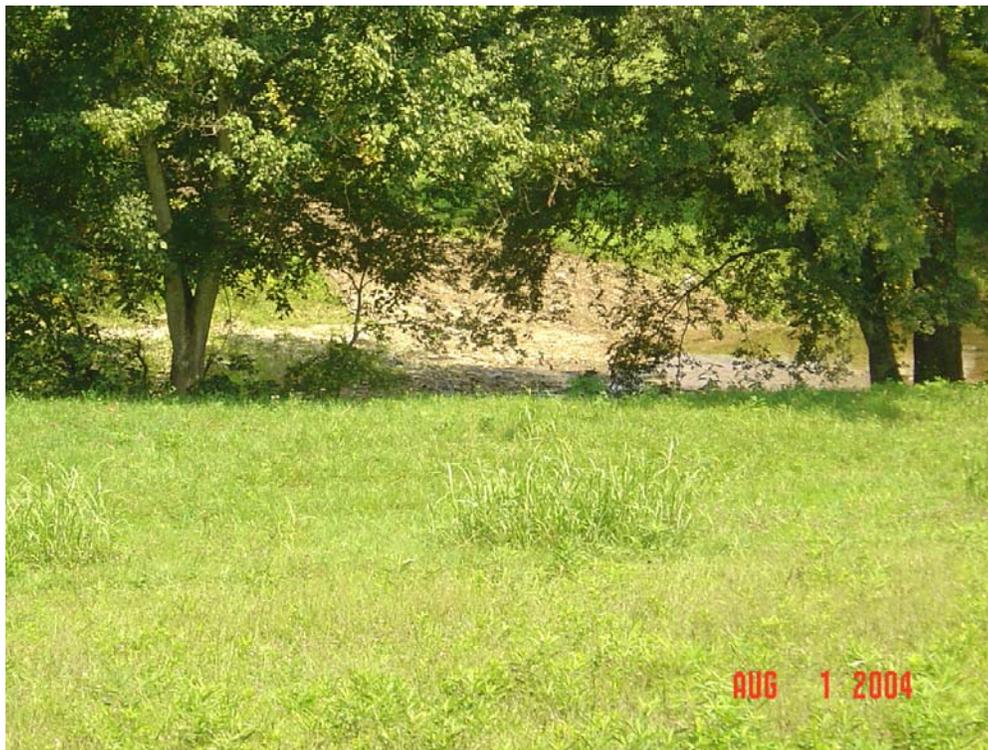
Figure F-15 Indian Creek Gravel Dredging and Bank Disturbance

Indian Creek (TN05130108048_1000) was placed on the 2002 303(d) List as not fully supporting designated uses due to siltation and habitat alteration associated with gravel dredging and road maintenance.

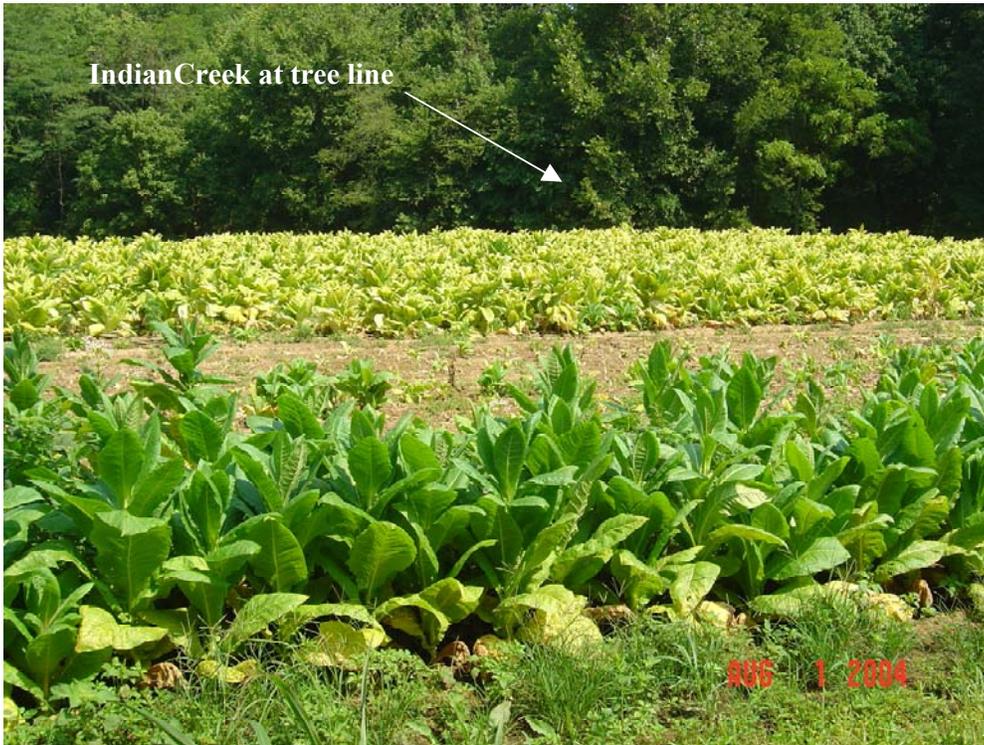
Figure F-16 Indian Creek Tobacco Row Crops Near Stream

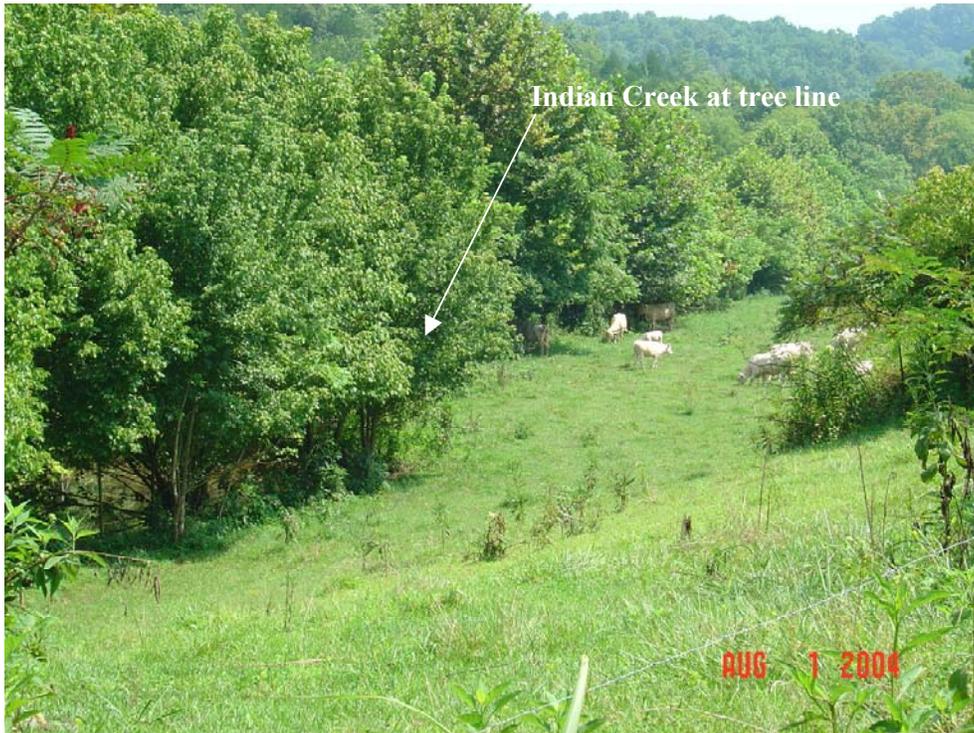
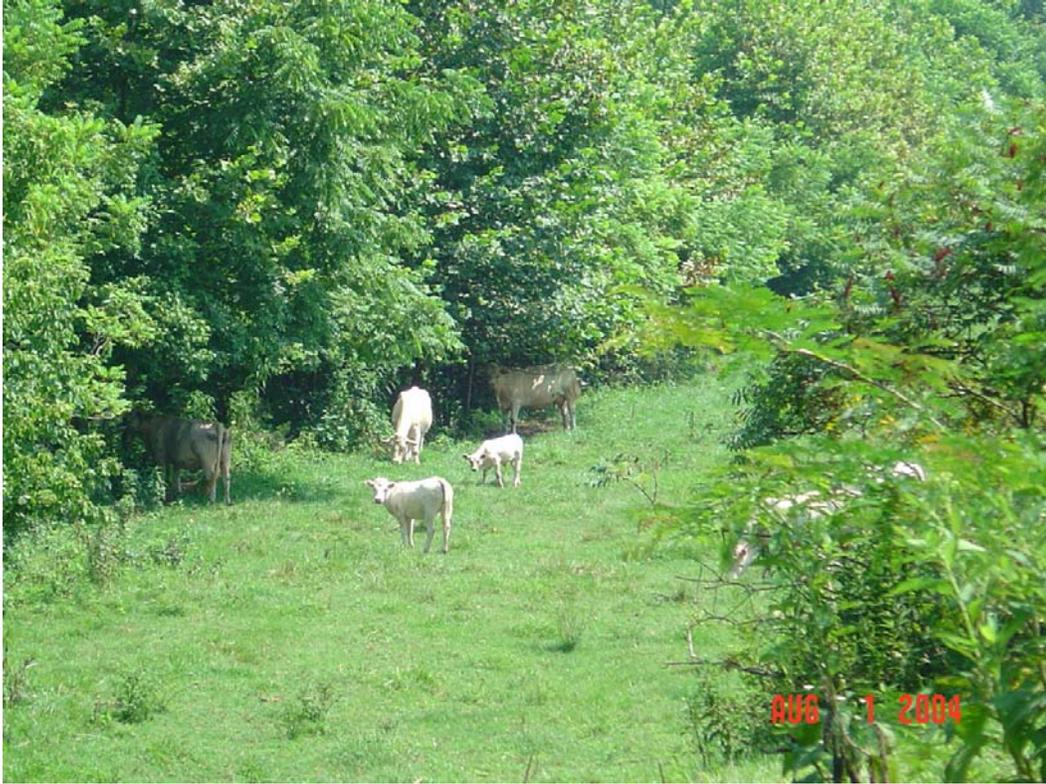
Figure F-17 Indian Creek Cattle With Stream Access

Figure F-18 Indian Creek Cattle with Stream Access
