TOTAL MAXIMUM DAILY LOAD (TMDL)
For
Siltation and Habitat Alteration
In The
Nolichucky River Watershed (HUC 06010108)
Cocke, Greene, Hamblen, Hawkins, Jefferson, Unicoi, and
Washington, Counties, Tennessee

FINAL
(Modified)

Tennessee Department of Environment and Conservation
Division of Water Pollution Control
6th Floor L & C Tower
401 Church Street
Nashville, TN 37243-1534

April 18, 2008

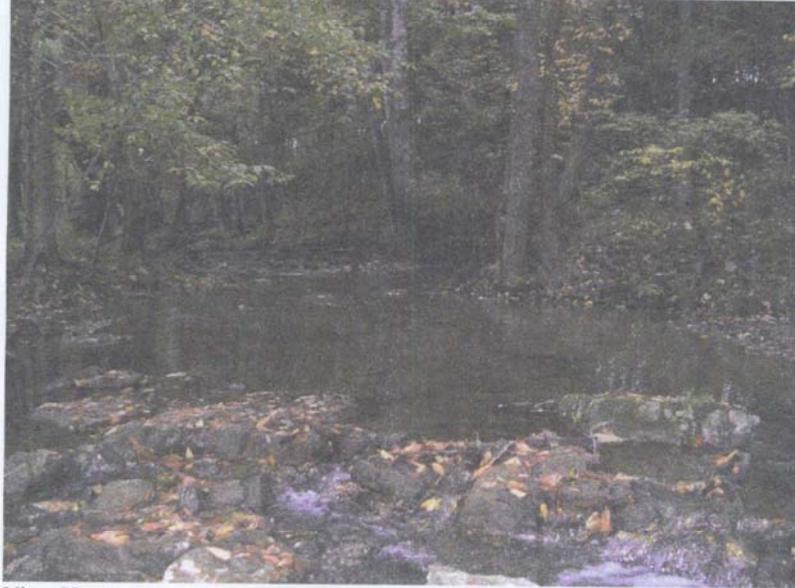
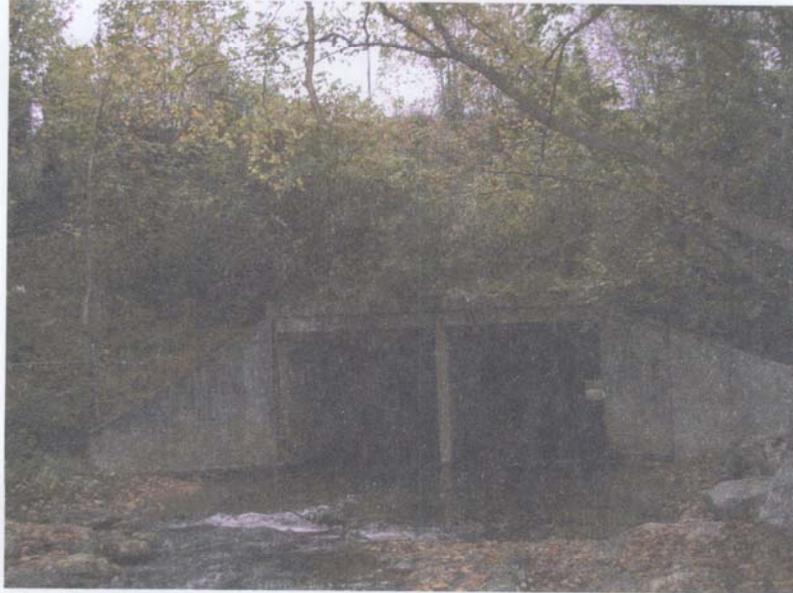
Figure A-2 Photo of Clear Creek at RM 1.3 - October 15, 2004

OWW0440-0420 – Clear Creek – Samples collected 10/15/2004 by Debbie Arnwine and Kim Sparks, TDEC WPC.

View Upstream

View Downstream
