Bid Package

City of Rutledge

Nance Building Column and Soffit Restoration

Current Photographs

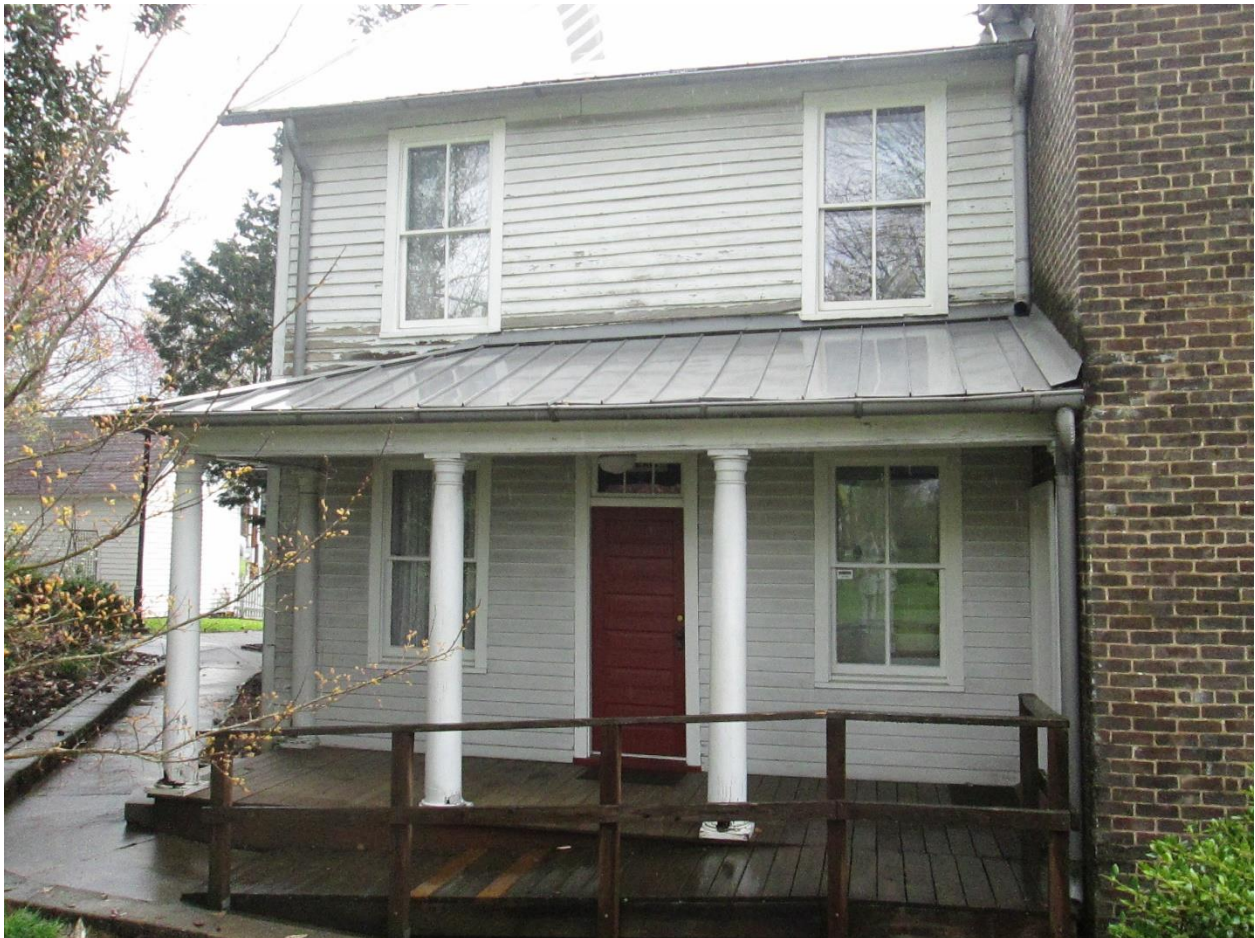
The west elevation includes three freestanding columns and two pilasters. The majority of these columns and pilasters present substantial deterioration (see Photographs 1-3).

Photograph 1. Partial view of the west elevation of the Nance Building, facing east, showing the entire porch including the three freestanding columns and two pilasters.

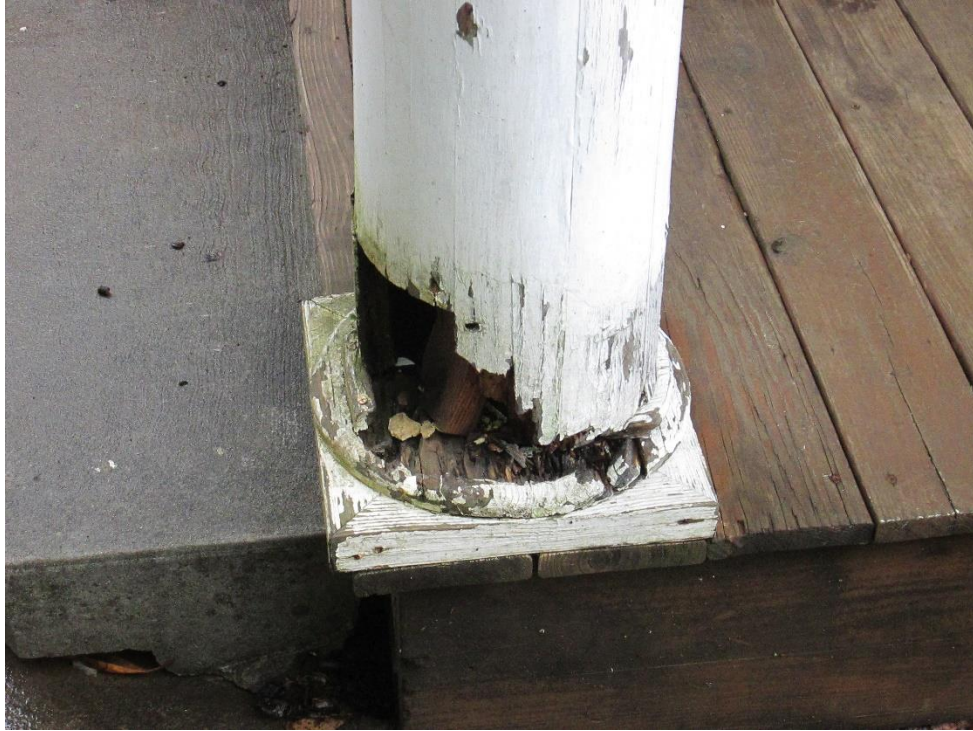
Photograph 2. Example of substantial deterioration of a freestanding column along the west elevation of the Nance Building.

Specification	Cost	Notes
Inspect/diagnose potential rot in all 14 columns and 6 pilasters		
Remove unsalvageable rotted wood from 7 columns and 2 pilasters as needed and piece-in or patch in-kind materials as needed*		
Hand-scrape, hand-sand, and repaint surfaces of 14 columns and 6 pilasters as needed, matching original paint		
Remove unsalvageable rotted wood from north elevation gable soffit as needed and piece-in or patch in-kind materials as needed*		
Hand-scrape, hand-sand, and repaint surface of north elevation gable soffit as needed, matching original paint

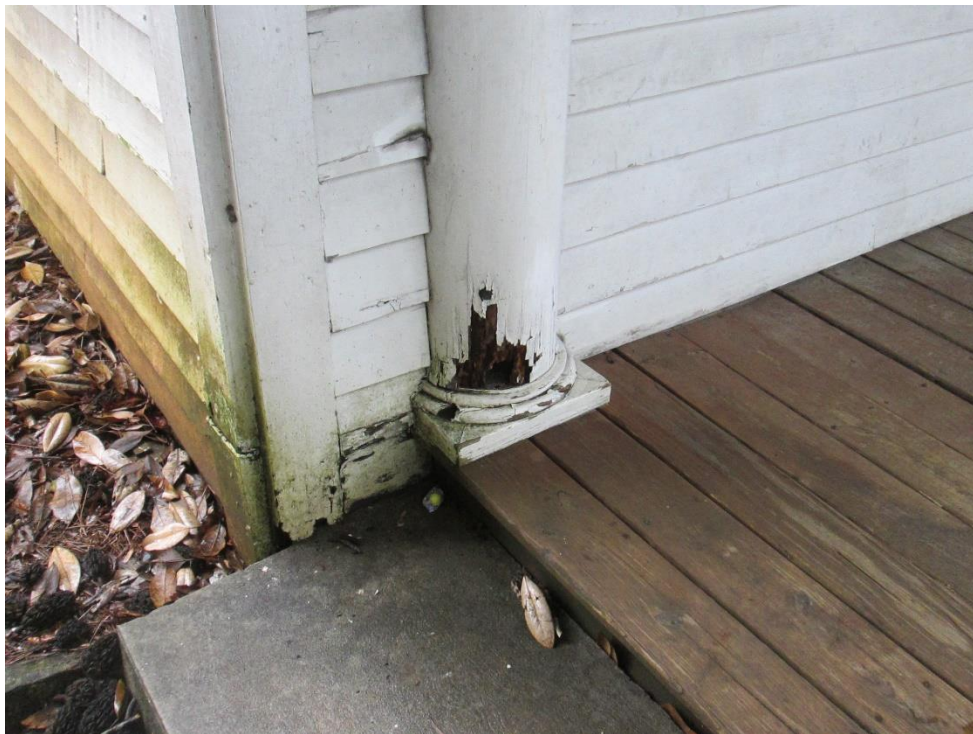
Photograph 3. Example of substantial deterioration of a pilaster along the west elevation of the Nance Building.

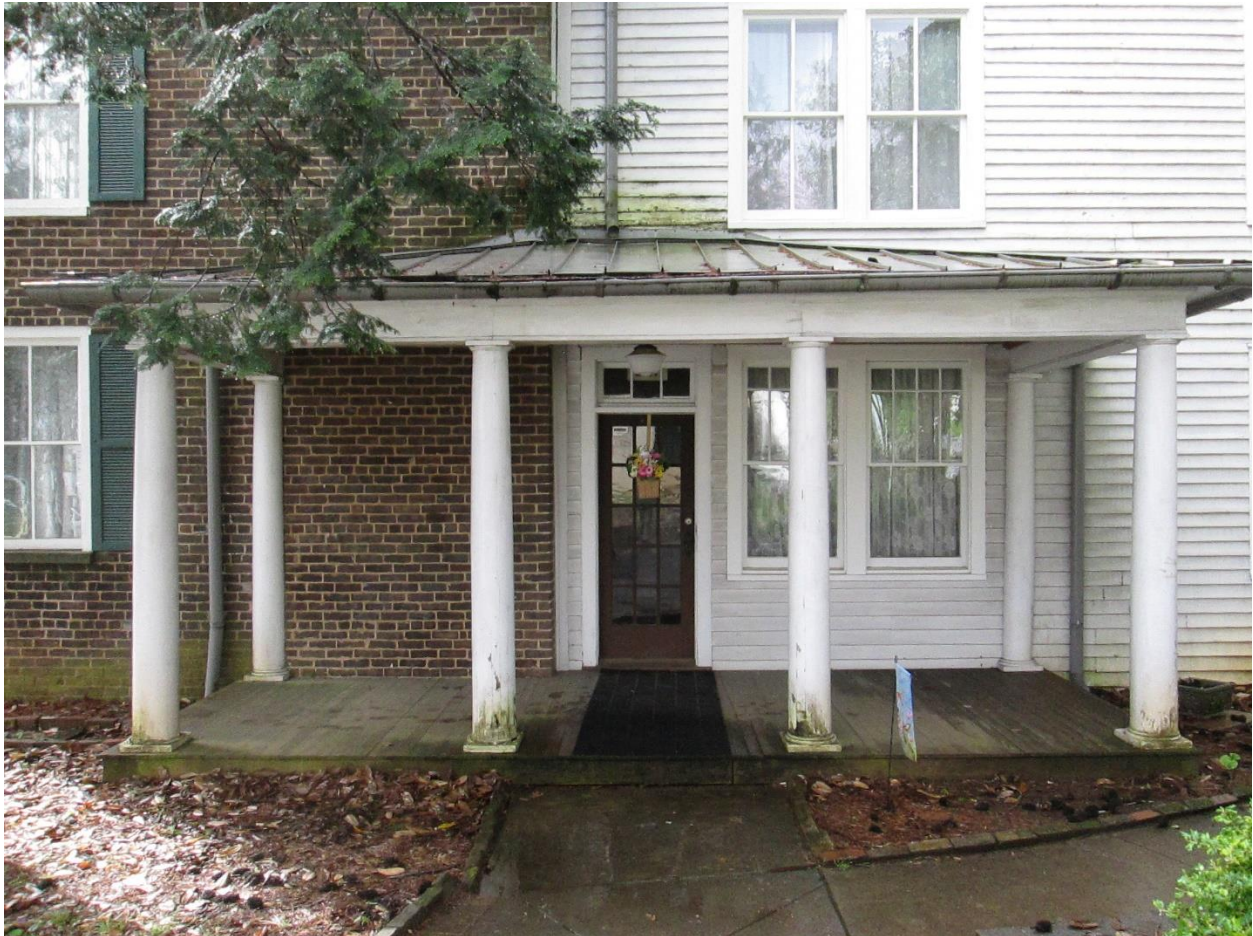
The north elevation includes four freestanding columns and two pilasters. Many of the freestanding columns present moderate deterioration; the pilasters are in fair condition and likely require only sanding and painting (see Photographs 4-6).

Photograph 4. Partial view of the north elevation of the Nance Building, facing south, showing the entire porch including the four freestanding columns and two pilasters.

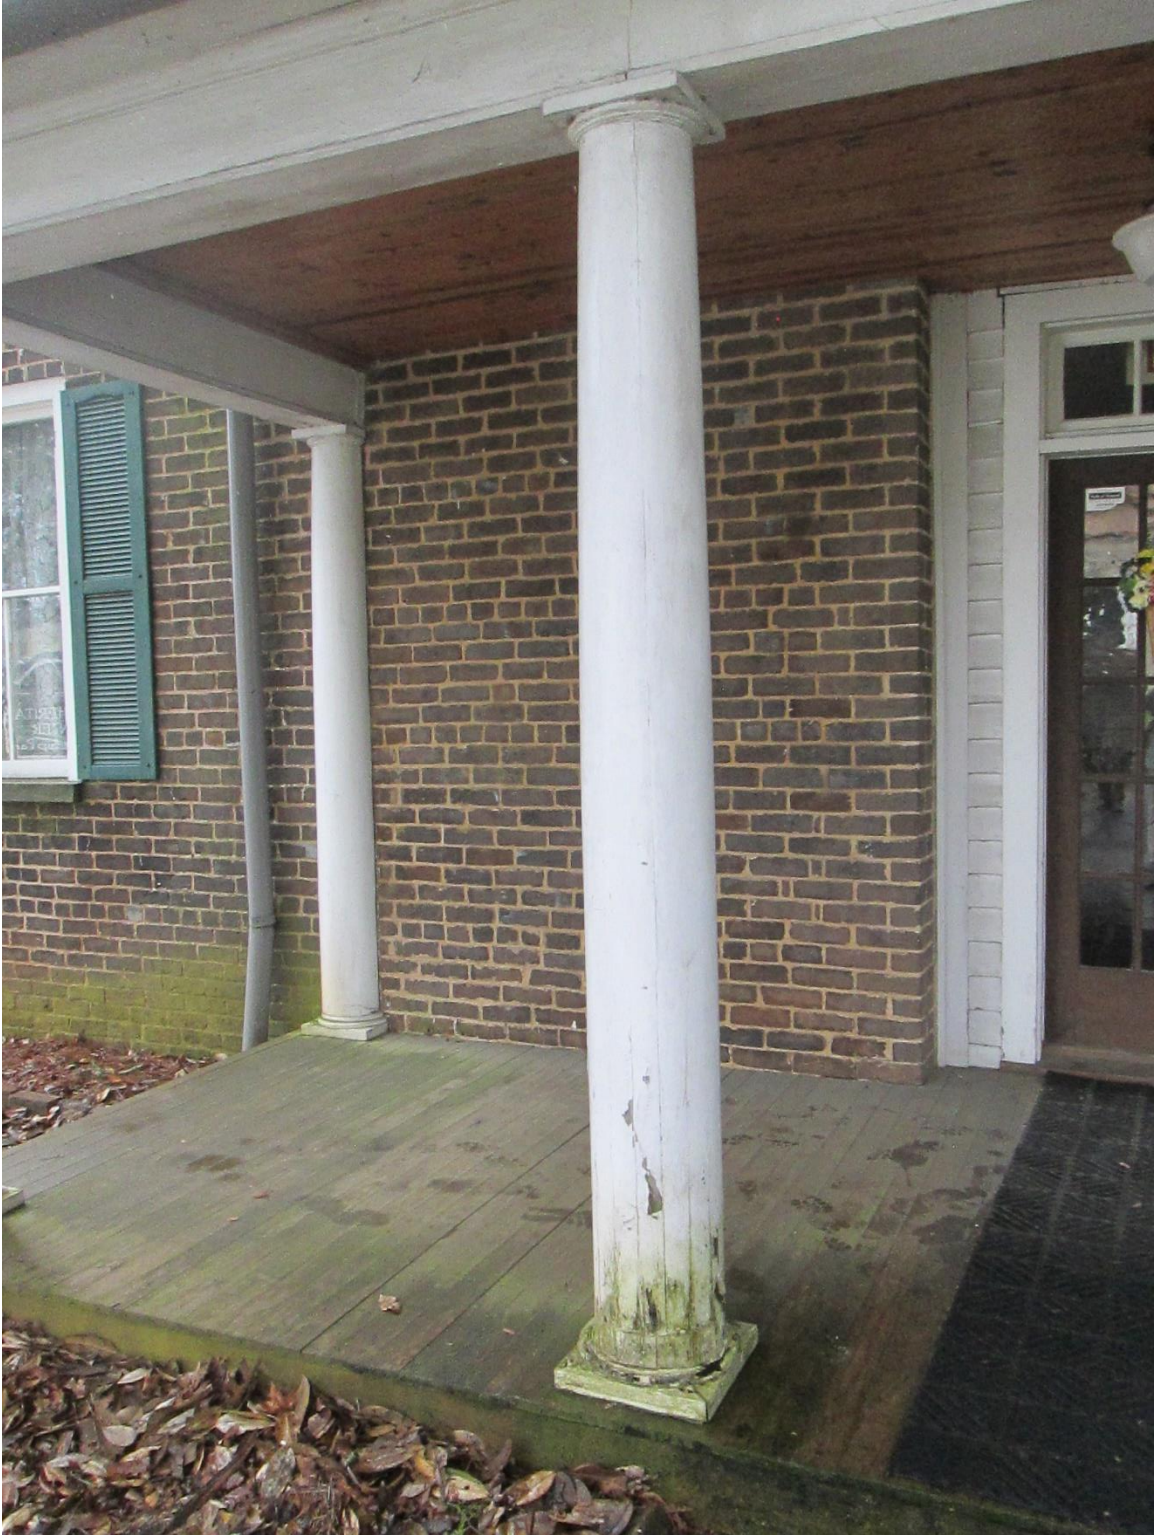
Photograph 5. Example of moderate deterioration of a freestanding column along the north elevation of the Nance Building

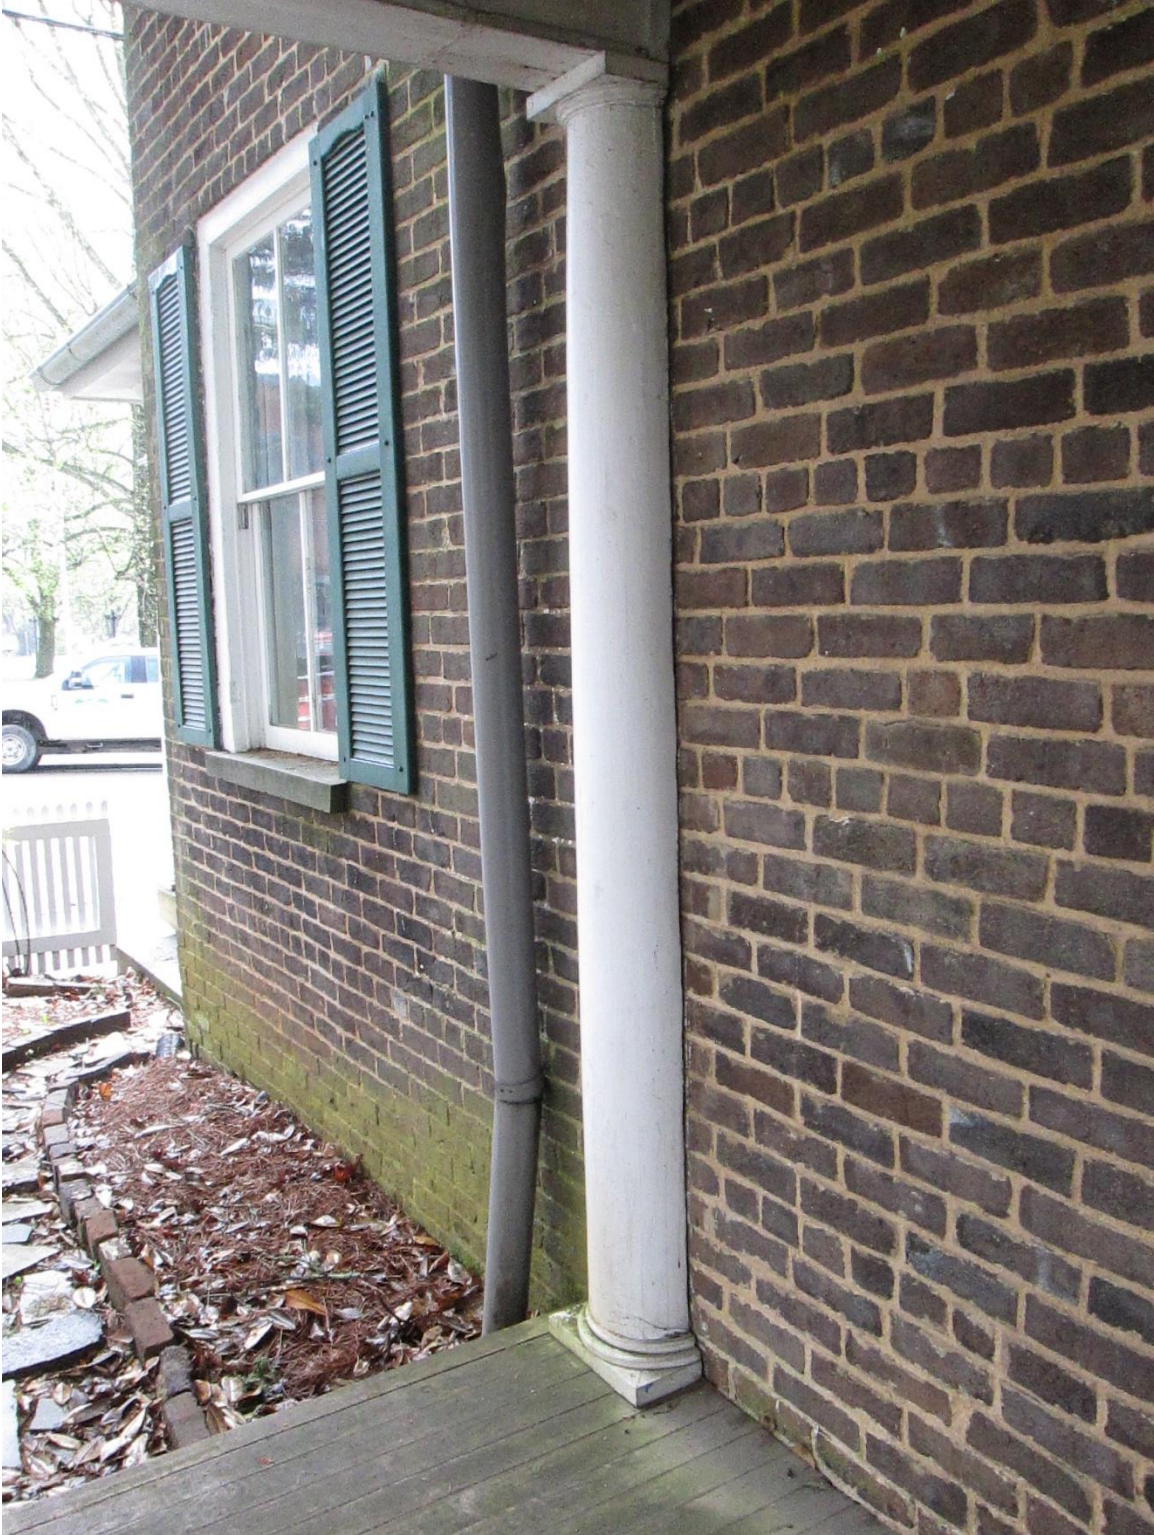
Photograph 6. Example a pilaster along the north elevation of the Nance Building in fair condition.

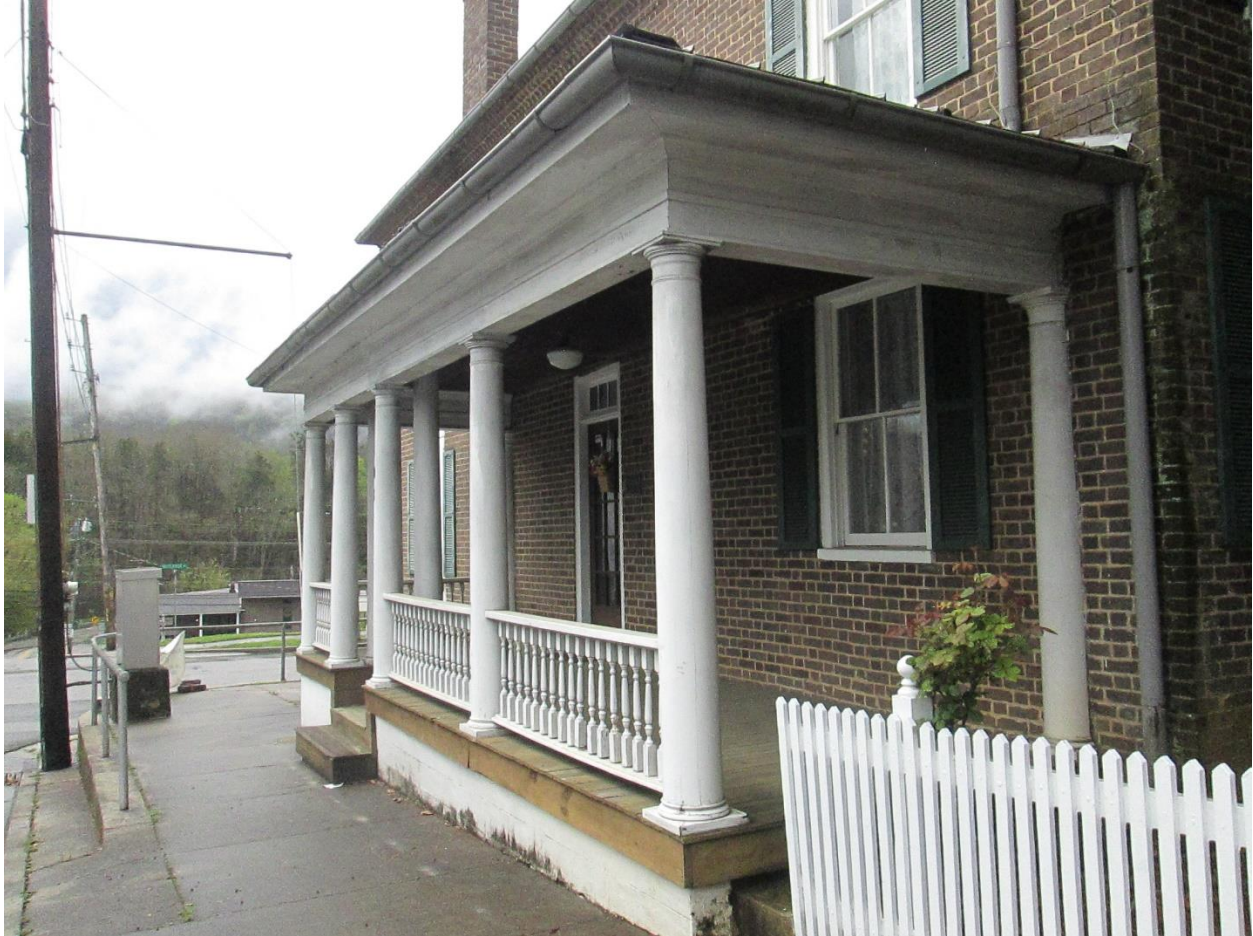
The east elevation (façade) includes seven freestanding columns and two pilasters. These columns are in fair condition and likely require only sanding and painting (see Photographs 7-9).

Photograph 7. Partial view of the east elevation (façade) of the Nance Building, facing southwest, showing the entire porch including the seven freestanding columns and two pilasters.

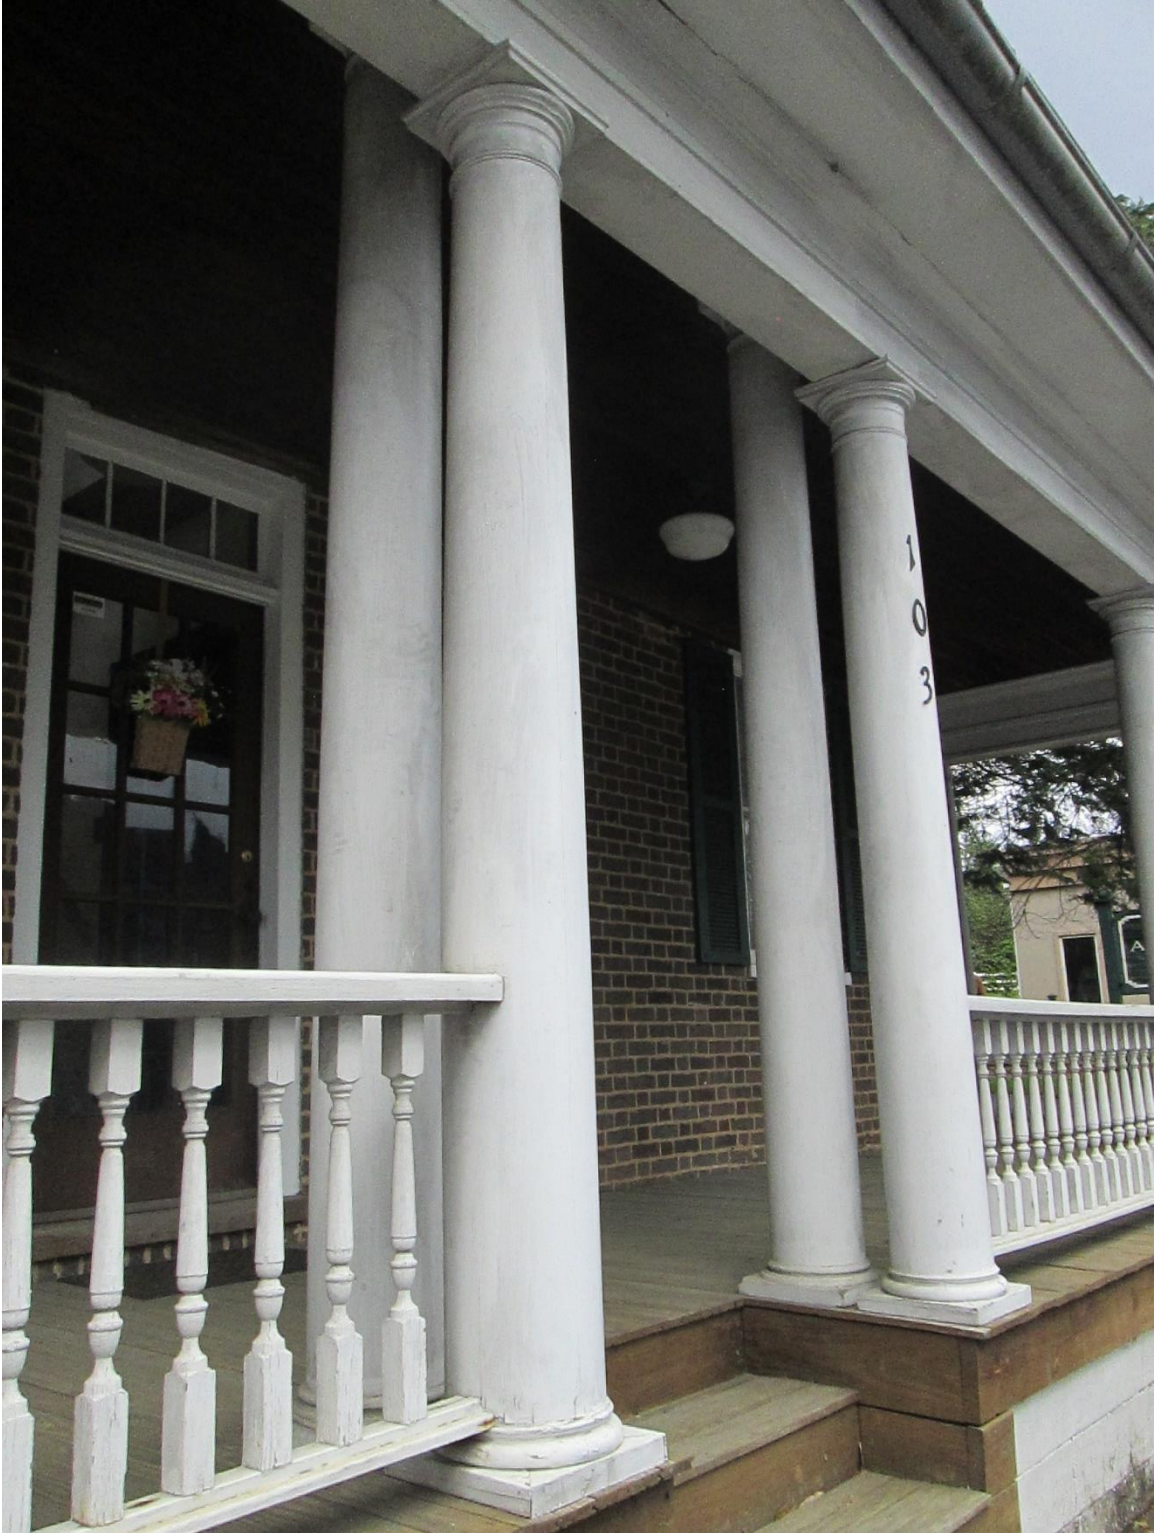
Photograph 8. Examples of the freestanding columns along the east elevation (façade) of the Nance Building, shown in fair condition.

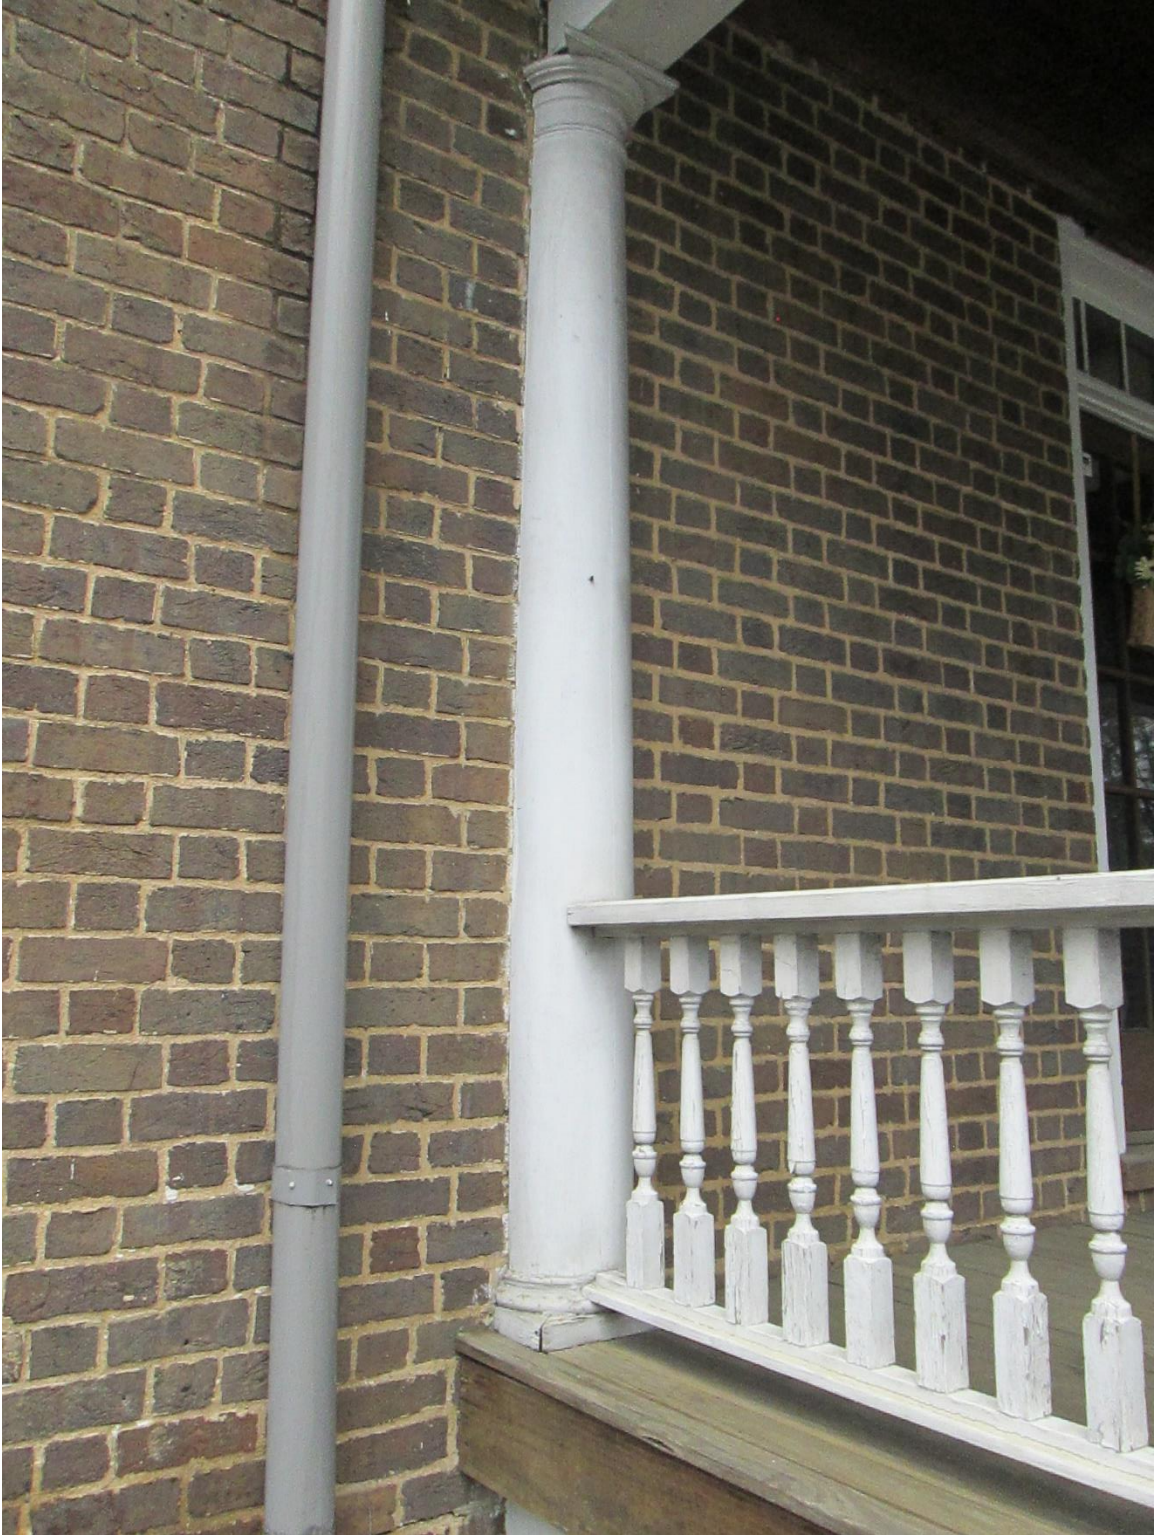
Photograph 9. Example a pilaster along the east elevation (façade) of the Nance Building, shown in fair condition.

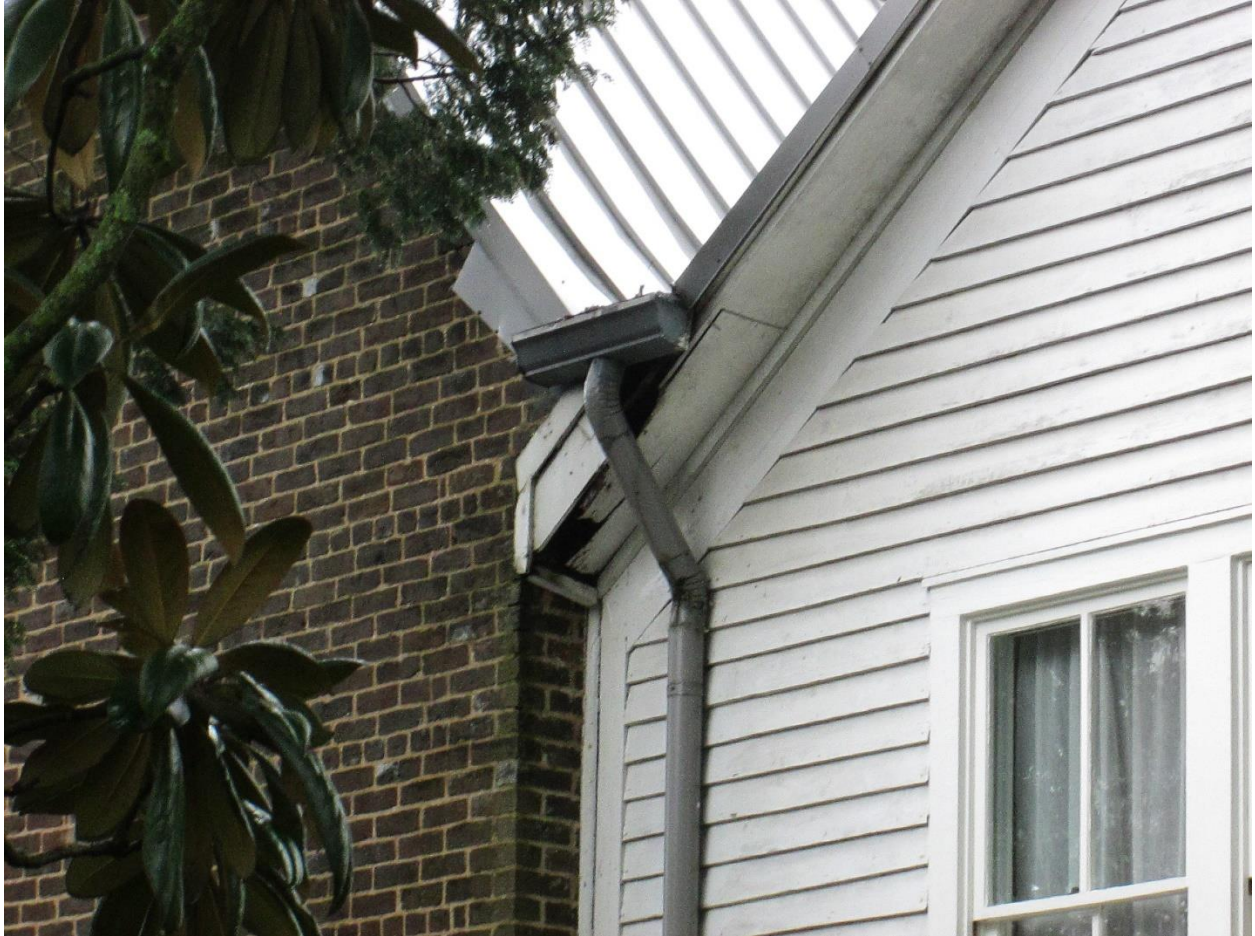
The north elevation presents substantial soffit deterioration along the north elevation gable. (see Photograph 10).

Photograph 10. Detail view of soffit along the north elevation gable of the Nance Building showing substantial deterioration.
