Bid Package

City of Rutledge

Nance Building Column and Soffit Restoration

Nance Building Columns and Soffit Restoration

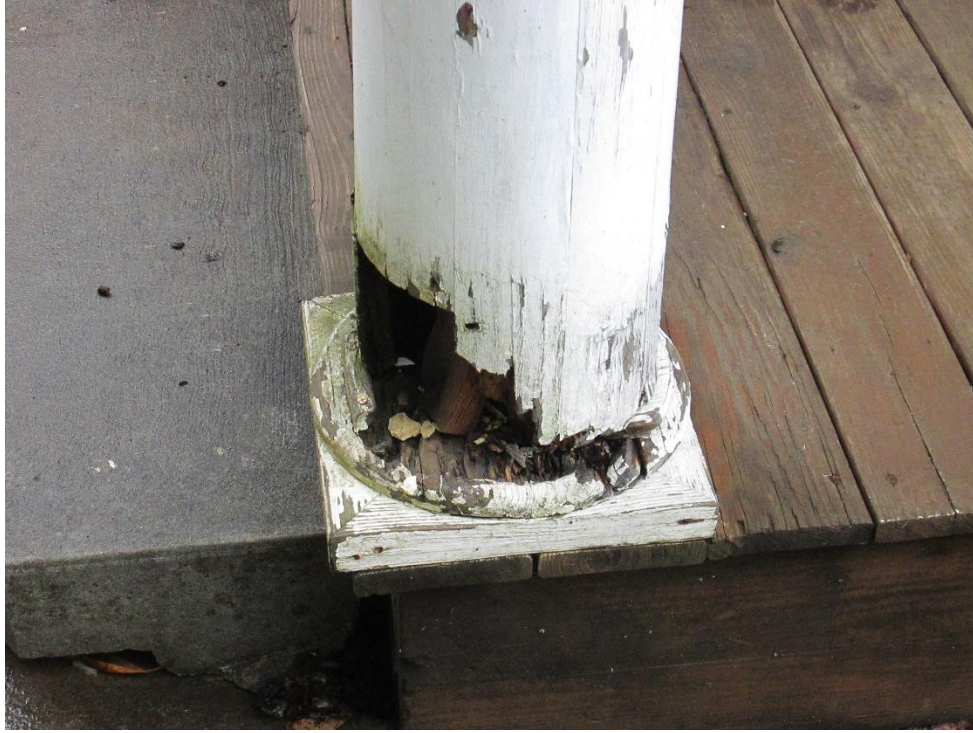
Photograph 2. Example of substantial deterioration of a freestanding column along the west elevation of the Nance Building.

Specification	Cost	Notes
Inspect/diagnose potential rot in all 14 columns and 6 pilasters		
Remove unsalvageable rotted wood from 7 columns and 2 pilasters as needed and piece-in or patch in-kind materials as needed*		
Hand-scrape, hand-sand, and repaint surfaces of 14 columns and 6 pilasters as needed, matching original paint		
Remove unsalvageable rotted wood from north elevation gable soffit as needed and piece-in or patch in-kind materials as needed*		
Hand-scrape, hand-sand, and repaint surface of north elevation gable soffit as needed, matching original paint

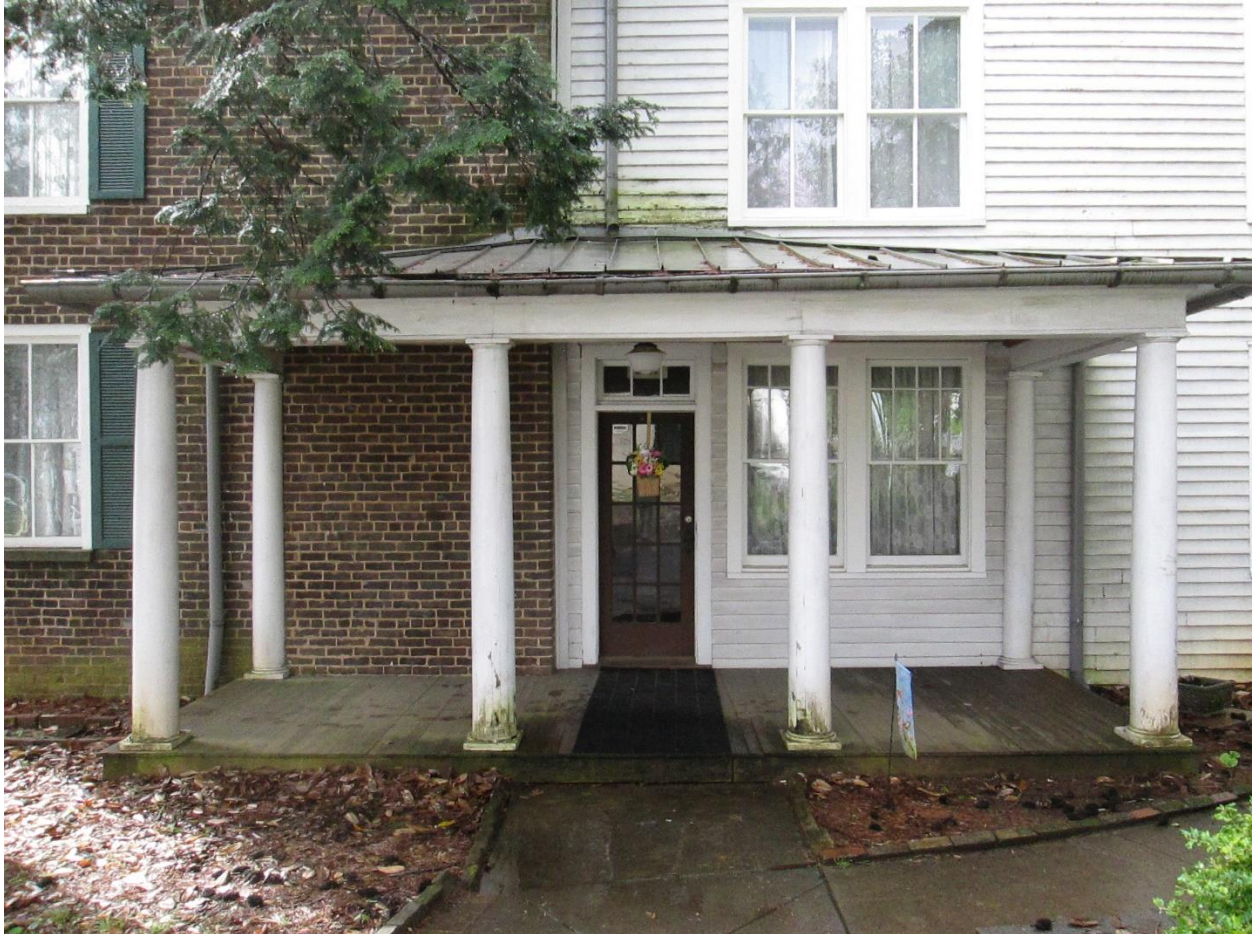
The north elevation includes four freestanding columns and two pilasters. Many of the freestanding columns present moderate deterioration; the pilasters are in fair condition and likely require only sanding and painting (see Photographs 4-6).

Photograph 4. Partial view of the north elevation of the Nance Building, facing south, showing the entire porch including the four freestanding columns and two pilasters.

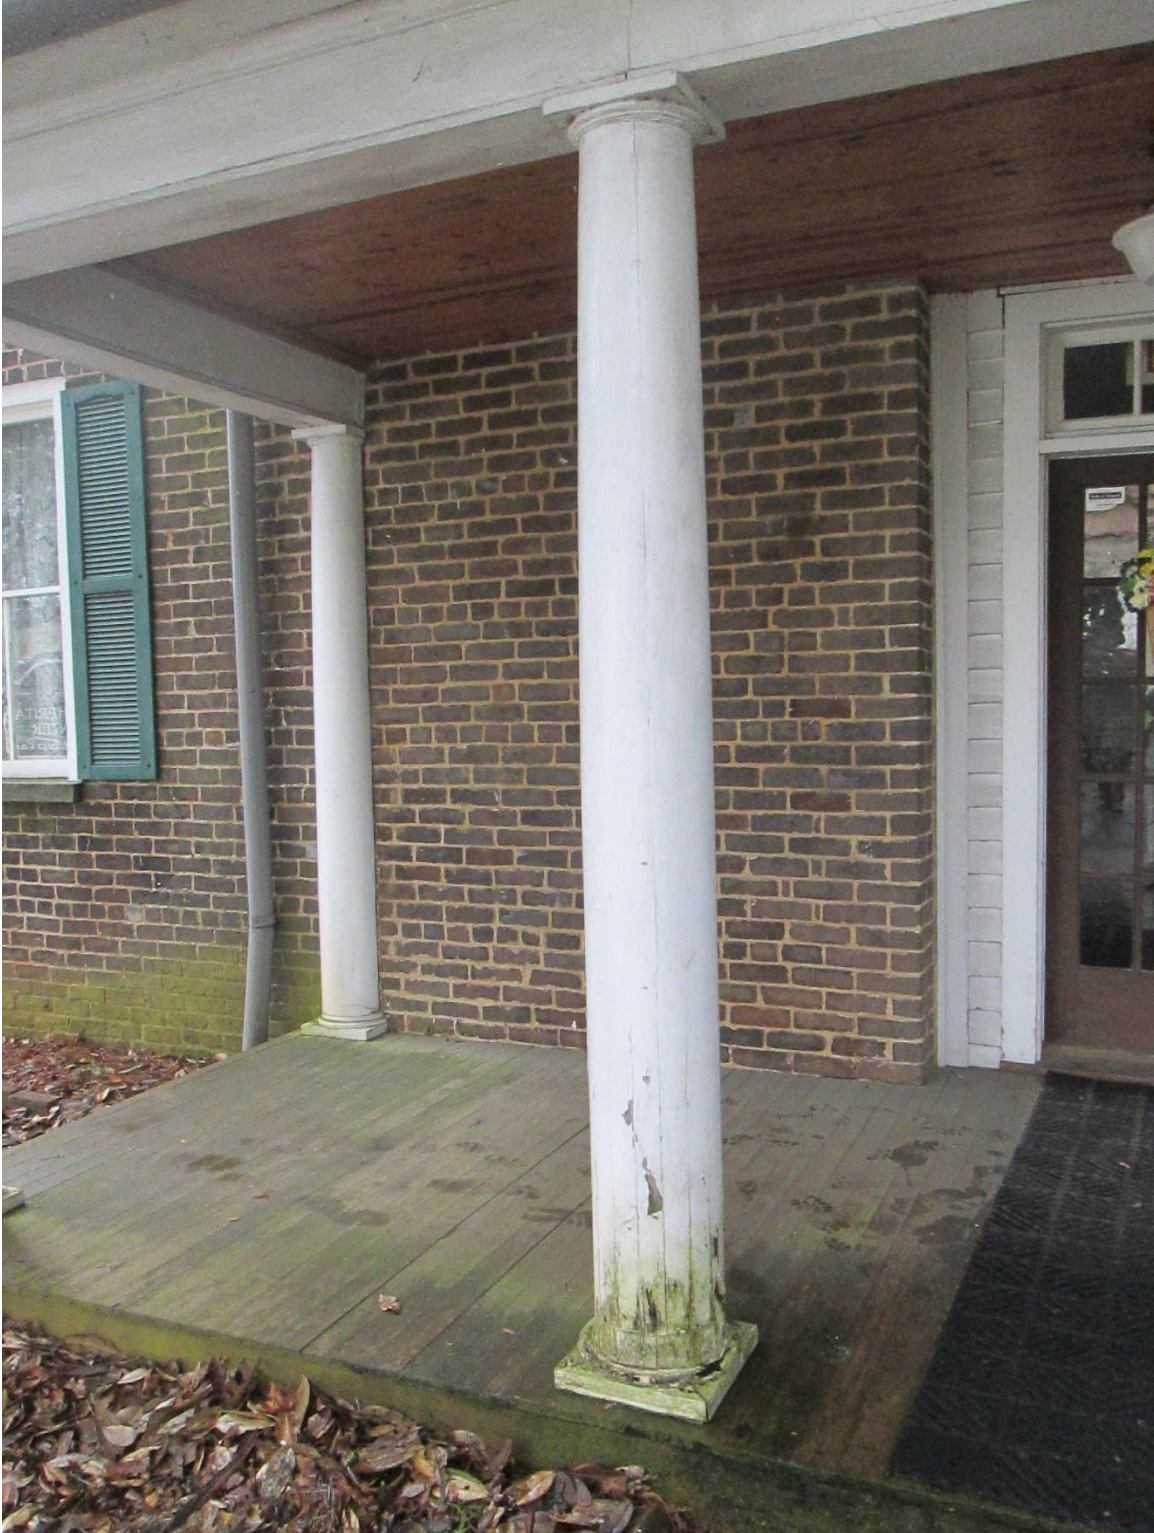
Photograph 5. Example of moderate deterioration of a freestanding column along the north elevation of the Nance Building

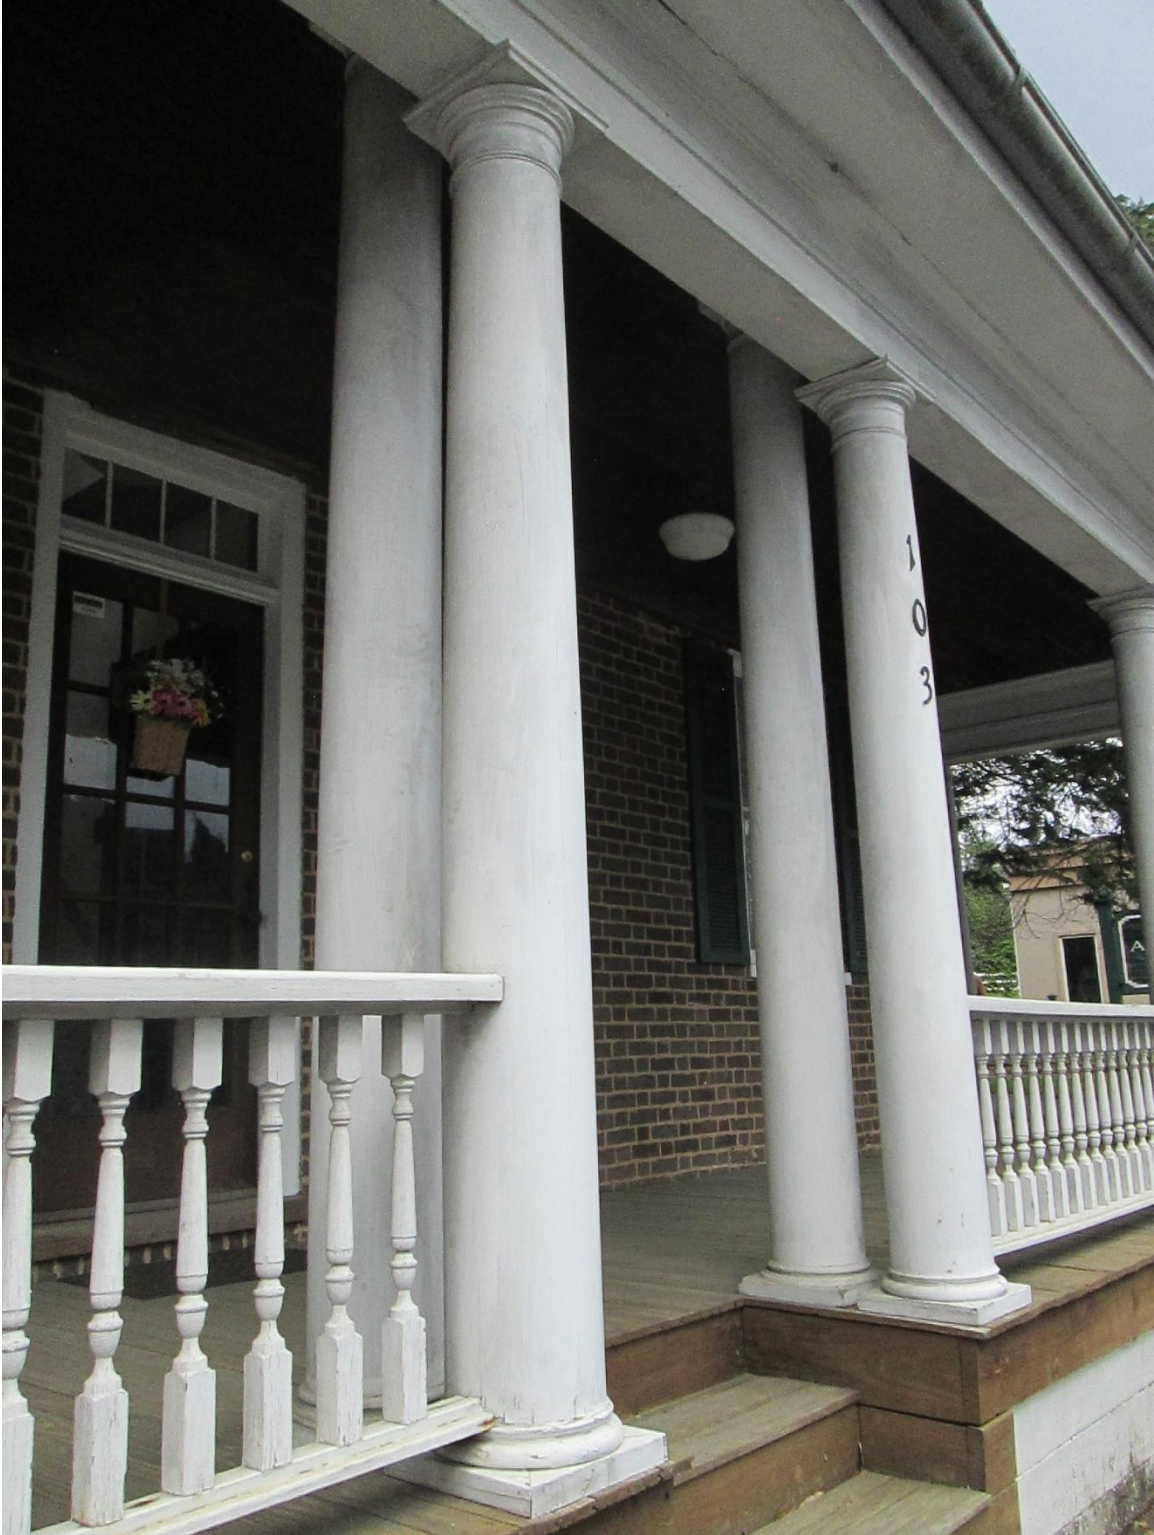
Photograph 8. Examples of the freestanding columns along the east elevation (façade) of the Nance Building, shown in fair condition.

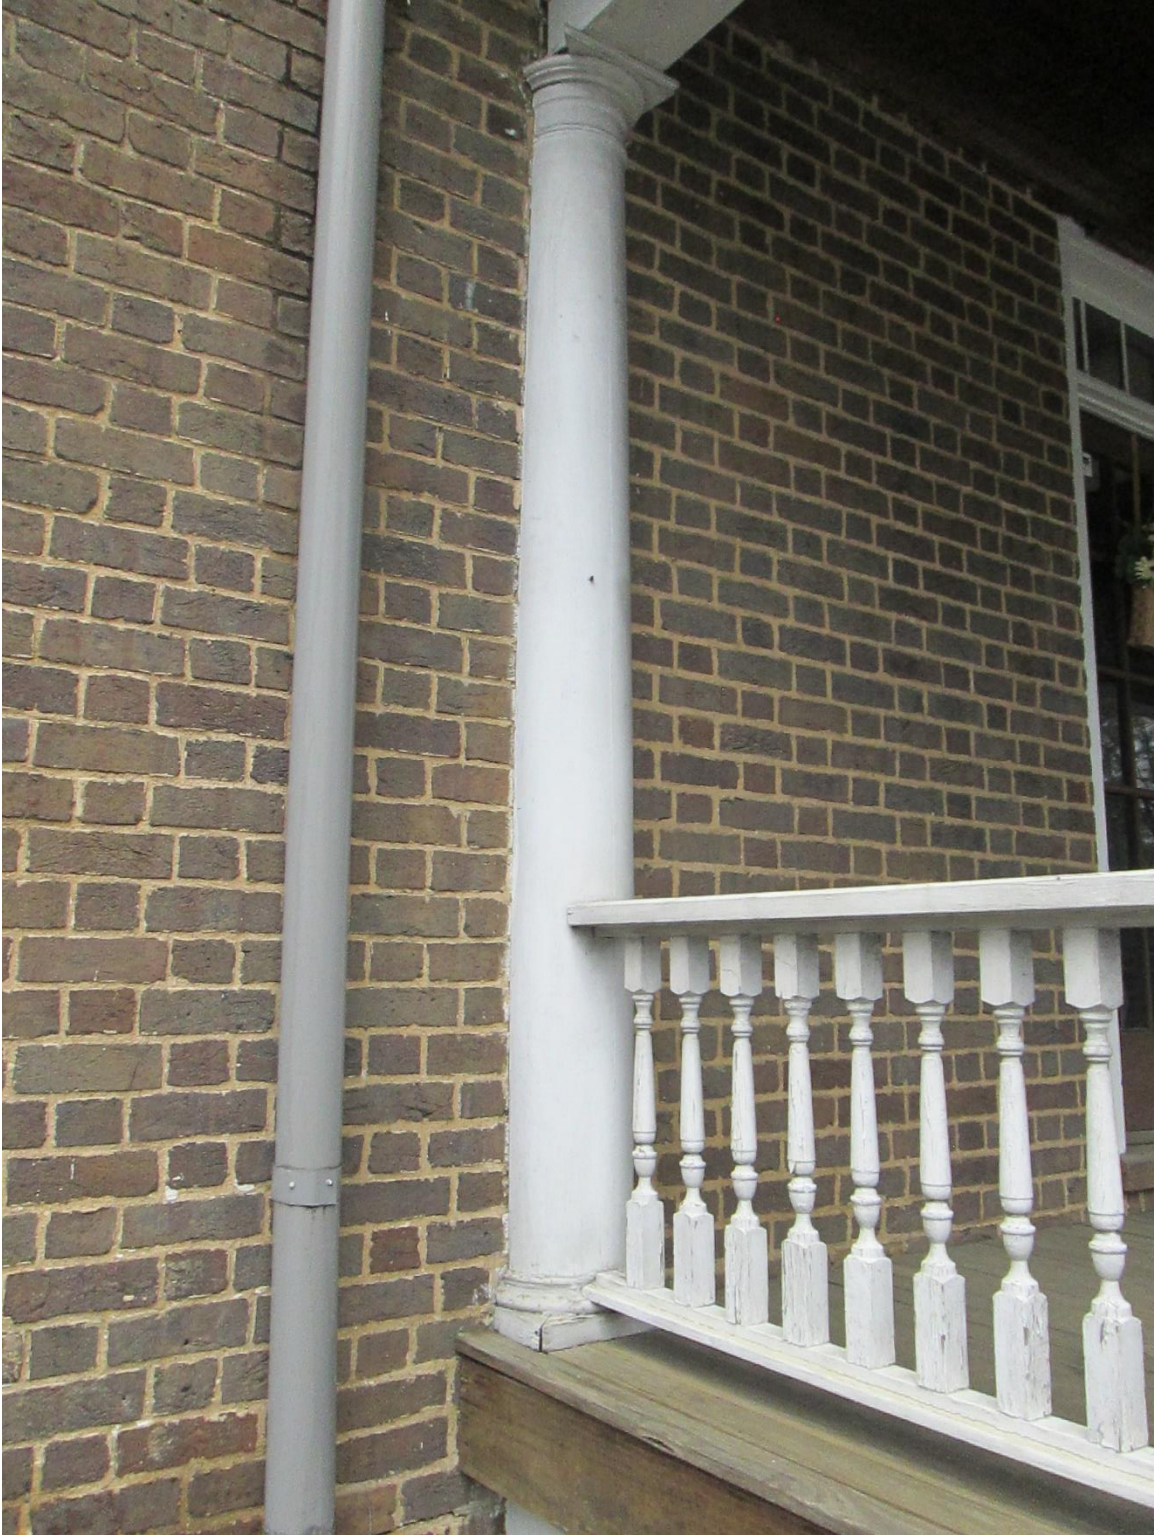
Photograph 9. Example a pilaster along the east elevation (façade) of the Nance Building, shown in fair condition.
