PHASE II PRELIMINARY SITE INVESTIGATION REPORT, DECEMBER 2012

Phase II Preliminary Site Investigation Report

Site 5 – Former A and M American Gas

Termini: Pellissippi Parkway from SR-33 to US-321/SR-73 Maryville, Blount County, Tennessee TDOT Project Number PE 62006-2213-94 TDOT PIN Number 101423.00

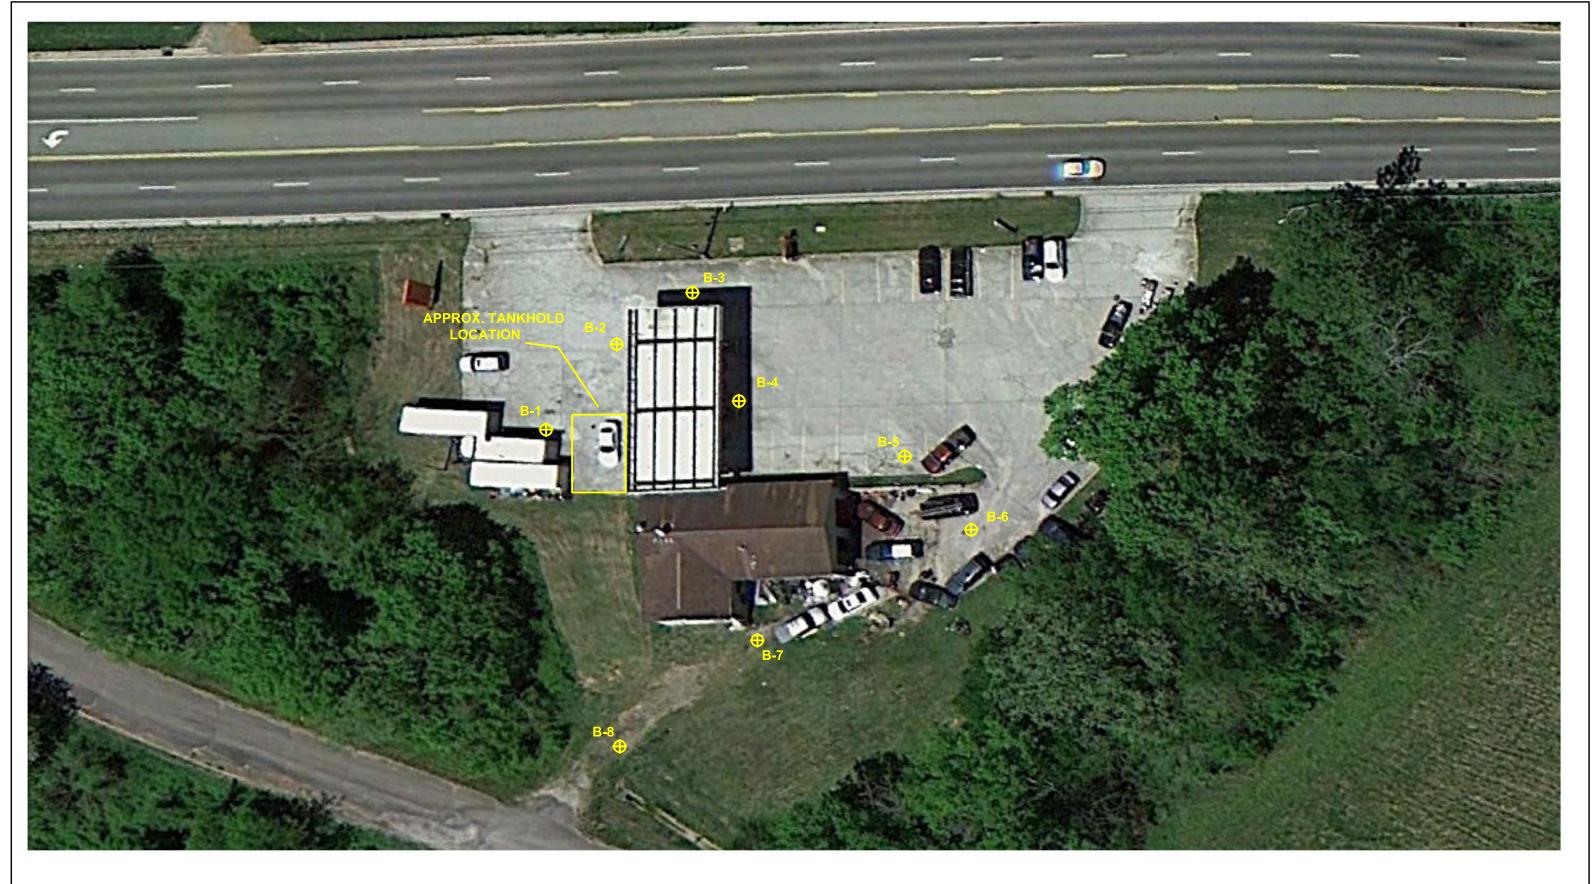
JOB NO.: 100-12-0061 APPROXIMATE SOIL BORING LOCATION MAP CLIENT: Parsons Brinkerhoff SITE 5 1900 Church Street, Suite 400 Nashville, TN 37203

On November 27, 2012, KSWA personnel mobilized to Site 5 and met with Tri-State Drilling, LLC (TSD) personnel to advance a total of eight (8) soil borings on Site 5, located at 3338 East Lamar Alexander Parkway in Maryville, Blount County, Tennessee. Underground utilities were located prior to drilling activities through the Tennessee One-Call system. All eight soil borings on Site 5 were advanced to the boring termination depth of approximately 15 feet below ground surface. A site vicinity map showing the general location of the subject project site is included as Figure 1. A soil boring location map showing the approximate locations of these eight borings is included as **Figure 2**. Photographs of the subject property are included in **Appendix A**.

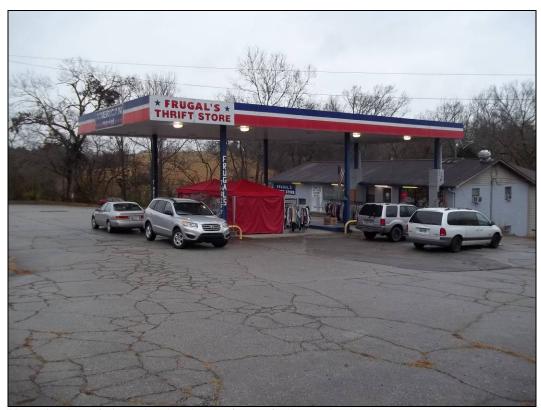
Photo 1: View of Site 5 showing that the former fueling station has been converted to a thrift store.

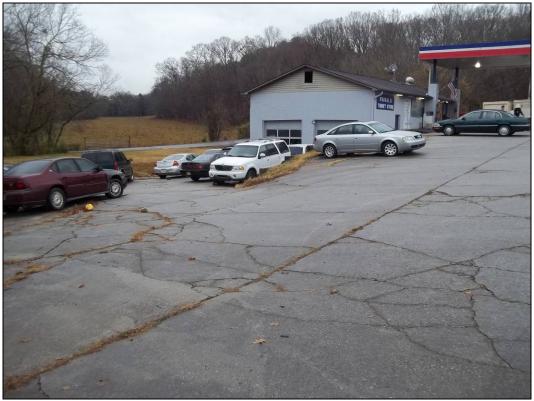
Photo 2: View of portion of Site 5 showing the former automotive service garage.

However, a registered underground storage tank (UST) system is presently located on the subject property. The UST tankhold is located adjacent to the southwest corner of the canopy and the northwest corner of the building structure (Reference Figure 2). According to *Sheet A9* of the 2008 *TDOT Technical Studies Map – Alignment A*, it appears that the proposed interchange right-of-way (ROW) may come extremely close to, if not actually intersect, the tankhold. Additionally, as a portion of the building was used as an automotive service garage up until several years ago, there are currently piles of tires, a waste oil tank, vehicle parts, and multiple vehicles located adjacent to this portion of the building.

If TDOT purchases the property, KSWA recommends that TDOT or the current owner remove the onsite UST system in accordance with TDEC DUST Closure Assessment Guidelines (CAG), as well as properly remove and dispose of the aforementioned items associated with the former automotive service garage, prior to the commencement of construction activities at Site 5. KSWA also recommends that an asbestos and lead-based paint survey be performed by an Environmental Protection Agency (EPA) AHERA-trained Asbestos Building Inspector prior to any demolition or alteration of the building structure or canopy located on Site 5.

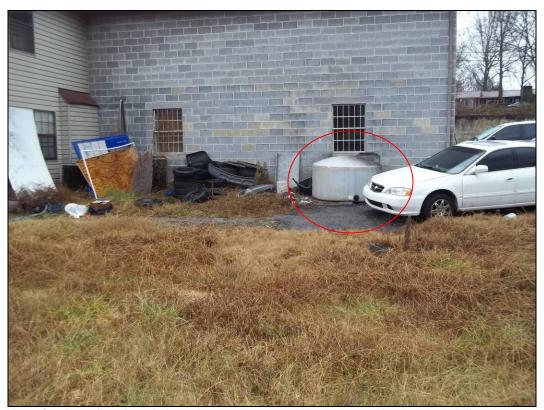
Soil Boring SB-07 was advanced on Site 5 behind the building structure, adjacent to the former automotive service garage (reference Figure 2, Photo 3). The soil boring was observed to consist of approximately 4 inches of topsoil at the surface, then turning to slightly moist to dry, slightly firm to firm, brown to red silty clay with some gray mottling, and minor rock/asphalt/brick fragments. The boring was terminated at 15 feet below ground surface as refusal was not encountered. None of the screened intervals had odors, and PID readings were all 0.0 to ppm. The 10-15 foot interval was selected for laboratory analysis.

Photo 3: View of portion of Site 5 showing the waste oil AST located behind the building structure.

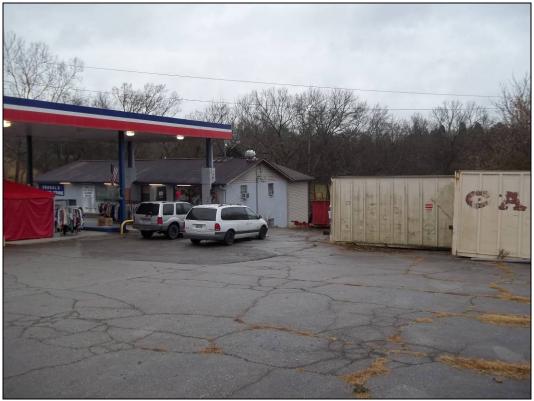
Soil Boring SB-01 was advanced on Site 5 on the west side of the canopy, adjacent to the tankhold (reference Figure 2, **Photo 4**). The soil boring was observed to consist of approximately 4 inches of asphalt at the surface, then turning to slightly moist to dry, slightly firm, brown silty clay with trace to abundant sand, and minor to abundant rock fragments. The boring was terminated at 15 feet below ground surface as refusal was not encountered. None of the screened intervals had odors, and PID readings were all 0.0 parts per million (ppm). The 10-15 foot interval was selected for laboratory analysis.

Photo 4: View of portion of Site 5 showing general location where soil boring SB-01 was advanced.

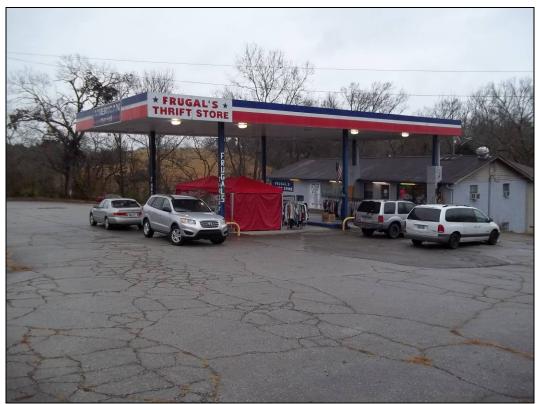
Soil Boring SB-02 was advanced on Site 5 adjacent to the northwest corner of the canopy (reference Figure 2, **Photo 5**). The soil boring was observed to consist of approximately 4 inches of asphalt at the surface, then turning to slightly moist to dry, slightly firm to firm, brown silty clay with abundant rock fragments. The boring was terminated at 15 feet below ground surface as refusal was not encountered. None of the screened intervals had odors, and PID readings were all 0.0 ppm. The 10-15 foot interval was selected for laboratory analysis.

Soil Boring SB-03 was advanced on Site 5 adjacent to the north side of the canopy (reference Figure 2, Photo 5). The soil boring was observed to consist of approximately 4 inches of asphalt at the surface, then turning to dry, slightly firm to firm, brown to red silty clay with minor to abundant rock fragments, and minor asphalt fragments. The boring was terminated at 15 feet below ground surface as refusal was not

Photo 5: View of portion of Site 5 showing general location where soil borings SB-02 and SB-03 were advanced.

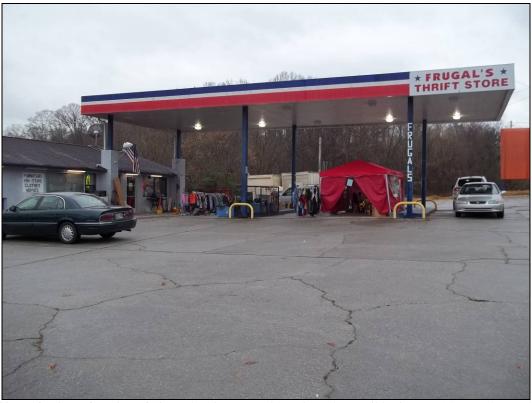
Soil Boring SB-04 was advanced on Site 5 adjacent to the east side of the canopy (reference Figure 2, **Photo 6**). The soil boring was observed to consist of approximately 4 inches of asphalt at the surface, then turning to dry, slightly firm to firm, brown to red silty clay with minor to abundant rock fragments. The boring was terminated at 15 feet below ground surface as refusal was not encountered. None of the screened intervals had odors, and PID readings were all 0.0 ppm. The 10-15 foot interval was selected for laboratory analysis.

Photo 6: View of portion of Site 5 showing general location where soil boring SB-04 was advanced.

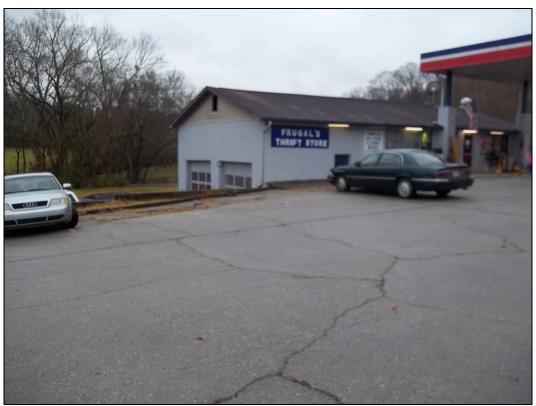
Soil Boring SB-05 was advanced on Site 5 adjacent to the northeast corner of the building and the former automotive service garage (reference Figure 2, **Photo 7**). The soil boring was observed to consist of approximately 4 inches of asphalt at the surface, then turning to slightly moist to dry, slightly firm to firm, red to brown silty clay with minor to abundant rock/asphalt fragments. The boring was terminated at 15 feet below ground surface as refusal was not encountered. None of the screened intervals had odors, and PID readings were all 0 parts per million (ppm). The 10-15 foot interval was selected for laboratory analysis.

Photo 7: View of portion of Site 5 showing general location where soil boring SB-05 was advanced.

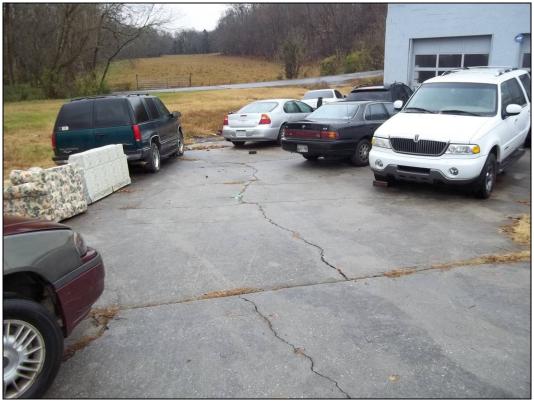
Soil Boring SB-06 was advanced on Site 5 adjacent to the east side of the building and the former automotive service garage (reference Figure 2, **Photo 8**). The soil boring was observed to consist of approximately 4 inches of asphalt at the surface, then turning to dry to moist, slightly firm to firm, brown silty clay with minor to abundant rock fragments. The boring was terminated at 15 feet below ground surface as refusal was not encountered. None of the screened intervals had odors, and PID readings were all 0.0 ppm. The 10-15 foot interval was selected for laboratory analysis.

Photo 8: View of portion of Site 5 showing general location where soil boring SB-06 was advanced.

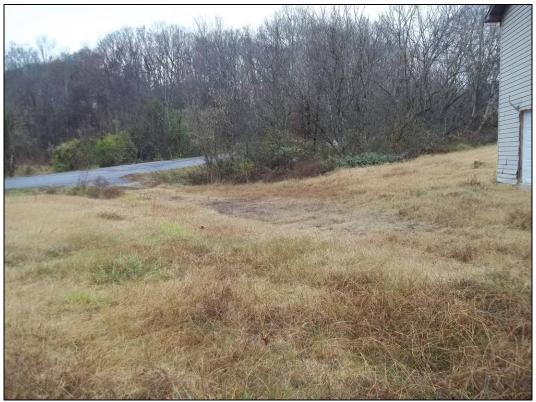
Soil Boring SB-08 was advanced on Site 5 behind the building structure, adjacent to the southeast corner of the building (reference Figure 2, **Photo 9**). The soil boring was observed to consist of approximately 4 inches of topsoil at the surface, then turning to slightly moist to saturated, slightly firm, red to brown silty clay with minor to abundant rock and asphalt fragments. The boring was terminated at 15 feet below ground surface as refusal was not encountered. None of the screened intervals had odors, and PID readings were observed to range from 0.0 to 0.8 ppm. The 0-5 foot interval was selected for laboratory analysis.

Photo 9: View of portion of Site 5 showing general location where soil boring SB-08 was advanced.
