2019-15

**FINAL REPORT**  
**Autonomous Truck Mounted**  
**Attenuator (ATMA) Pilot**

University of Tennessee Center for Transportation Research

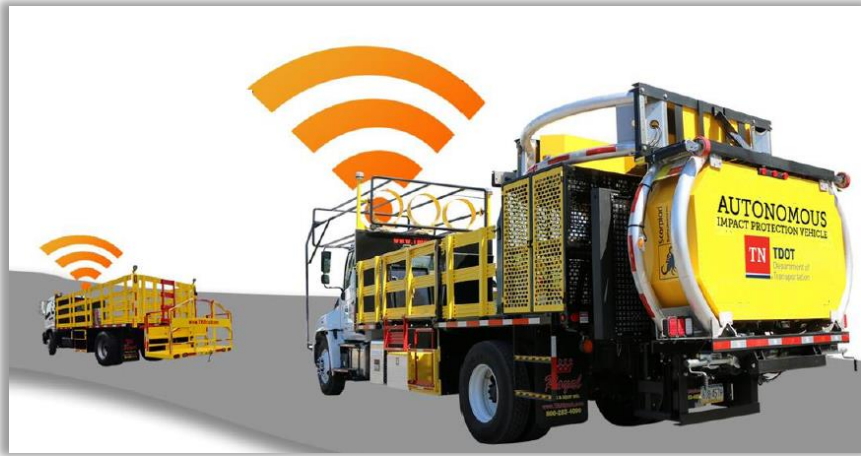
Figure 1 - ATMA’s Leader Follower Concept

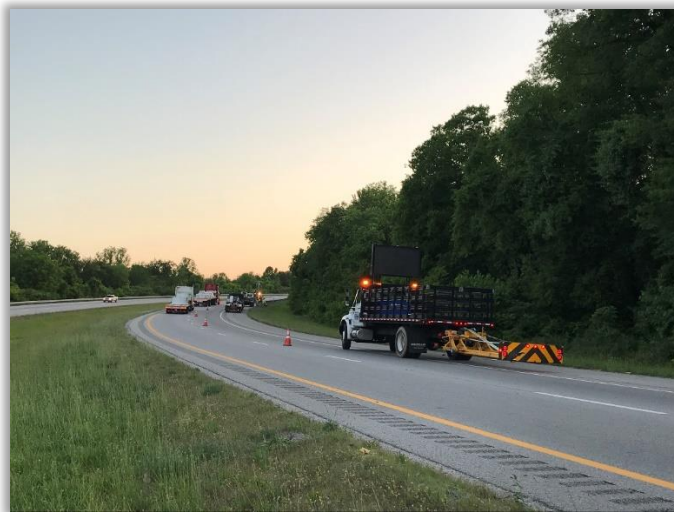
Currently, TDOT's TMAs or contracted TMAs do not have a system (eg.: GPS with timestamp) that tracks the positioning of the TMA in relationship to the other service vehicles involved in the work zone operation. Two-way radios are the primary means of communication used by TMA operators. TMA operators also rely on truck horns as an alarm to warn other work zone personnel of hazardous conditions or operator distraction. TDOT supervisors didn't identify specific distractions (cell phone use, etc) noticed during field operations but were concerned with driver complacency. These concerns are more significant in interstate operations. High volumes of traffic locations require concentration, attentiveness and alertness, opposed to locations with lower traffic volumes.

*Figure 3 - Typical TDOT TMA Operation*

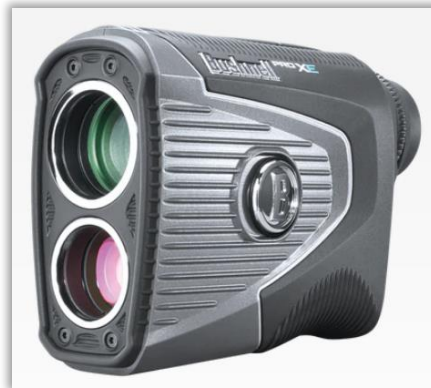
Based on this information, the research team recommends TDOT to explore the use of rangefinders with laser technology (Figure 4). This device would allow a TMA operator to better estimate and maintain the follow and roll ahead distance between a TMA and a service vehicle. Currently available laser technology allows for precise distance measurements up to 500 yards.

These devices can compensate for slope and weather conditions (temperature and barometric pressure) at an estimated cost of less than \$750 per unit.

Figure 4 - Rangefinder

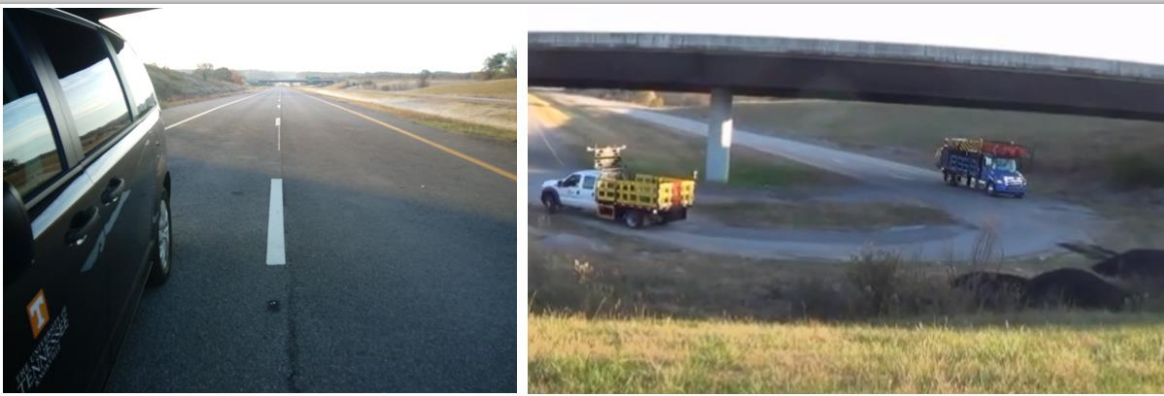
Figure 6 - Straightaway and Turnaround at I-840

Location 1 – West end of I-840 in Dickson County, TN – 1,800 feet of straightaway in flat terrain with good pavement conditions, two 12 foot lanes plus a 10 foot shoulder and an unpaved turnaround under an overpass connecting to an additional 700 feet of similar roadway conditions. Figures 5 and 6 illustrate location 1.

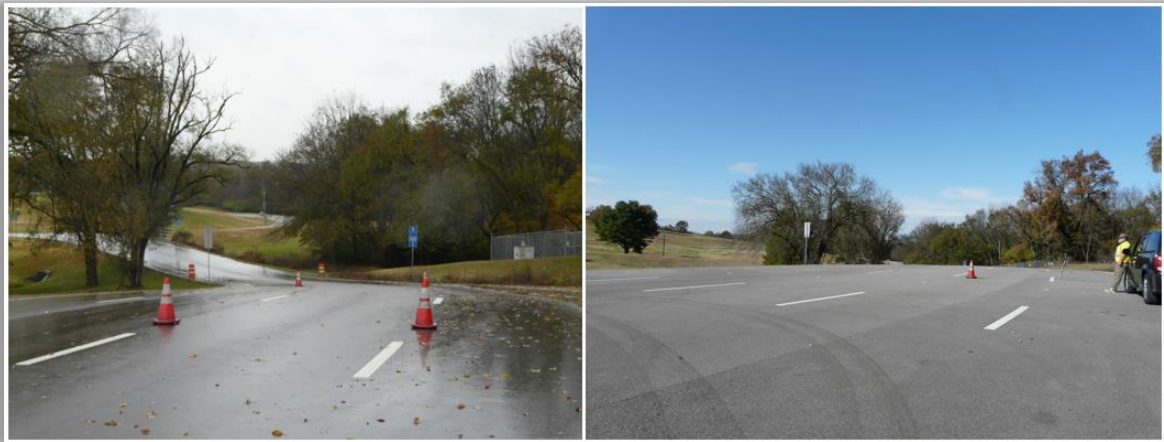
Figure 8 - TDSTC / TIM

Location 2 – Tennessee Department of Safety Training Center (TDSTC) / Traffic Incident Management Training Facility (TIM) – 1,800 foot loop in hilly terrain, with varying width, intersections with tight turn radii, and tree cover on portions of the track. Figures 7 and 8 illustrate location 2.

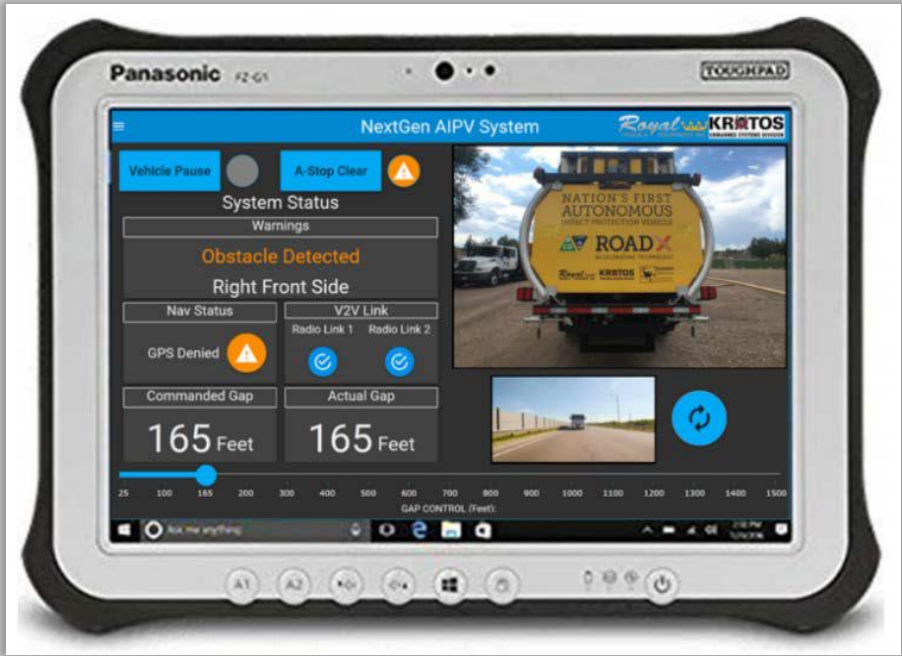
touchscreen tablet computer in the LV with Graphical User Interface (GUI) software. The display provides clear images in all lighting conditions. The GUI enables the operator in the LV to remotely set the Gap (Follow) Distance between the LV and ATMA to prescribed distances using a slider-bar touchscreen control.

Figure 9 - Graphic User Interface (GUI) device located on Leader Vehicle

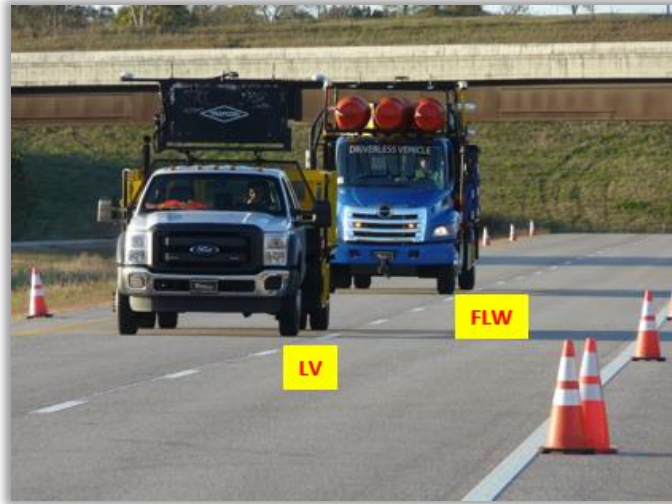
A Ford F550 was used as the leader vehicle (LV). Dimensions are 25'L x 8'6"W and the GPS units were located 11'4" from the front. A HINO 268 truck was used as the follower vehicle (FLW). Dimensions are 32'5"L x 8'9"W and the GPS units were located 9'9" from the front. The AIPV was equipped with a Scorpion truck mounted attenuator that measured 15'2" when deployed. Figure 10 presents the LV and the FLW (AIPV). For the purpose of this report, AIPV (Autonomous Impact Protection Vehicle) is used to denote the follower vehicle and the term ATMA system is used to denote the LV plus the AIPV.

Figure 10 - Leader (LV) and Follower (FLW/AIPV) Vehicles

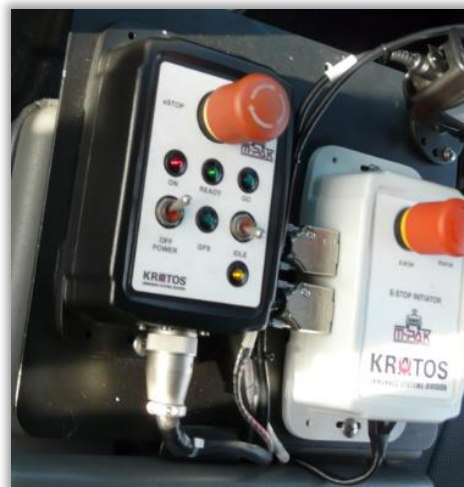
Figure 11 - Leader Vehicle Internal A-Stop and E-Stop Buttons

Figure 11 presents the Operator Control Unit (OCU) installed internally in the LV that controls the two modes of operation: IDLE and GO mode. In IDLE mode the safety operator of the ATMA system is in control of the AIPV instead of the autonomous system. In GO mode the AIPV operates autonomously. The OCU also controls the manually activated Automatic Stop (A-Stop), red button to the left. The E-Stop independent initiator controls the Emergency Stop (E-Stop), red button to the right. The main operational difference between the two types of Stop control is that the A-Stop does not kill the AIPV engine and can be reset from the LV. The A-Stop can also be initiated automatically by the ATMA system as explained in *Section 5.1.1*.

Two testing scenarios (detailed in Chapter 6) were used to demonstrate the applicability of the A-Stop and E-Stop buttons. The equipment worked as expected.

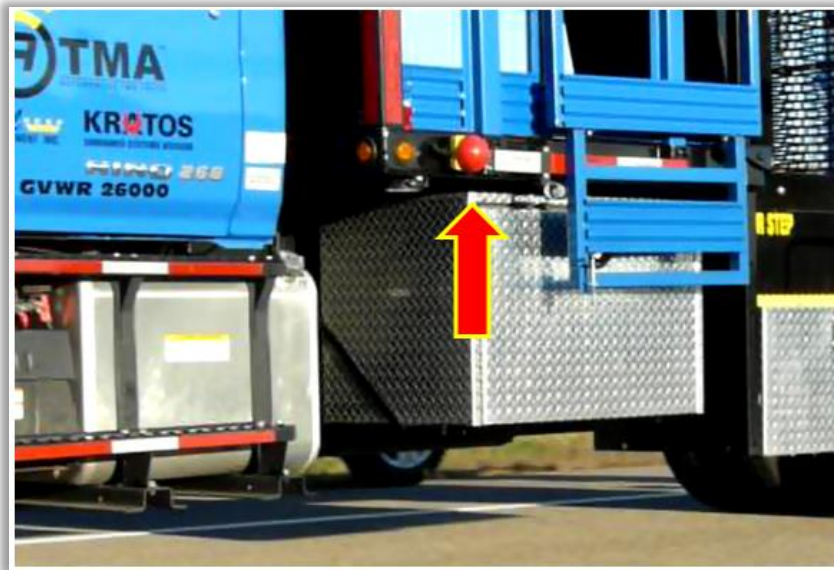
Figure 12 presents the equipment installed outside of the AIPV that controls the manually activated Emergency Stop (E-Stop). There are two large red buttons, one on each side of the AIPV.

*Figure 12 - AIPV External E-Stop Button*

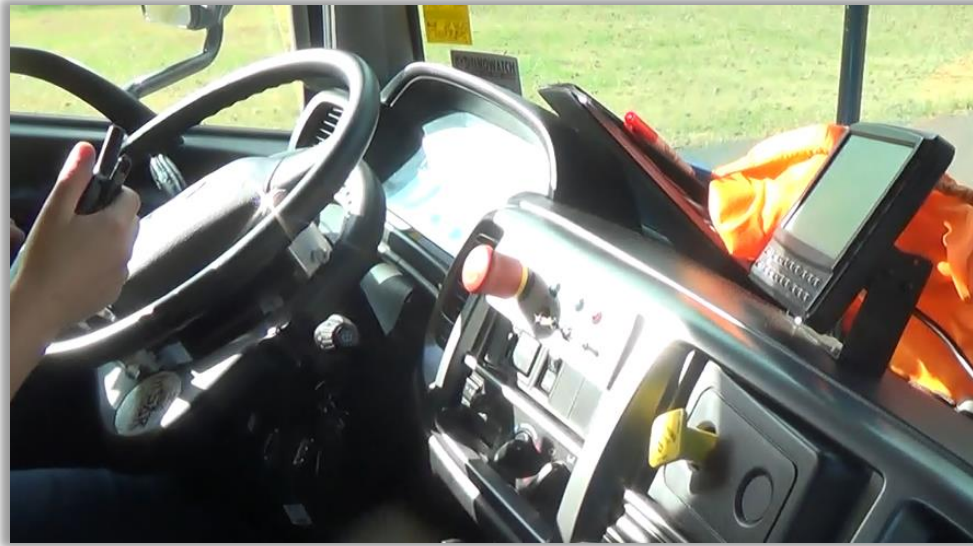
The AIPV also has an OCU controlling the IDLE or GO mode of operation, with a red E-Stop button that can be manually activated (Figure 13). The applicability of the internal E-Stop on the AIPV may be considered limited but the equipment worked as expected as demonstrated in a testing scenario (detailed in Chapter 6). The yellow button is used for the parking brakes.

Figure 13 - AIPV Internal E-Stop Button

Figure 13 also shows the equipment installed below the steering wheel that is used to control the vehicle autonomously, the Multi-Platform Appliqué Kit or M-PAK™ Steering Wheel Actuator / Smartmotor Assembly. The research team noticed it as a potential inconvenience, since it limits the space available for sitting. The ATMA system developer discourages users of the system to remove the steering wheel actuator on the AIPV, to prevent damage, misalignment and improper installation. The research team was informed that, in response to user feedback, the steering wheel actuator design has been modified after the testing procedures took place, to allow greater flexibility, during the installation process, and to increase clearance for the driver when the vehicle is being manually operated.

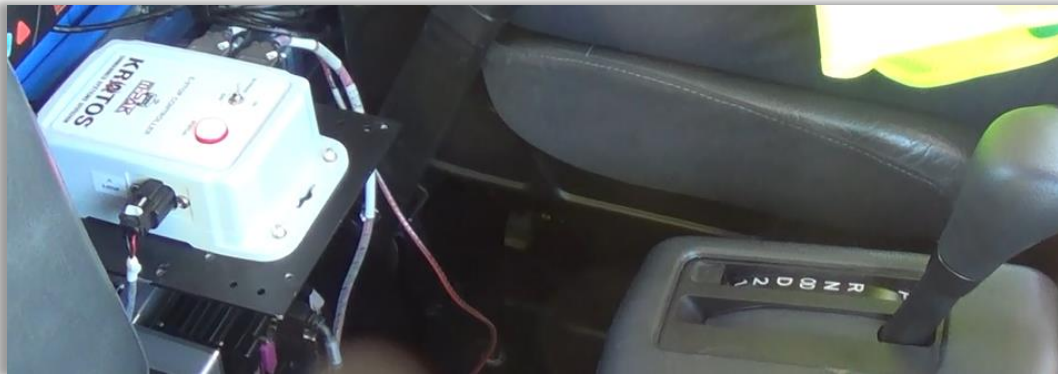
The AIPV vehicle has an E-Stop Controller unit that activates and releases the E-Stop (Figure 14). *Section 5.2.3* details its use on the restart procedure after E-Stop.

Figure 14 - AIPV E-Stop Controller Unit

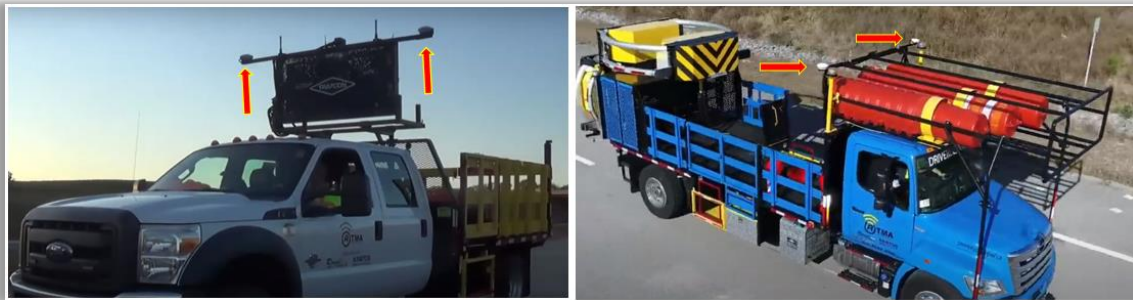
The LV and the AIPV are equipped with a pair of GPS antennas each (Figure 15), that collect absolute data from 15 to 18 satellites at any given moment. *Section 5.2.2* describes a GPS lining up procedure executed before each test case scenario.

Figure 15 - GPS Antennas

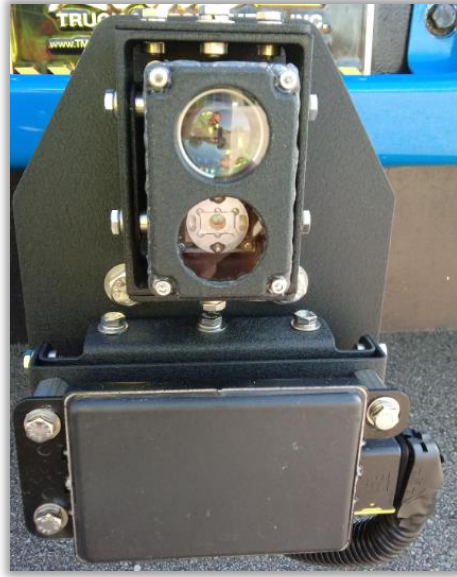
The forward-looking obstacle detection sensors mentioned in *Section 5.1.1* are installed in the AIPV. Light and radar is used for obstacle detection. The top sensor in Figure 16 is a Lidar unit and the bottom sensor is a Delphi ESR (Electronic Scanning Radar).

Figure 16 - Forward-looking Obstacle Detection Sensors

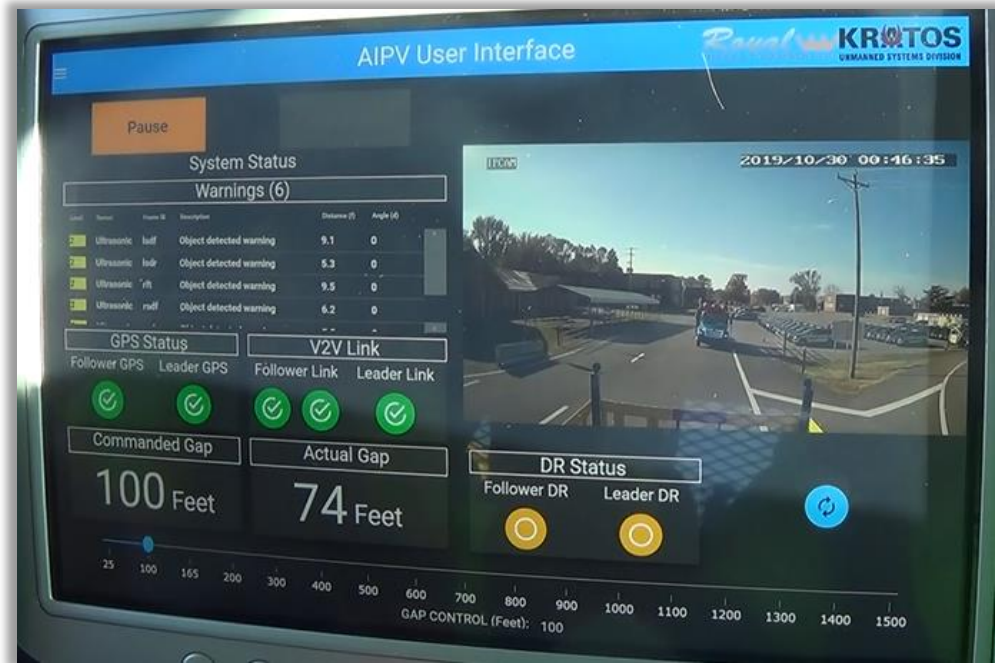
The GUI described in *Section 5.1.4* was mounted in the LV on the passenger side, not interfering with the driver ability to control the vehicle but within easy reach. The screen was easily readable at all light conditions. The process to disconnect and reconnect the GUI to its bracket and communications cables was not cumbersome and took less than 3 minutes. A video of the procedure can be found here: [https://youtu.be/G\\_Fxtkbuezw](https://youtu.be/G_Fxtkbuezw). Figure 18 presents a screenshot of the GUI.

Specific warning messages pop up at the top of the screen and promptly warn the driver of a system malfunction. An example of an E-crumb error (where the AIPV was not able to locate the LV next data point position) can be found here: <https://youtu.be/Tbiy2FyXiNg>. It is necessary to note that the Gap Control slide bar does not accommodate for all potential following distances required by TDOT's Work Zone Field Manual for Maintenance Operations (eg.:175 feet, 225 feet). No other GUI issues were noticed during the testing procedures.

Figure 18 – Graphic User Interface (GUI) Panel

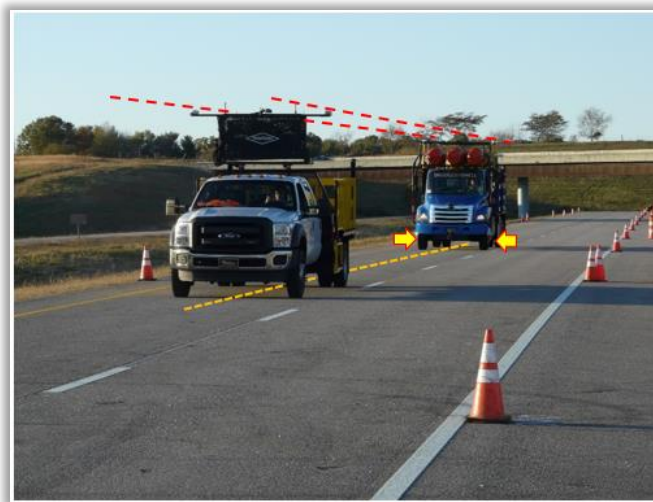
Figure 19 illustrates the pre-operational check for the alignment procedure presented on the AIPV GUI panel. First, it is necessary to position the AIPV exactly behind the LV with a 25 feet to 75 feet gap. That is done by visually aligning the center of the AIPV with the center of LV. Second, the front wheels on the AIPV need to be pointing straight, in line towards the LV. That sets the steering wheel actuator to position “zero”. For example, if the autonomous mode is engaged with the AIPV front wheels pointing to the left, as the LV starts moving straight forward, the AIPV would move to the left. Figure 20 illustrates the line-up process during the testing procedures.

Figure 20 – LV and AIPV during Line-up Procedure

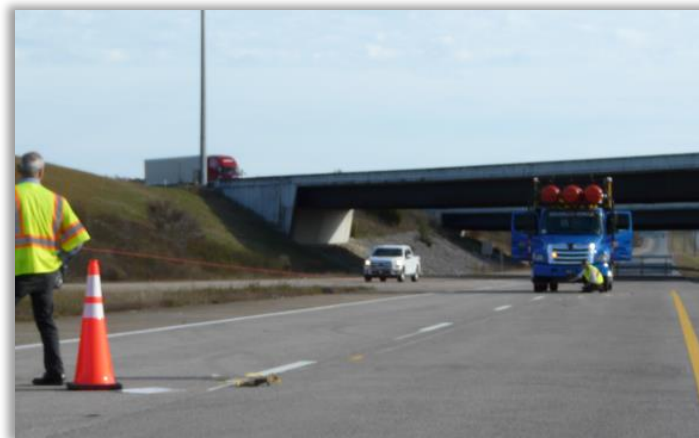
Also, the ATMA system was not operating normally during the initial testing procedures, according to the system operator personnel present in the testing site. A recalibration process of the system was performed (Figure 21). A system relay was exchanged and after the lengthy testing delay, the system was deemed ready for testing. The testing schedule was affected.

Figure 21 – ATMA System Recalibration Process

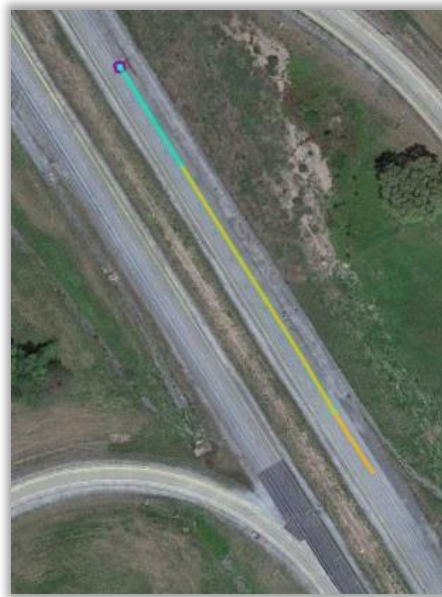
Test procedure: The command gap was set to 100 feet on the GUI. The LV and the AIPV were activated. The LV operator was asked to drive in a straight line at a target speed of 10 mph and stay centered in the lane. Data was collected for two runs. Figure 22 presents the plotted path of the test, with the orange line representing the LV and the blue line representing the AIPV.

Figure 22 – Test Path – Following Accuracy on Straight Line Test

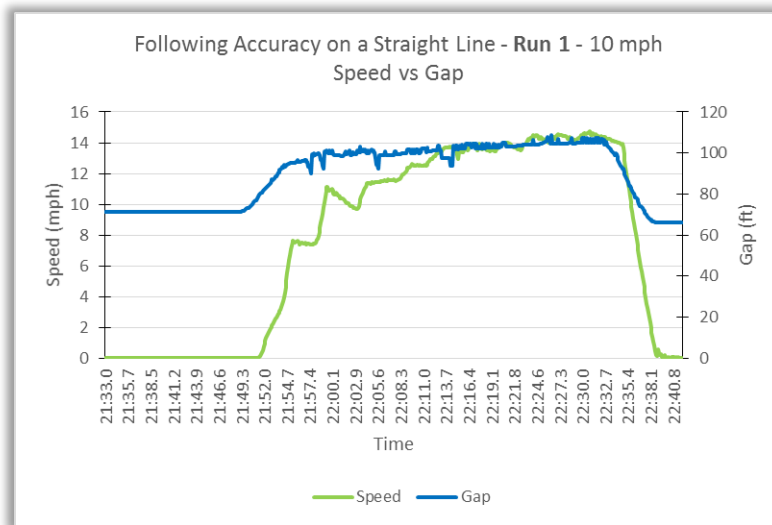
Figure 24 plots the speed vs the gap distance between the LV and the AIPV, with the speed change on the primary Y-axis as a function of time on the x-axis. A secondary y-axis plots the gap of the AIPV in relationship to LV. The plot for Run 2 is in the APPENDIX.

Figure 24 – Speed vs Gap – Following Accuracy on Straight Line Test

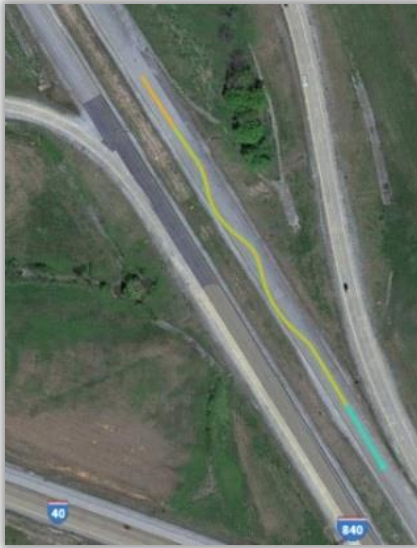
Figure 26 – Test Path – Following Accuracy on Slalom Course Test

Test procedure: A slalom course was set by positioning 5 cones 100 feet apart between the two lanes on I-840. The command gap was set to 100 feet on the GUI. The LV and the AIPV were activated. The LV operator was asked to drive at a target speed of 5 mph in a zig-zag pattern from one lane to another going through the cones. Data was collected for two runs. Figure 26 presents the plotted path of the test, with the orange line representing the LV and the blue line representing the AIPV.

**Expected result:** The AIPV maintains the lateral accuracy of  $\pm 6$  inches from the LV path and the following gap distance of  $\pm 15$  feet between the LV and the AIPV.

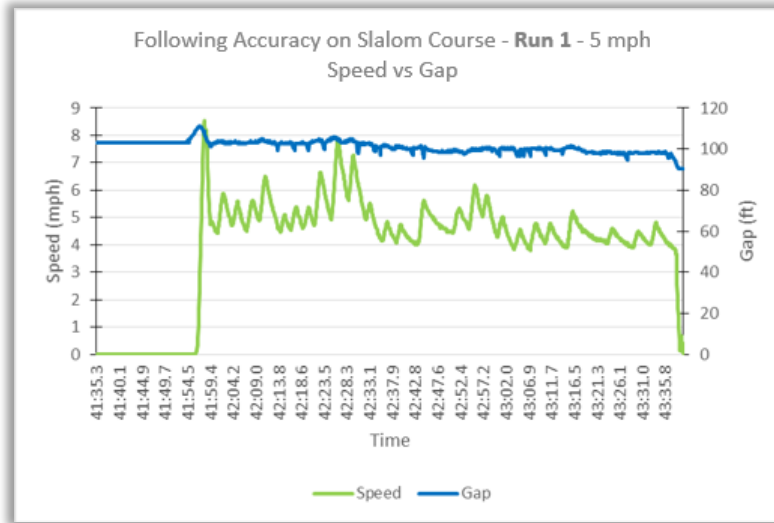
Figure 28 plots the speed vs the gap distance between the LV and the AIPV, with the speed change on the primary Y-axis as a function of time on the x-axis. A secondary y-axis plots the gap of the AIPV in relationship to LV.

Figure 28 – Speed vs Gap – Following Accuracy on Slalom Course Test

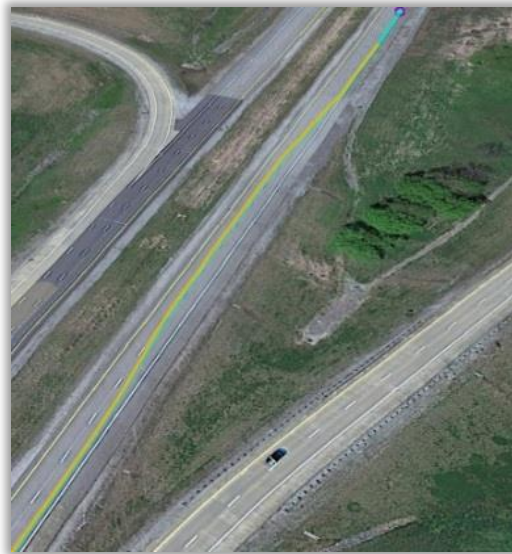
Test procedure: Using the 2 lanes of I-840, the right side lane was tapered from the shoulder to the left most lane, between 200 feet and 400 feet. After a 100 feet straight segment another taper was created from the left most lane back to the shoulder, between 500 feet to 700 feet. The command gap was set to 100 feet on the GUI. The LV and the AIPV were activated. The LV operator was asked to drive at a target speed of 10 mph, navigating the lane change described above. The test was repeated at a target speed of 15 mph. Data was collected for a total of four runs. Figure 30 presents the plotted path of the test, with the orange line representing the LV and the blue line representing the AIPV.

Figure 30 – Test Path – Following Accuracy on Lane Change Test

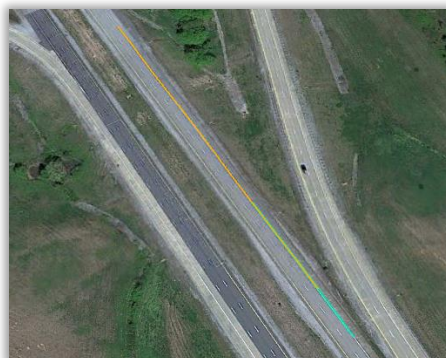
Figure 38 – Test Path – Trash Pick-up

Test procedure: The LV and the AIPV operated on the shoulder. The command gap was set to 300 feet on the GUI. The LV and the AIPV were activated. The LV operator was asked to drive at a target speed of 10 mph along the shoulder to the first predetermined stopping location. After the first stop, the LV moved 200 feet to the second predetermined stopping location. Data was collected for two runs. Figure 38 presents the plotted path of the test, with the orange line representing the LV and the blue line representing the AIPV.

Expected result: The AIPV maintains the following gap distance of  $\pm 15$  feet between the LV and the AIPV.

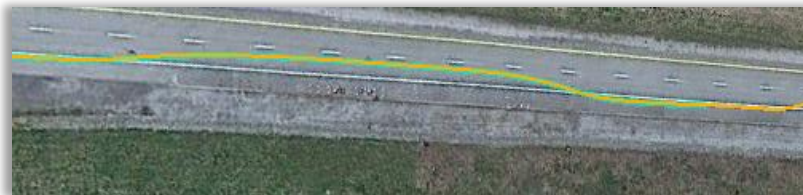
Figure 41 – Test Path – Herbicide Application

Test procedure: The LV and the AIPV operated on the shoulder. The command gap was set to 200 feet on the GUI. The LV and the AIPV were activated. The LV operator was asked to drive at a target speed of 10 mph along the shoulder, encroach on the adjacent lane at a predetermined location in the test track and return to the shoulder. Data was collected for two runs. Figure 41 presents the plotted path of the test, with the orange line representing the LV and the blue line representing the AIPV.

Expected result: The AIPV is capable to continuously shadow/protect the service vehicle (LV).

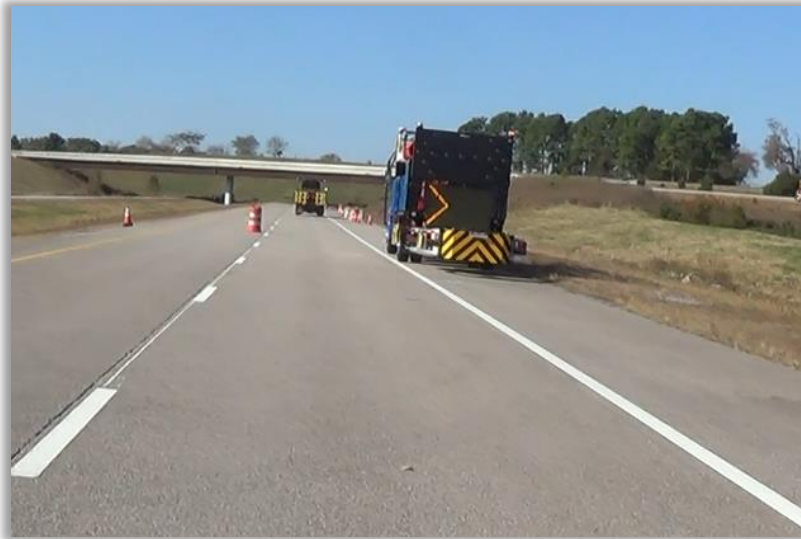
Results: As mentioned in *Chapter 5*, when in operation, the LV transmits its position, speed, and heading to the AIPV vehicle in a sequential series of Vehicle-to-Vehicle (V2V) “e-Crumbs” messages. The AIPV then maneuvers from one e-Crumb to the next following the path of the LV at a user-defined vehicle-gap. Figure 42 presents the moment the service vehicle (LV) encroached in the adjacent lane during the testing. From that point, for the next 19 seconds, the AIPV was unable to shadow the service vehicle as required. The AIPV simply continued to follow the e-Crumbs laid out by the LV on the shoulder. While the LV returned to the shoulder, the AIPV followed the e-Crumbs laid out by the LV on the adjacent lane. The ATMA system was not capable of continuously shadow/protect the service vehicle (LV).

Figure 42 – Unprotected Service Vehicle – Herbicide Application Test

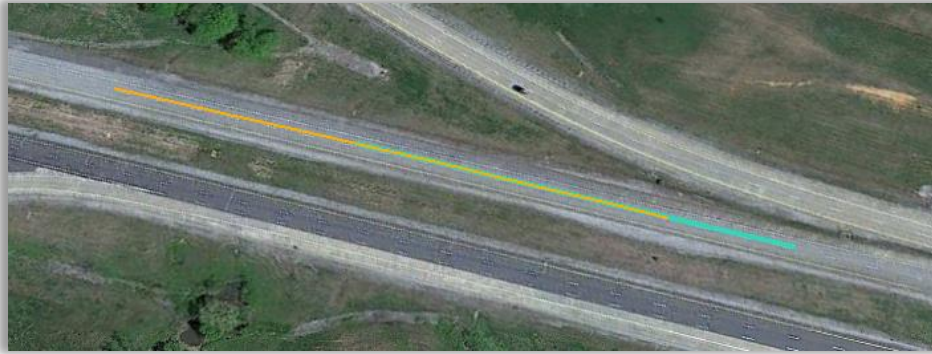
Test procedure: The command gap was set to 200 feet on the GUI. The LV and the AIPV were activated. The LV operator was asked to drive at a target speed of 10 mph to the first predetermined stopping location. After the first stop, the LV moved to the second predetermined stopping location. After the second stop, a UT team member walked towards the AIPV. Data was collected for two runs. Figure 43 presents the plotted path of the test, with the orange line representing the LV and the blue line representing the AIPV.

Figure 43 – Test Path – Pothole Patching

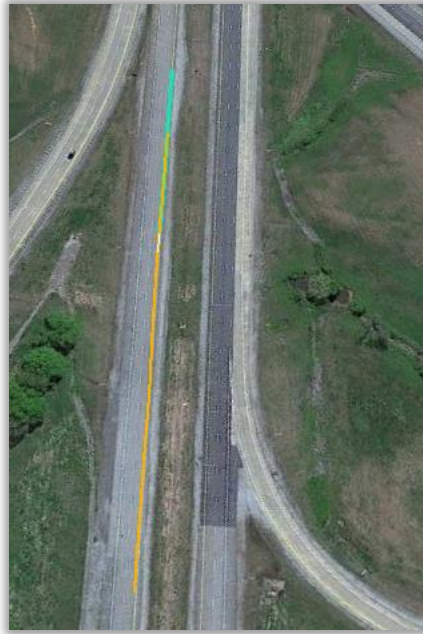
Figure 46 – Test Path – Obstacle Detection - Front

Test procedure: The command gap was set to 200 feet on the GUI. The LV and the AIPV were activated. The LV operator was asked to drive in a straight line at a target speed of 10 mph. Once the LV cleared a pre-determined location in the test track, a traffic barrel connected to a rope was pulled in front of the AIPV. Data was collected for two runs. Figure 46 presents the plotted path of the test, with the orange line representing the LV and the blue line representing the AIPV.

Expected result: The AIPV detects the traffic barrel and executes an A-Stop.

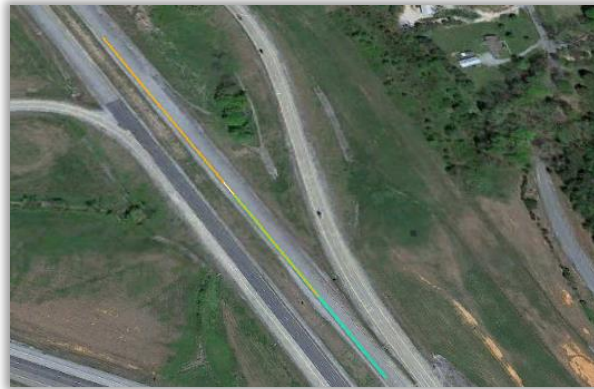
Figure 47 – Test Path – Vehicle Intrusion

Test procedure: The command gap was set to 300 feet on the GUI. The LV and the AIPV were activated. The LV operator was asked to drive in a straight line at a target speed of 10 mph. A UT research team member drove a vehicle alongside the AIPV and then moved in front of the AIPV, positioning the vehicle between the LV and the AIPV. Data was collected for two runs. Figure 47 presents the plotted path of the test, with the orange line representing the LV and the blue line representing the AIPV.

Expected result: The AIPV detects the vehicle in its path and executes an A-Stop.

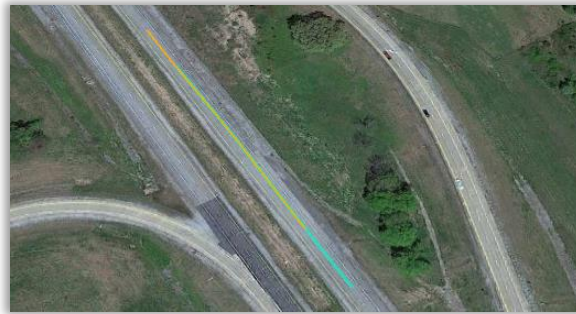
Figure 48 – Test Path – Sensitivity to Passing Vehicles

Test procedure: The command gap was set to 100 feet on the GUI. The LV and the AIPV were activated. The LV operator was asked to drive in a straight line at a target speed of 10 mph. A UT research team member drove a vehicle on an adjacent lane to the AIPV, going away and towards the autonomous vehicle. Data was collected for two runs. Figure 48 presents the plotted path of the test, with the orange line representing the LV and the blue line representing the AIPV.

Expected result: The ATMA system detects the vehicles on the GUI but does not execute an A-Stop.

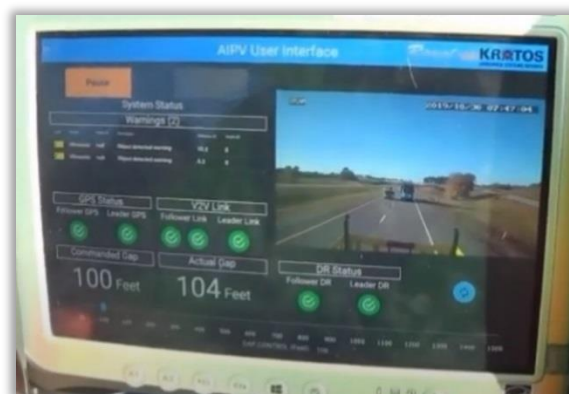
Figure 49 – GUI Display during Sensitivity to passing Vehicles Test

Additional information: Figure 49 presents the GUI display as the vehicle was driving alongside the AIPV, going away from the autonomous vehicle. The ultrasonic sensors detection can be noticed at the top left of the screen, with two warning messages.

Results: The ATMA system detected the vehicle passing the AIPV on both runs and did not execute an A-Stop.

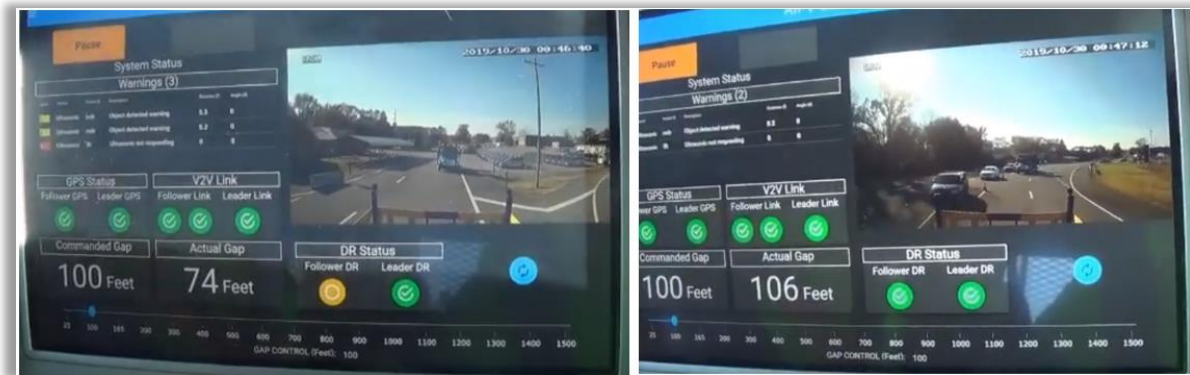
Figure 51 – GUI Display during Object Recognition Test

**Additional information:** Figure 51 presents the GUI display as the AIPV was driving alongside the parked vehicles. The screenshot to the left is during ROLLOUT and several warnings messages from the ultrasonic sensors can already be noticed at the top left, even though there were no vehicles/objects nearby. The screenshot to the right is during the RUN, and the ultrasonic sensors generated several warning messages as the AIPV drove by. Even though having sensors monitoring the side of the AIPV is beneficial, the warning messages were considered not useful due to the inconsistent relay of information.

**Results:** The ATMA system was not able to consistently detect and recognize the parked vehicles. The ATMA system did not execute an A-Stop.

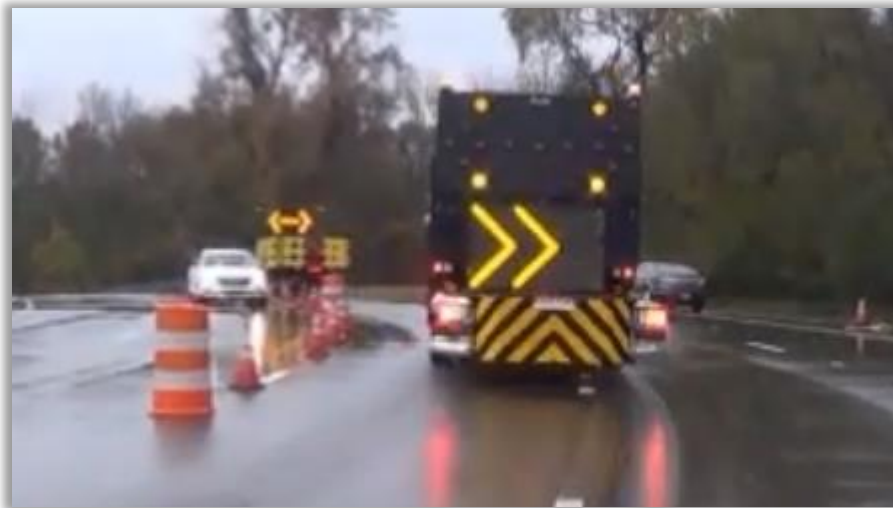
Figure 53 – ATMA System during Headlights Test

happened without a readily known reason. The events were apparently generated by the obstacle detection system. Therefore this test was designed “on the fly” to learn if potential sources of light would disturb the detection components of the AIPV. Notice that it was raining during the test (Figure 53), what generated pavement glare as well towards the system.

Results: The ATMA system was not affected by the flashing headlights. The ATMA system did not execute an A-Stop.

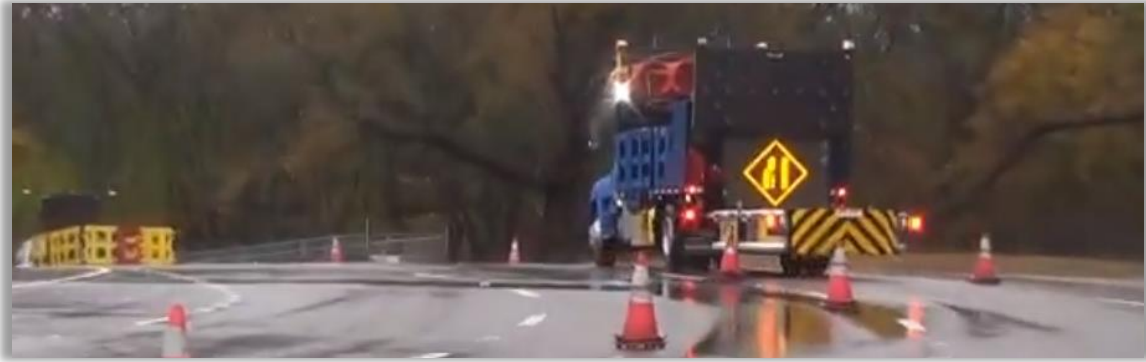
Figure 55 – ATMA System during Cone Detection Test

Additional information: During the week long testing of the ATMA system, a few A-Stop events happened without a readily known reason. The events were apparently generated by the obstacle detection system. Therefore this test was designed “on the fly” to learn if typical work zone objects, like reflective traffic ones, would disturb the detection components of the AIPV (Figure 55).

Results: The ATMA system did not detect the reflective cones. The ATMA system did not execute an A-Stop.

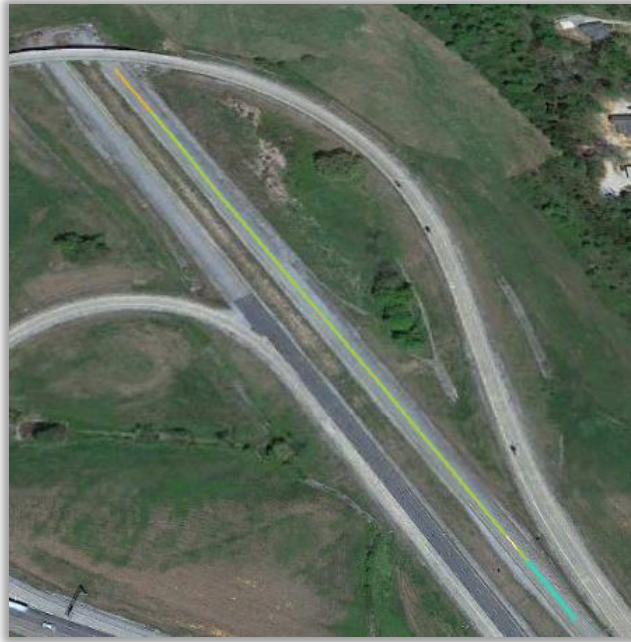
Figure 56 – Test Path – Speed Test

Test procedure: The command gap was set to 100 feet on the GUI. The LV and the FLW were activated. The LV operator was asked to drive in a straight line at a target speed of 10 mph and when the gap distance was reached, initiate a pause command on the GUI system (as specified in Section 5.1.1) to bring the AIPV to a temporary stop. The LV operator continued to drive at the same speed up to a gap distance of 300 feet. The pause command was then released, allowing the AIPV to start the process of catching up to the LV and stabilize at the command gap distance of 100 feet. Data was collected for two runs. Figure 56 presents the plotted path of the test, with the orange line representing the LV and the blue line representing the AIPV.

Expected result: The AIPV would not exceed 20 mph as specified in Section 5.1.1.

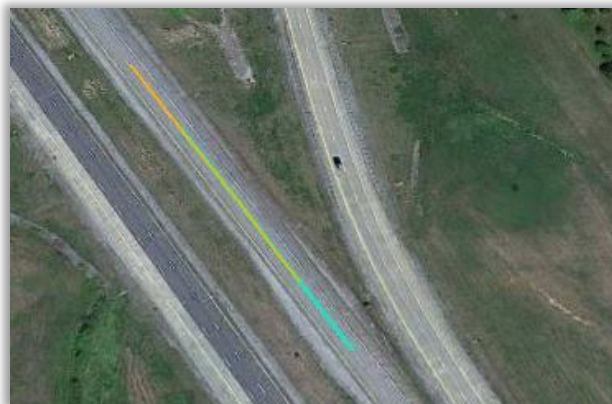
Figure 59 – Test Path - Braking

Test procedure: The command gap was set to 100 feet on the GUI. The LV and the AIPV were activated. The LV operator was asked to drive in a straight line at a target speed of 10 mph. Once the LV has reached a pre-determined location in the test track, the driver will engage the brake instantly. Data was collected for two runs. Figure 59 presents the plotted path of the test, with the orange line representing the LV and the blue line representing the AIPV.

Expected result: The AIPV should stop immediately within a safe distance from the LV.

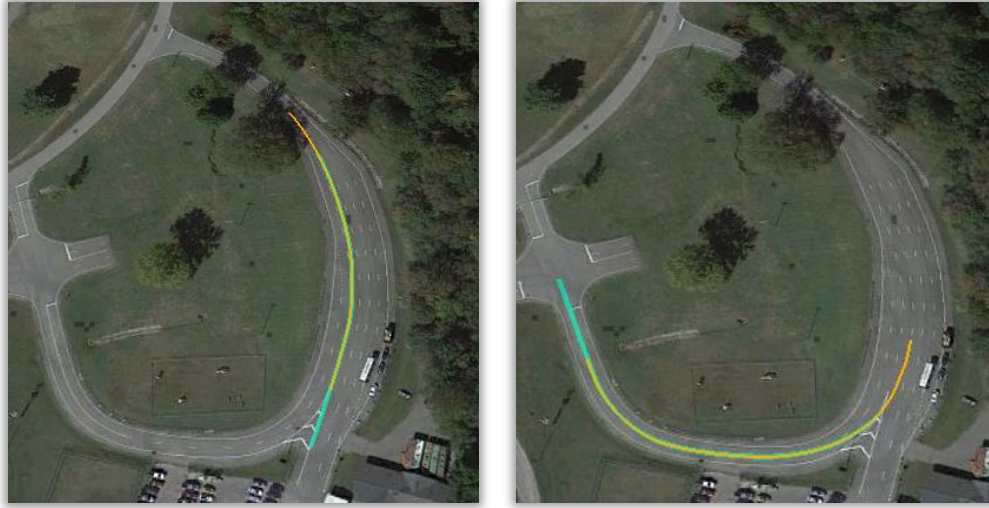
Figure 60 – Test Paths – Bump Test

Test procedure: The command gap was set to 100 feet on the GUI. The LV and the AIPV were activated. The LV operator was asked to drive at a target speed of 5 mph. Once the LV has reached a pre-determined location in the test track, a UT team member pulled a 4x4 log into the AIPV path. The test was conducted on a straighter section of the test track and repeated on a curve. Data was collected for four runs. Figure 60 presents the plotted path of the test, with the orange line representing the LV and the blue line representing the AIPV.

**Expected result:** The AIPV maintains the lateral accuracy of  $\pm 6$  inches from the LV path.

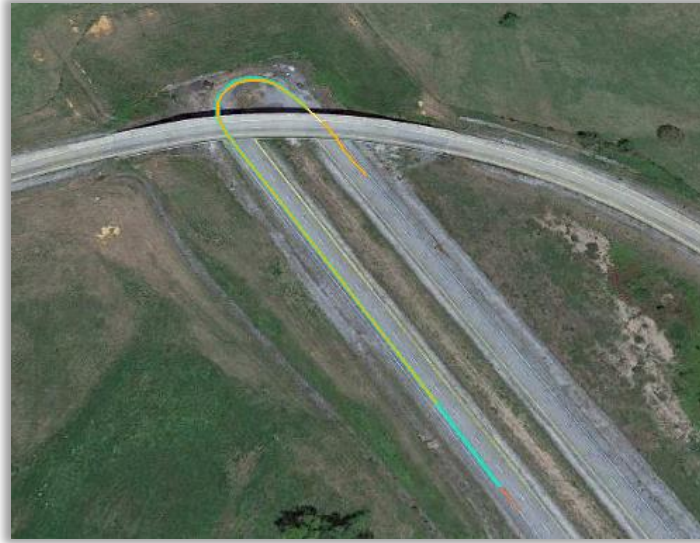
Figure 63 – Test Path – Turn under Overpass

Results: The ATMA system was able to navigate the turn, using the INS (as explained in *Section 5.2.4*) but an e-crumb error (where the AIPV was not able to locate the LV next data point position) caused an A-Stop towards the end of the testing.
