2015 ANNUAL REPORT

TENNESSEE STATE BUILDING COMMISSION

This Annual Report describes preservation and significant maintenance and management work completed on historic and cultural resources at Andrew Jackson's Hermitage by the Andrew Jackson Foundation (AJF) in calendar year 2015 and proposed work for calendar year 2016. This annual report submission to the State Building Commission (SBC) is required under Tennessee Code Annotated section 4.13.104. The following is a brief description of proposed property acquisition, construction, demolition, alteration, restoration, or preservation works in progress. Projects involving routine maintenance and minor repairs are not included. Projects are listed in order of priority.

Hermitage Mansion

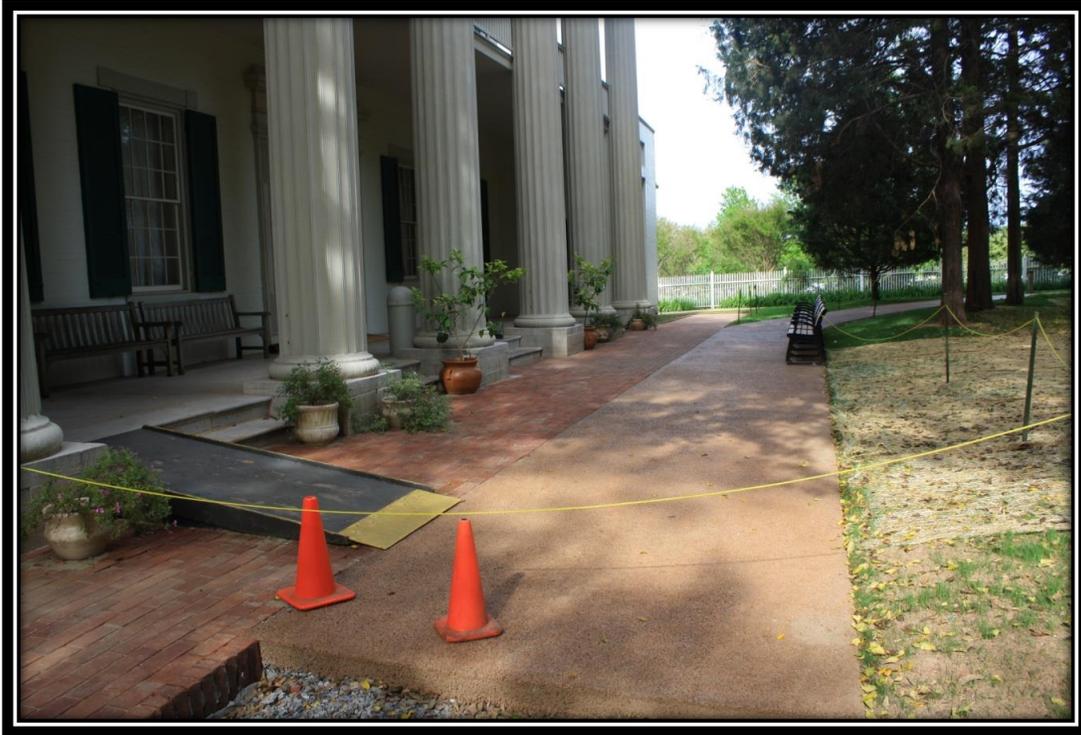
This photo shows the completed brick pathways and pervious concrete colored and blended with aggregate to match the appearance of the historic carriage drive.

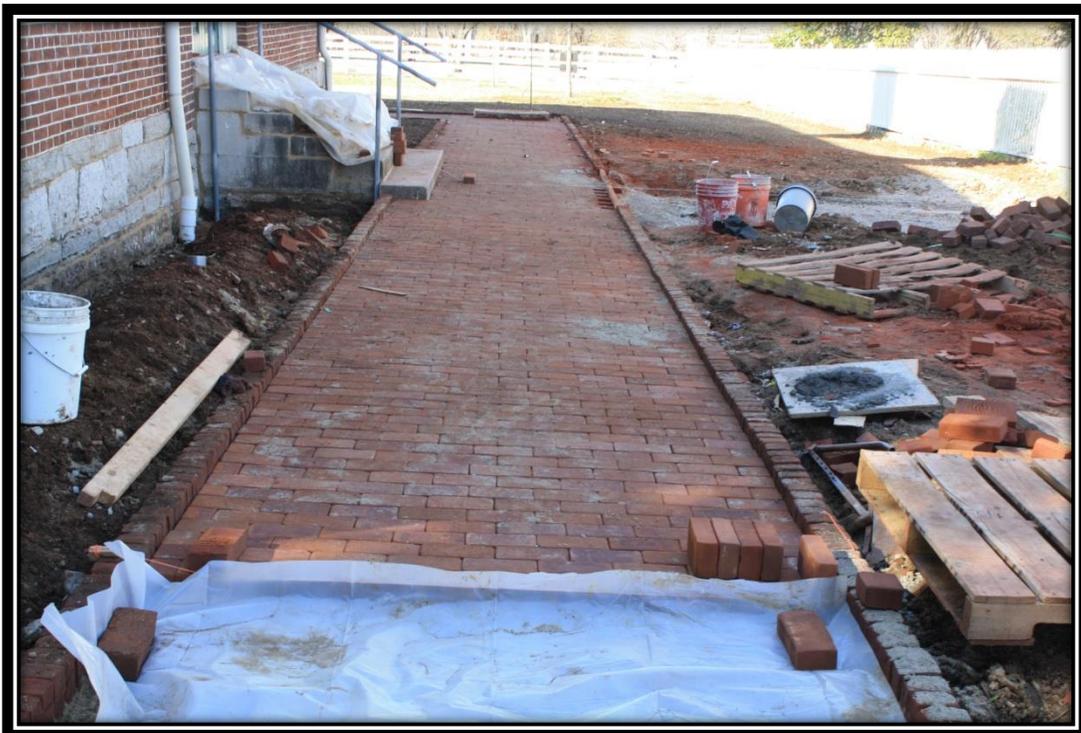
Pathway on the east elevation of the Hermitage mansion. Area to left of pathway is now a planting bed that allows rainwater and runoff to seep into French drain system below.

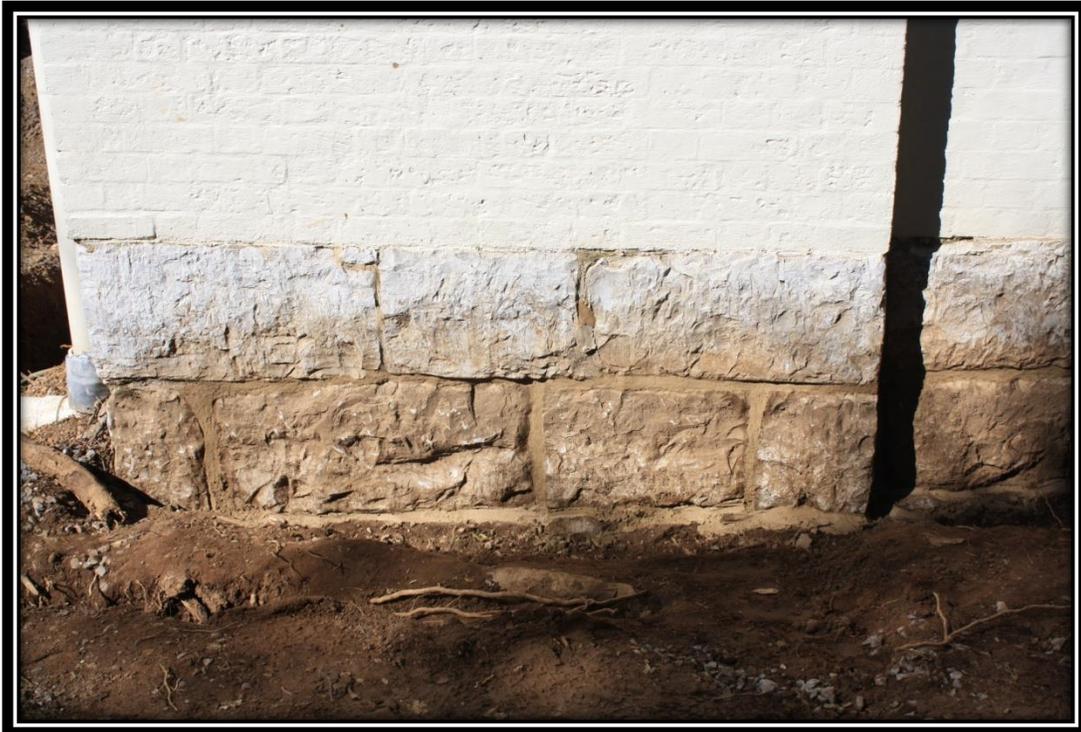
A section of the Hermitage mansion's south foundation wall with re-pointing completed.

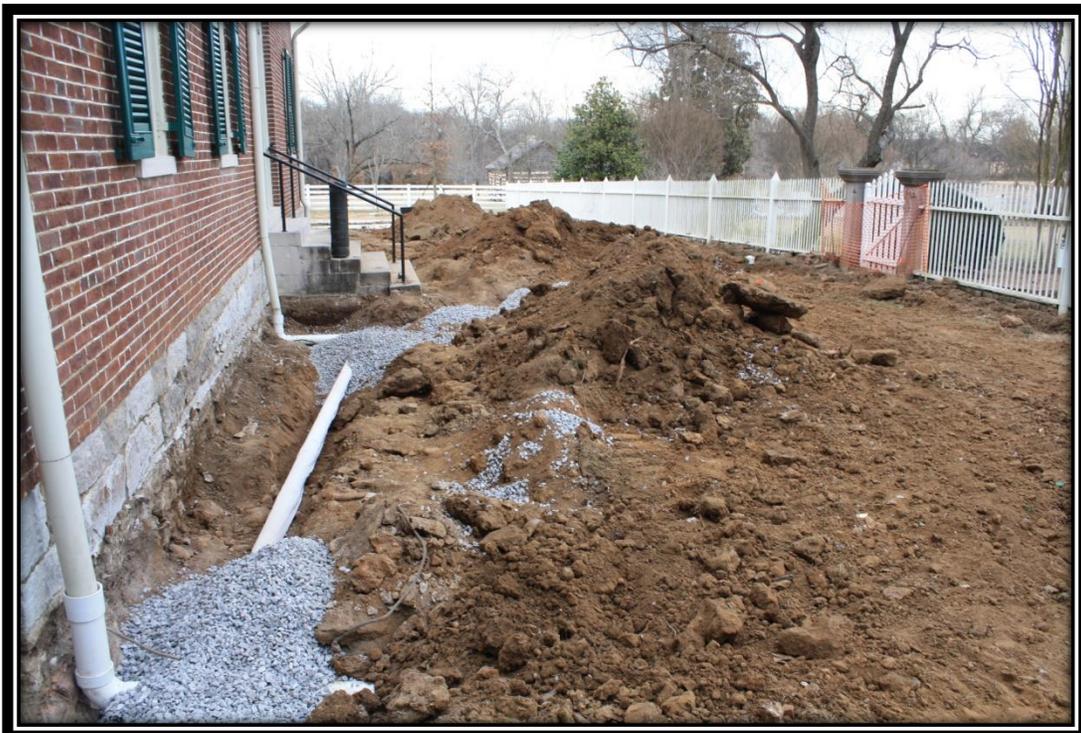
Typical French drain installation along the foundation of the Hermitage mansion. Perforated PVC drain covered with cloth, attached to drain lines, and then covered in gravel.

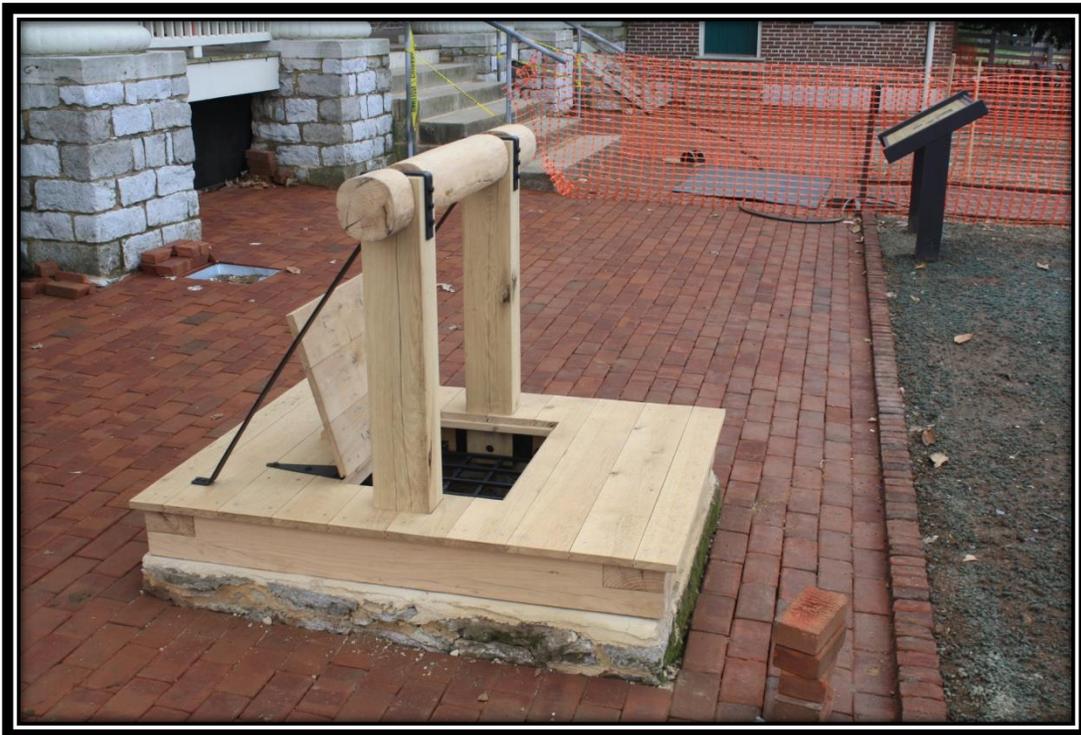
New well cover and pathways on the north side of the Hermitage mansion.
