A 45 year old male employee working as a ride operator-in-training, was caught between the turntable of the Wisdom 2000 Starship ride and the stationary trailer on which the turntable sits while greasing the tandem.

Crushed Between parts of an amusement ride—Insp # 1681434 James Gang Amusements LLC

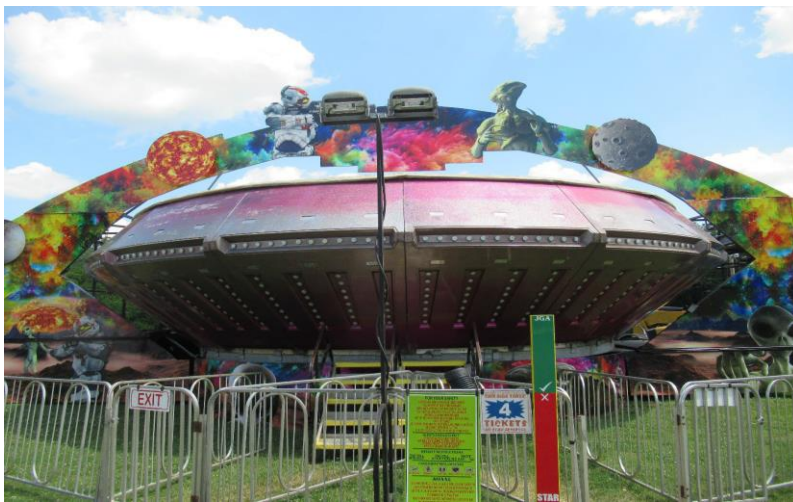
The center bearing (Fig. 1) has two grease fittings (alternately referred to as “zerks” or “alemites”), located directly opposite each other. The center bearing is made of an inner and outer ring containing several small ball bearings in the space between the rings. The space between these rings needs to be greased regularly.
