Work Zone Alert Systems

Research Final Report from the University of Memphis | Sabysachee Mishra, Mihalis M. Golias and Diwas Thapa | April 1, 2021

Sponsored by Tennessee Department of Transportation Long Range Planning
Research Office & Federal Highway Administration

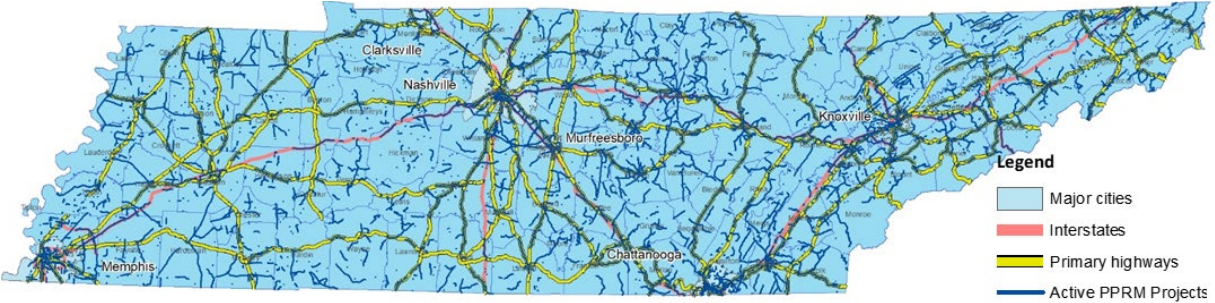
Figure 3-1. Active highway projects across Tennessee

Figure 3-1 shows the distribution of on-going highway projects across Tennessee. Highways near major cities like Memphis, Nashville, Chattanooga, and Knoxville have more active projects. Therefore, highway work zones are mostly concentrated near major cities.

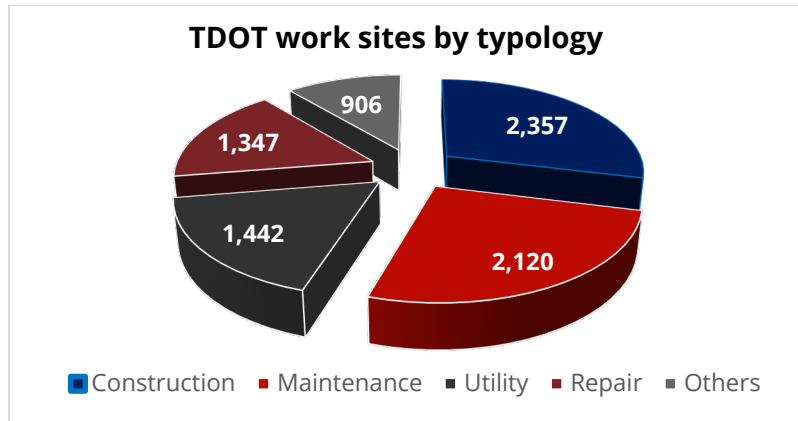
Figure 3-2. Work sites by type of work

The Manual of Uniform Traffic Control Devices (MUTCD), 2009 suggests the use of traffic control devices based on work zone duration and movement of work [21]. The manual categorizes work zones into five groups based on work duration and movement. These are as follows, i) long-term stationary, ii) intermediate-term stationary, iii) short-term stationary, iv) short duration, and v) mobile. The type of work (construction, maintenance, utility, and repair) is closely related to this classification. For example, maintenance and utility operations are often short-term and mobile lasting less than a day and requiring intermittent or continuous movement of work. On the other hand, construction operations are often stationary and long-term lasting more than a day. Due to this reason, lane closures for construction work zones are often maintained over a longer period. Figure 3-2 presents the share of different types of work in highway projects between 2002-2016. Most of the projects undertaken during the duration were construction projects (29%) followed by maintenance projects (26%), utility projects (18%) and repair projects (16%).

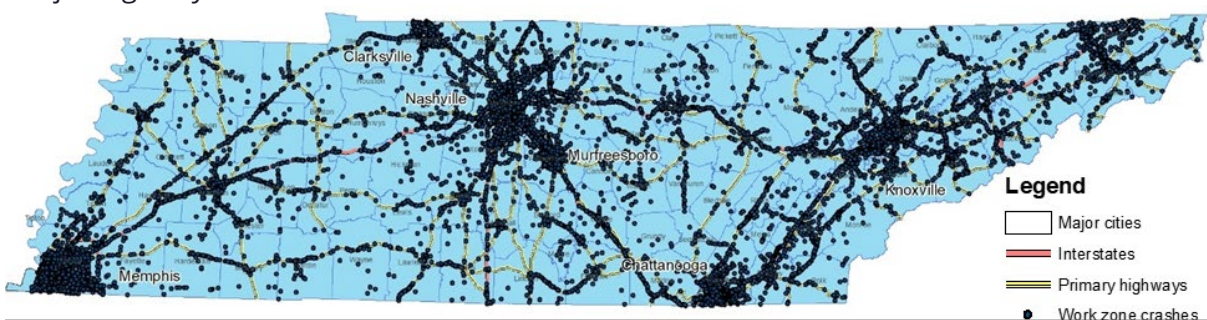
Figure 3-3. Location of all reported work zone crashes between 2002-2019

Work zone crash data for analysis was collected from E-TRIMS. E-TRIMS provides a database of all recorded highway crashes in Tennessee along with details on its location, roadway characteristics, weather conditions, type of work, type of crash, etc. In this analysis, all work zone related incidents from 2002-2019 were analyzed. Figure 3-3 presents the location of all reported work zone crashes during the period. Based on the figure, it is evident that the frequency of crashes is greater around the main cities Memphis, Clarksville, Nashville, Murfreesboro, Chattanooga, and Knoxville. Also, more crashes are observed on interstates and major highways.

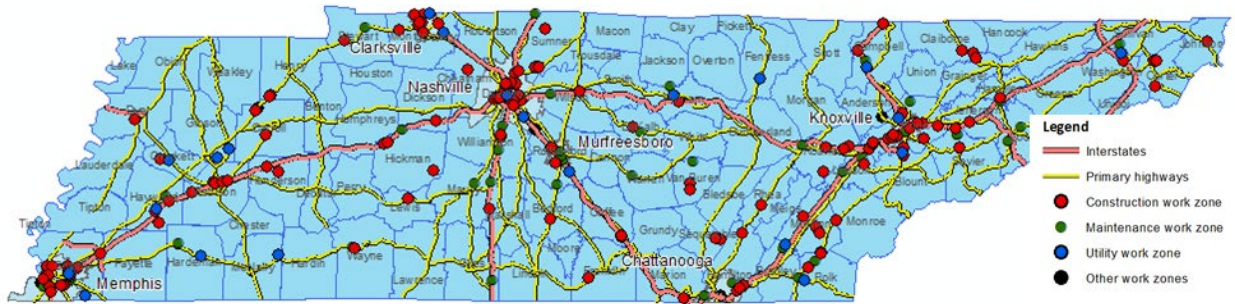
Figure 3-4. Location of fatal work zone crashes by work zone typology

All fatal work zones crashes recorded between 2002-2019 are categorized by work zone typology and presented in Figure 3-4 and TABLE 3-2. Fatal crashes are notably more frequent near Memphis, Clarksville, Nashville, and Knoxville. Also, construction work zones on interstates show comparably larger number of fatalities than maintenance and utility work zones. As shown in TABLE 3-2, most fatalities during the analysis period occurred in construction work zones followed by maintenance work zones. More than 85% of all work zone crash fatalities can be attributed to construction and maintenance work.

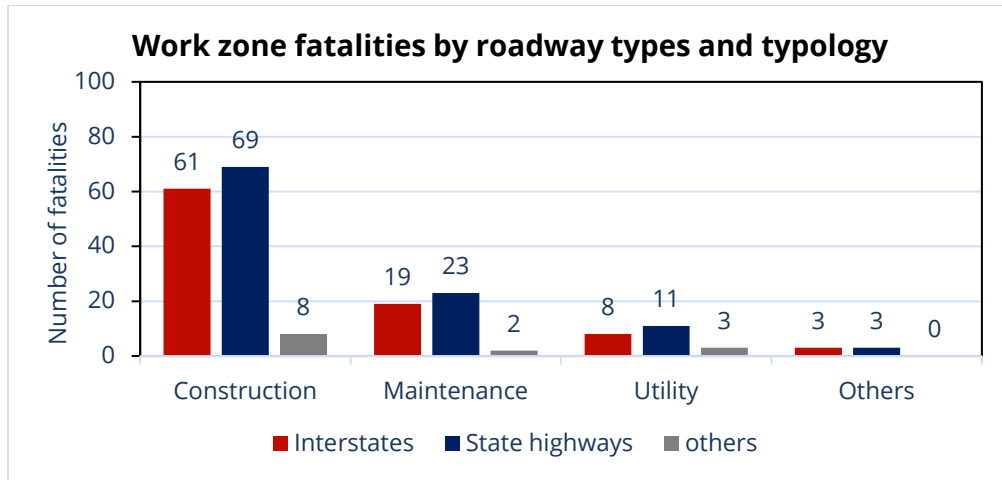
Figure 3-5. Fatal work zone crashes by roadway type and work zone typology

According to the collected data, most work zone fatal crashes have occurred on major highways. Of 210 fatalities, 91 of them have been on interstates and 106 on state highways. This suggested that safety interventions should first be focused on major highways. Figure 3-5 shows the frequency of fatal work zone crashes by roadway type and work zone typology.

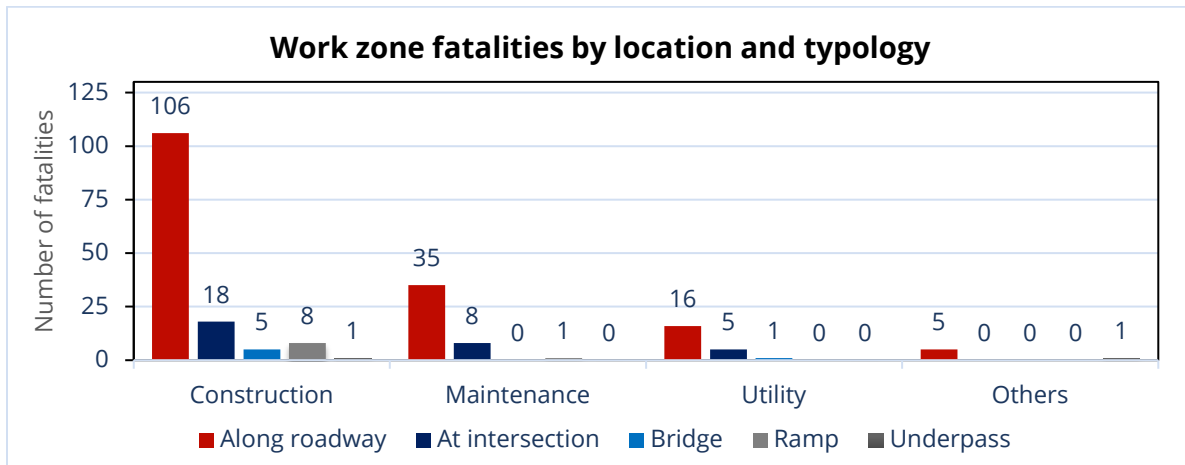
Figure 3-6. Fatal work zone crashes by location and work zone typology

A considerable proportion of work zone fatalities have occurred along roadways, followed by intersections. This could be a result of relatively considerable number of work zone activities on roadways compared to intersections, bridges, ramps, and underpasses.

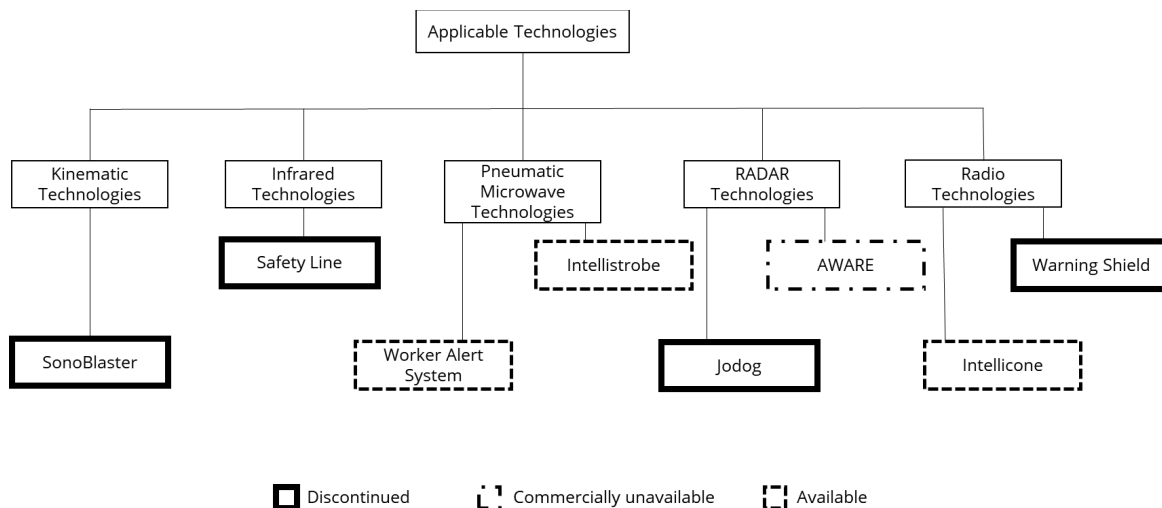
Figure 4-1. Identified WZIA technologies

A systematic review of the literature and web search on WZIA products identified technologies shown in Figure 4-1. Three technologies were selected based on availability for testing and future procurement. These were Intellicone, AWARE and Worker Alert System. A description of these technologies follows.

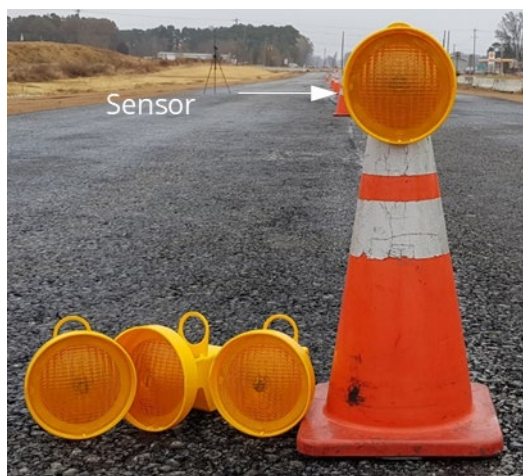
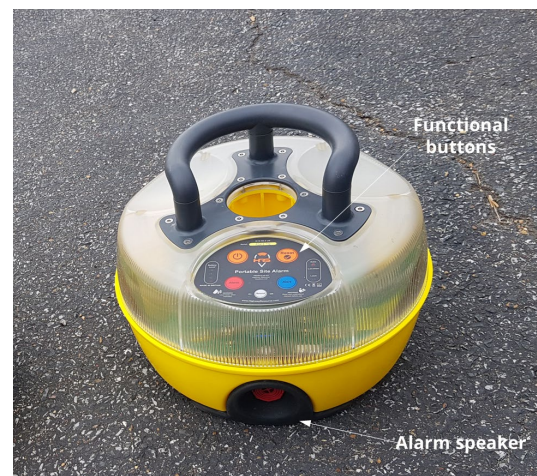
(a) Traffic cone mounted sensor

(b) Portable Site Alarm showing layout of functional buttons and alarm speaker

Intellicone is an impact activated system that uses two components, traffic cone mountable sensor and Portable Site Alarms (PSA). These components are shown in Figure 4-2. The sensor uses LED lamps with built-in accelerometers to detect motion from vehicular impact on traffic cones. The LEDs are designed to be lit when the sensor is armed and ready for use. Additionally, the LEDs also help to draw a driver's attention and highlight the work zone perimeter specially in poor lighting conditions. The sensors are powered by a user replaceable heavy-duty battery, which can be easily swapped manually without the use any tools. The PSA contains built-in LEDs, speakers, and a non-removeable battery that can be charged using an AC adapter that comes included with the PSA. In a typical arrangement, the sensors are mounted on traffic cones around a work zone perimeter, and the PSA is kept close to the workers. When an intrusion is detected by the sensors, wireless radio signals are communicated to the PSA. The PSA produces flashing lights in addition to a high-pitched alarm to alert workers of the intrusion. The sensors can communicate intrusions to the PSA in two ways. When the PSA is within wireless transmission range of the sensor, the sensors can transmit radio alerts directly to PSA. However, when the PSA is out of a sensor's transmission range, the signals are transmitted from one sensor to another until it reaches the nearest PSA.

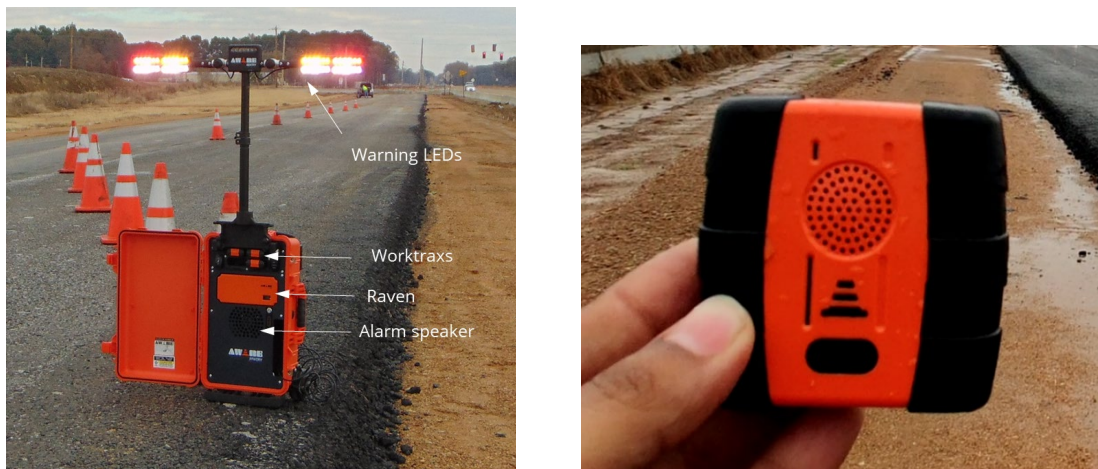
(a) Sensor/alarm assembly

AWARE is a radar-based advanced warning system capable of detecting intrusions using speed of the oncoming vehicle. Two versions of the system are currently under development. The first is a lane intrusion system capable of detecting work zone intrusions, and the second is called the Sentry that is primarily designed for use by flaggers. Both systems use the same components. A key difference between the two is that the lane intrusion system can be mounted on moving vehicles and equipment whereas the Sentry is housed in a hard case that is kept fixed at a location. Only the Sentry was available to the researchers at the time of the testing. The Sentry is comprised of two components; a sensor/alarm housing unit consisting of a radar sensor called Raven, LEDs, and an alarm speaker, and personal alarms called Worktrax. These are shown in Figure 4-3. Four Worktraxs are included with each Sentry. Worktrax alarms can be either strapped onto a worker's arm or carried in pockets. The sensor/alarm housing unit has in-built batteries that can be charged using an AC adapter included in the unit. The Worktrax alarms are charged automatically when placed inside the housing unit. The Sentry can be programmed to use desired configurations in detecting errant vehicles. This is done using a smartphone application that is provided by the manufacturer. The application connects to the Sentry using a Bluetooth connection. The application can be used to configure the relative position and orientation of the Sentry with respect to the road and set the threshold speed limit for detecting intrusions. The recommended setup for the Sentry is to place it in a shoulder along with a flagger trained to operate it. When a vehicle approaches the work zone at a speed higher than the configured speed limit, the vehicle is marked as an intruder and alerts are produced. Alerts in the main housing units are produced by flashing LEDs and a siren from the sound speaker. Additionally, the Worktraxs produce a vibratory and high-pitched chirping sound.

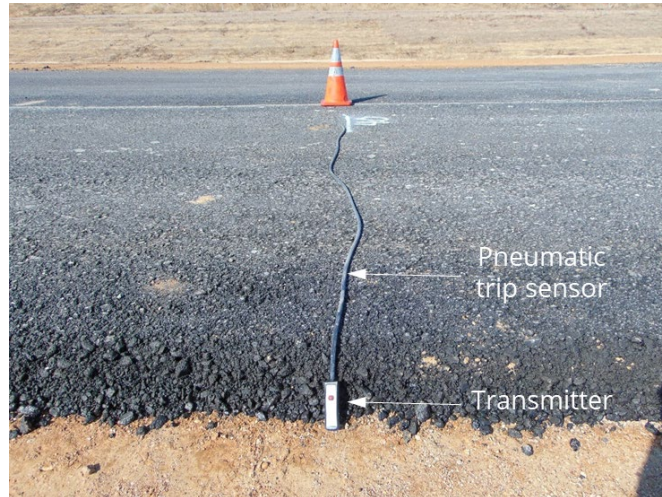
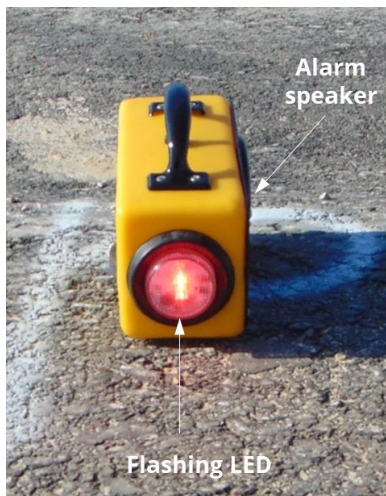
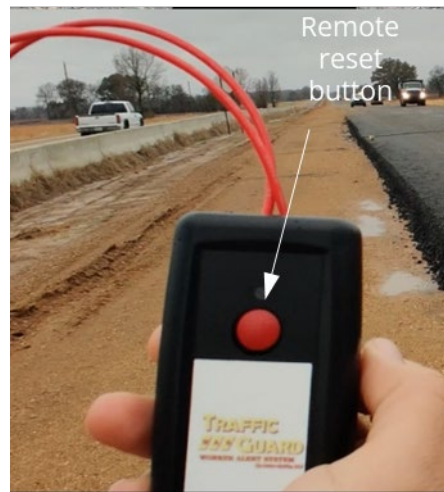
(a) Pneumatic sensor hose

(b) Portable Alarm Case (PAC) showing LED and position of the alarm speaker

(c) Personal Safety Device (PSD) with the remote reset button

The Traffic Guard Worker Alert System is a pneumatic sensor-based technology comprised of three components: a pneumatic trip hose sensor with a signal transmitter, a Portable Alarm Case (PAC) housing a sound speaker alarm and LEDs, and Personal Safety Devices (PSD) for workers. These components are shown in Figure 4-4. The pneumatic sensor and PSD are powered by standard AA and AAA batteries, respectively. The PAC uses replaceable batteries that can be charged using an AC power adapter that come included with the PAC. The standard length of the pneumatic sensor available for purchase is 12 ft and 18 ft. The sensor hose is designed to detect pressure after it has been runover by an intruding vehicle. The PSDs can either be carried on a pocket or strapped onto the arm. PSDs are also provided with a reset button that facilitates alarm reset in case false alarms are triggered. In the field, the sensor is typically laid across the lane closure at the end of the transition taper where the intruding

vehicle is most likely to run over it. The PAC is placed in the work area, close to workers. When pressure from an intruding vehicle is detected, the signal transmitter attached to the sensor hose sends alerts to the PAC and PSD within its range. The PAC produces flashing lights and sound alarm to alert the workers while the PSD produces a vibratory alert.

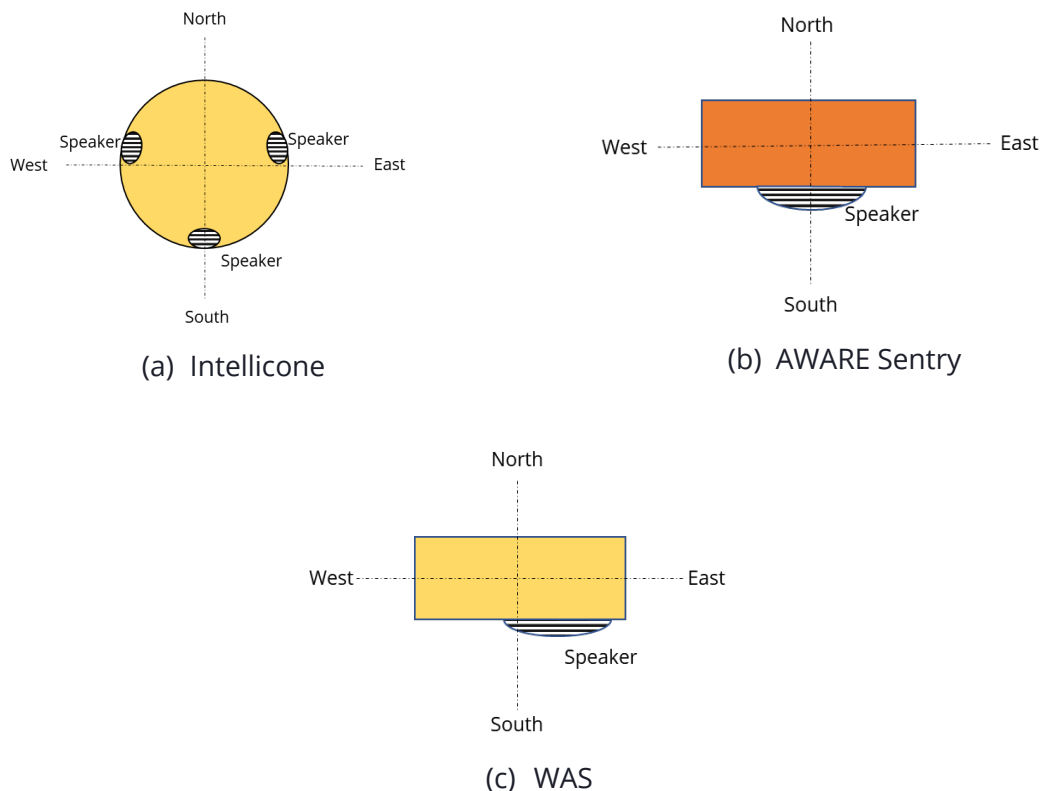
Figure 4-6. Relational directions used in measuring sound intensities of the technologies shown in top view. Placement of alarm speakers within the alarm units is also shown.

Duration and intensity of sound alerts are crucial factors in determining noticeability of sound alarms. The intensity of sound alert perceived by the workers was measured at different distances from the alarms using a sound meter. The distance was varied between 0 ft and 300 ft at 50 ft intervals. Due to the test site's proximity to traffic nearby, ambient sound on the test site was measured prior to the tests and found to be 45 dB. Therefore, alarm sound intensities were measured only up to 300 ft to ensure that there was no interference from the ambient noise. At each interval, three readings for sound intensity and duration were recorded. Sound intensity of the alerts was measured on four perpendicular directions to the alarm. This was done to test if orientation of the alarms had considerable influence on the intensity of alerts produced. Previous studies have found that the intensity of alert is affected by the orientation of the alarm [12]. This is particularly relevant considering the placement of alarm speakers in the alarm units of the chosen technologies. Specifically, the placement of alarm speakers in Intellicone is symmetrical as it has three alarm speakers placed at about 120° to one another. The placement of speakers in AWARE and WAS, however, is asymmetrical since they are mounted only on one side of their respective alarm cases (see Figure 4-6 for details).

All experimental trials for Intellicone were carried out after mounting the PSA on a 28" traffic cone while no particular arrangement was necessary for AWARE. For WAS, the experiments were carried out with the PAC placed on the ground. To test for directionality in alarms, the sound intensities were measured on four perpendicular directions marked as shown in Figure 4-6.

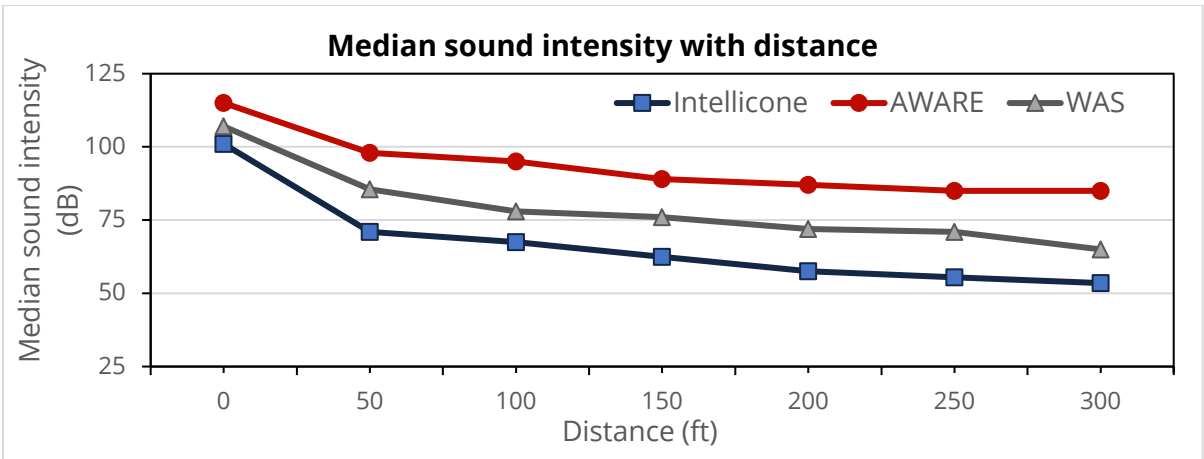
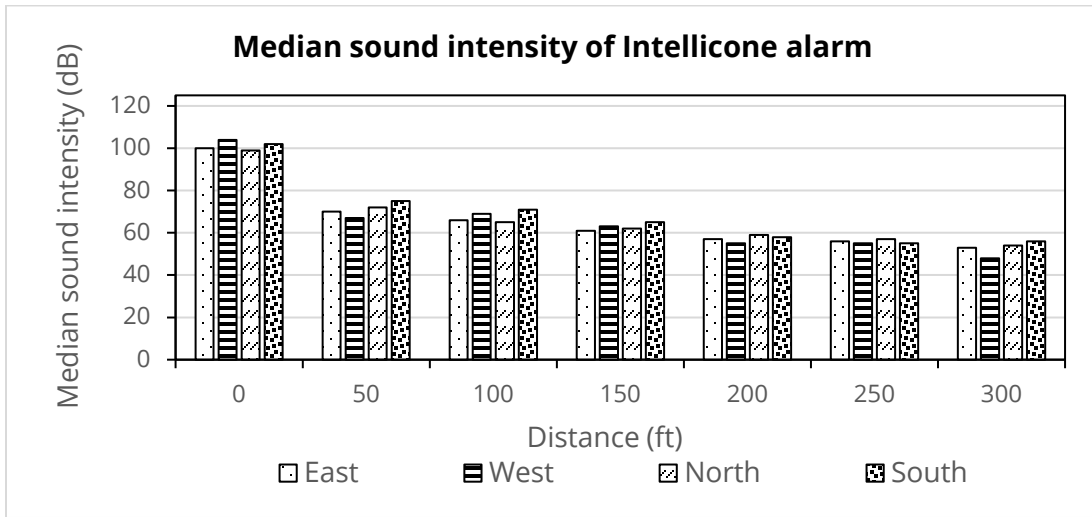
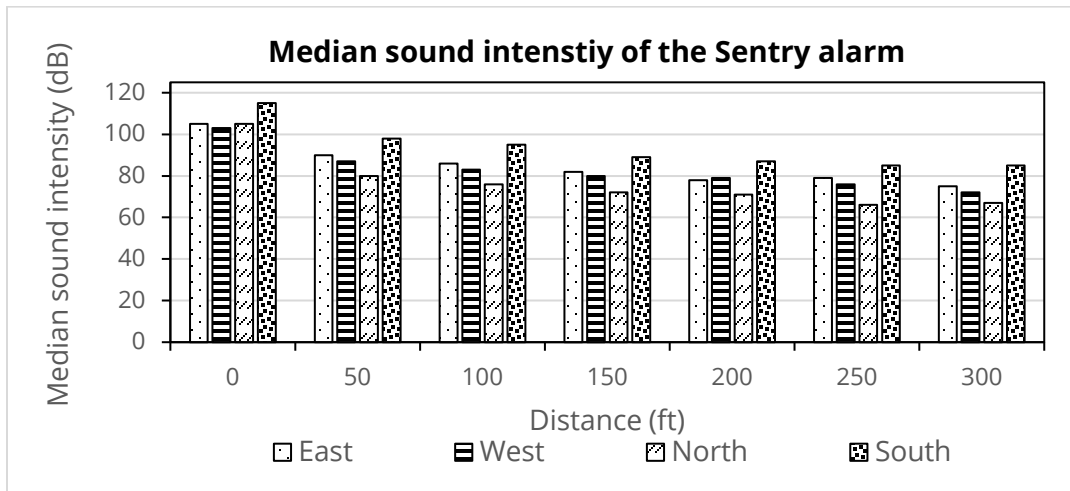
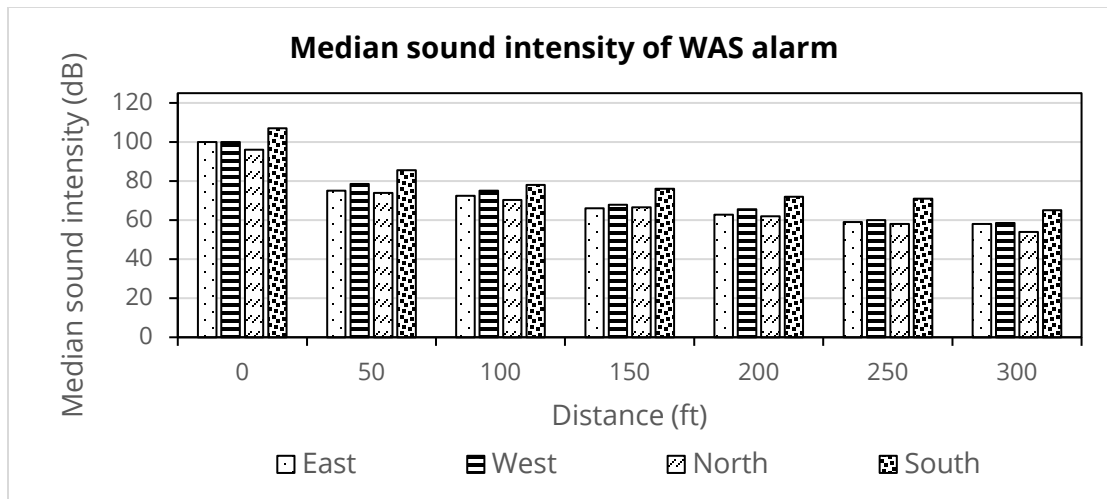
Figure 4-7. Variation in the sound intensity of alerts with distance

(a) Variation of intensity with distance and direction: Intellicone

(b) Variation of intensity with distance and direction: AWARE Sentry

(c) Variation of intensity with distance and direction: WAS

At 0 ft, the intensity of sound produced by all three systems was found to be comparable and between 100-120 dB as shown in Figure 4-7. However, the difference in intensity was more prominent as the distance increased. At 300 ft, the highest sound intensity was measured for AWARE followed by WAS, and Intellicone. Figure 4-8 shows the intensity of alarms observed in four perpendicular directions. As expected, both AWARE and WAS showed notable directionality in sound alarms. Greater sound intensity was observed for AWARE and WAS with the speakers facing the sound meter (South direction). On the other hand, sound intensity of alarms produced by Intellicone was found to be more or less consistent on all directions.

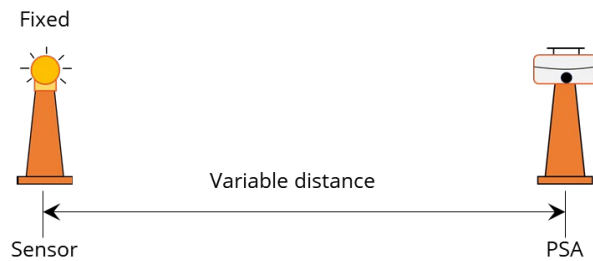
Figure 4-9. Experimental setup for determining transmission range of Intellicone

In the experimental setup, the sensor units for the technology being tested was fixed at a point. The alarm unit was then placed at 50 ft intervals from the sensor unit. The communication between the sensor and alarm units were then tested by attempting to trigger alerts in the alarm using the sensor. For example, for Intellicone, the transmission distance between a sensor and a PSA was determined by fixing the sensor and moving the PSA away from the sensor at 50 ft intervals 50ft, 100ft, 150ft and so on (see Figure 4-9). At each of these intervals, three attempts were then made to activate the alerts by knocking down the sensors. If all three attempts were successful the transmission was assumed to be complete (or 100%), otherwise the transmission was assumed to be incomplete. The distance beyond which incomplete transmission was observed was considered as the transmission range [12]. A similar procedure was followed for AWARE and WAS components.

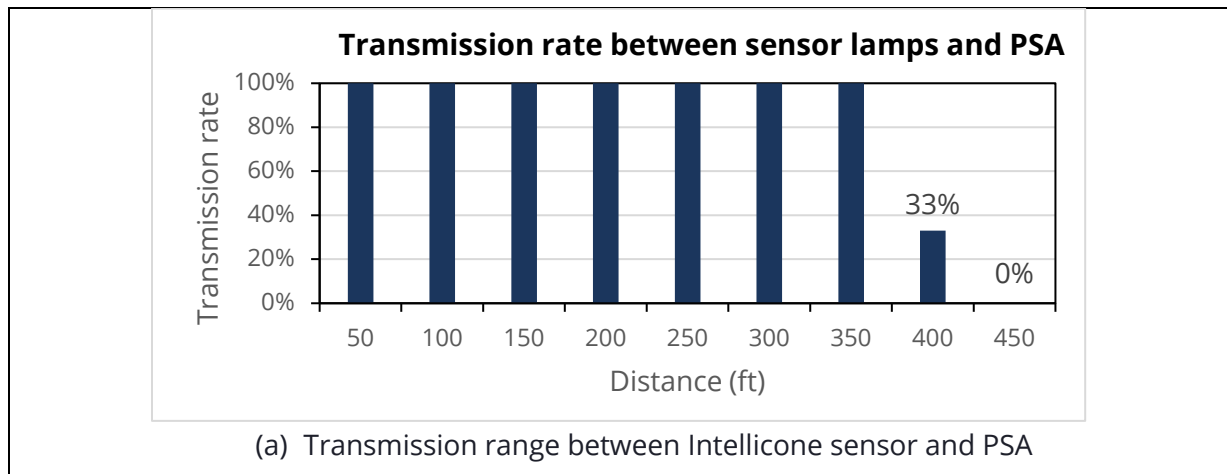
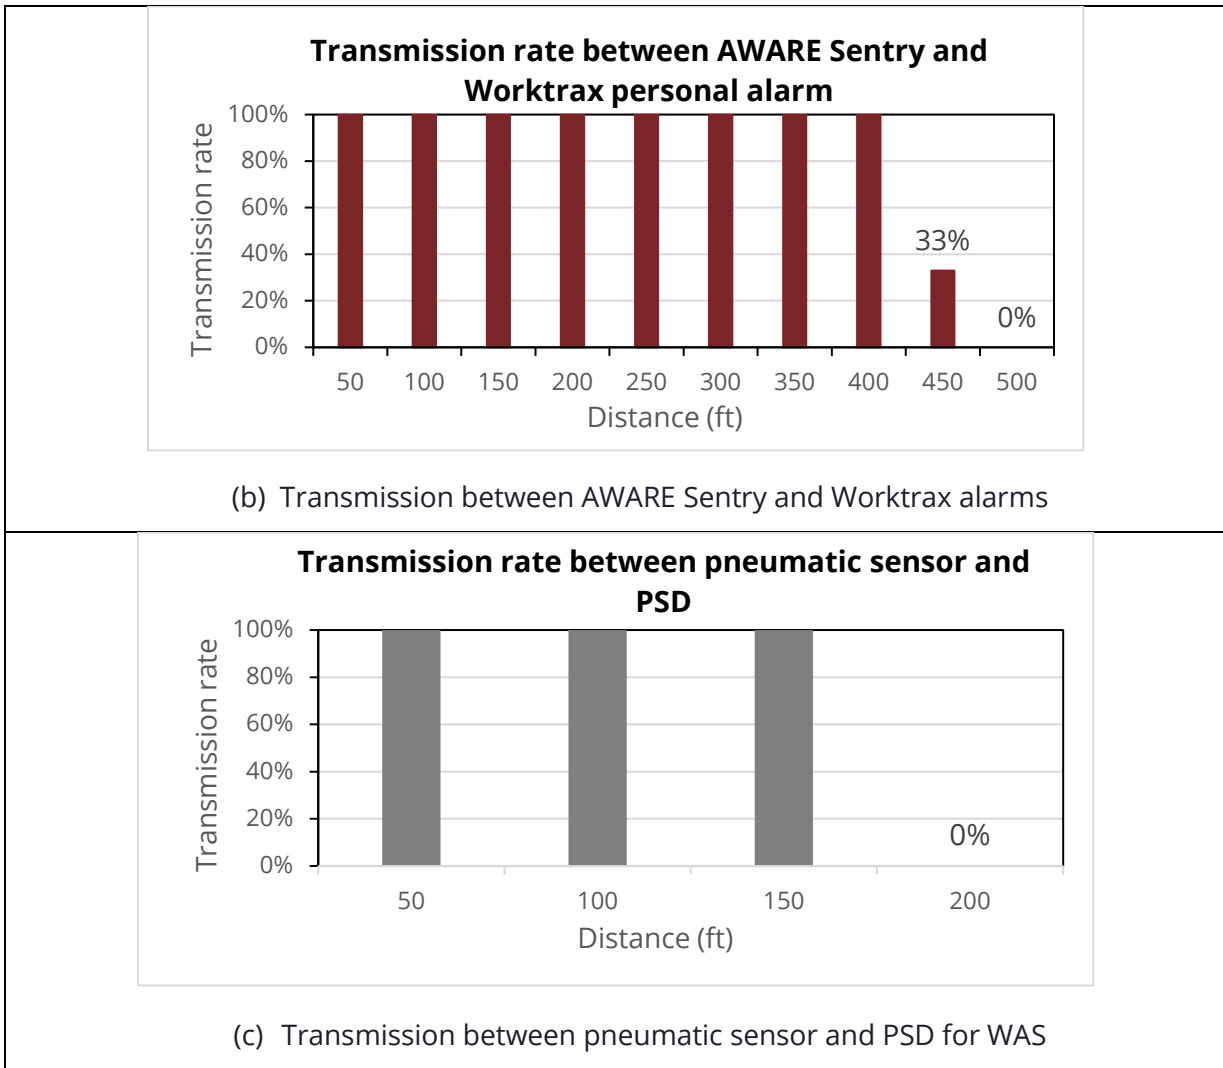
Figure 4-10. Transmission range of different technology components

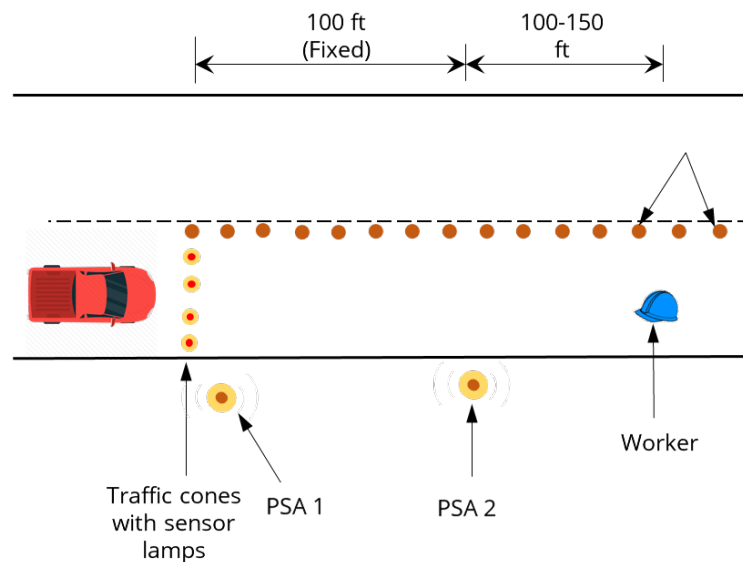
Figure 4-11. Experimental setup for testing alarm activation and worker response

Prior to the experiment, the worker was instructed to react to the sound of the alarm and ignore the sound of the vehicle crashing into the traffic cones. A pickup truck was used as the test vehicle and intrusions were emulated for speeds of 30 mph, 45 mph and 60mph. At each experimental trial, activation of alarms and the worker's response time was noted. It is noteworthy that worker response time here is the time between the vehicle entering the work zone perimeter and the worker reacting to the alarm.

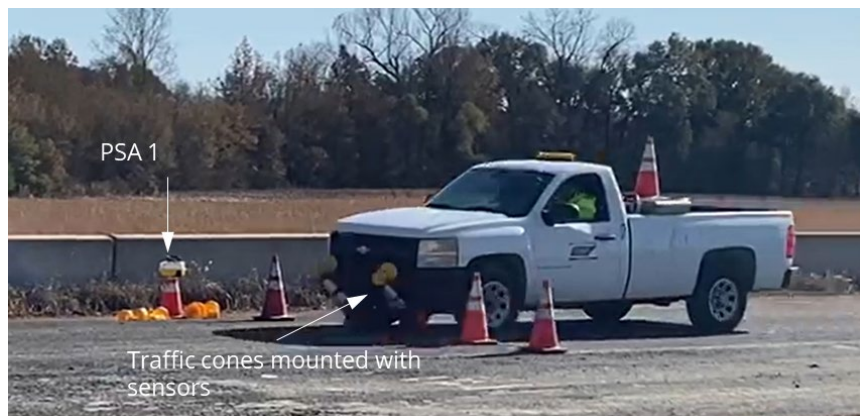
Figure 4-12. Crash testing of Intellicone sensors

TABLE 4-5 presents the summary of successful activations observed during the experiment. For test speed of 30 mph, the sensor detected the intrusion successfully only two thirds of the time. The overall accuracy decreased even more at 45 mph. At test speed of 60 mph, the alerts failed to activate on all occasions indicating that at higher speeds the technology was less reliable.

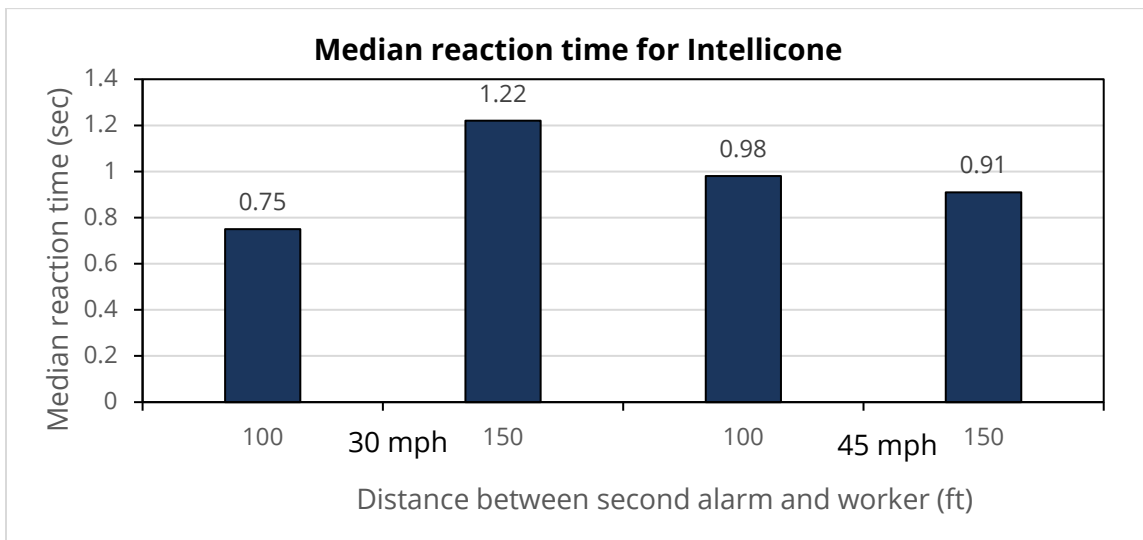
Figure 4-13. Observed worker reaction time for Intellicone

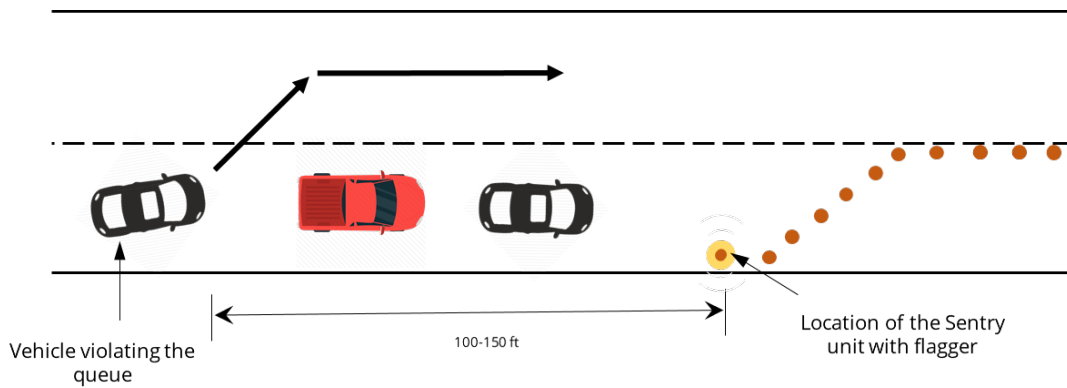
Figure 4-14. Experimental arrangement for testing AWARE Sentry: Scenario 1

The Sentry can be used to detect vehicles violating a queue formed in flagging operations using the threshold speed limit. In this experiment, the Sentry's accuracy was determined by first setting the speed limit on the Sentry and driving test vehicles towards it at different speeds to check for alert activation. Three vehicles were queued as shown in Figure 4-14 with the test vehicle placed between 100-150 ft from the Sentry. For the first set of experiments, a test vehicle was driven at 10 mph from behind the queue with the speed limit set to 15 mph on the Sentry to test for false positive alerts. In the second experiment, the same test vehicle was driven at 20 mph with the speed limit set to 15 mph to check for false negative alerts. The two experiments were then repeated with the speed limit set to 20 mph and the test vehicle travelling at 15 mph and 25 mph, respectively. The activations of the alerts were then noted.

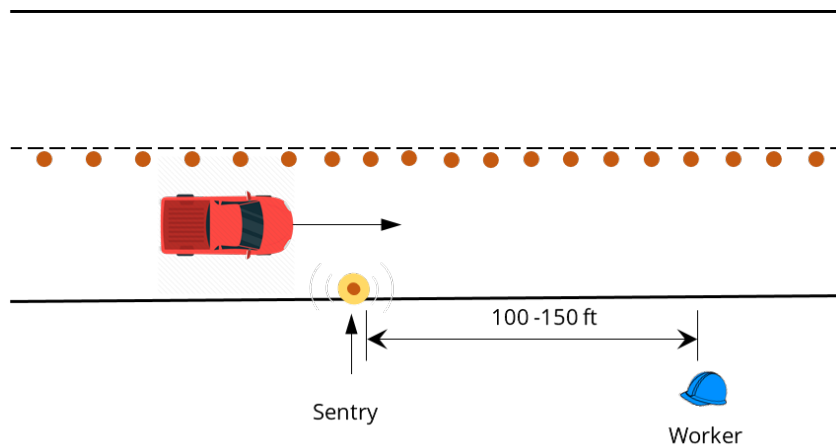
Figure 4-15. Experimental arrangement for testing AWARE Sentry: Scenario 2

Scenario 2 tested the accuracy of alarms when vehicles passed by the Sentry at high speeds. The key distinction between the first and second scenarios was that for the first scenario, vehicles approached the Sentry from behind the queue. For this scenario, the Sentry was setup on the shoulder with the speed limit on the Sentry set to 10 mph. A worker equipped with a Worktrax personal alarm was placed within the work zone and a test vehicle driving at speed higher than 10 mph was driven towards the worker (see Figure 4-15). Any consequent alarm activations were then recorded. The experiment was conducted for test speeds of 30 mph, 45 mph and 60 mph. The Sentry was able to produce accurate alerts on all experimental trials as shown in TABLE 4-7.

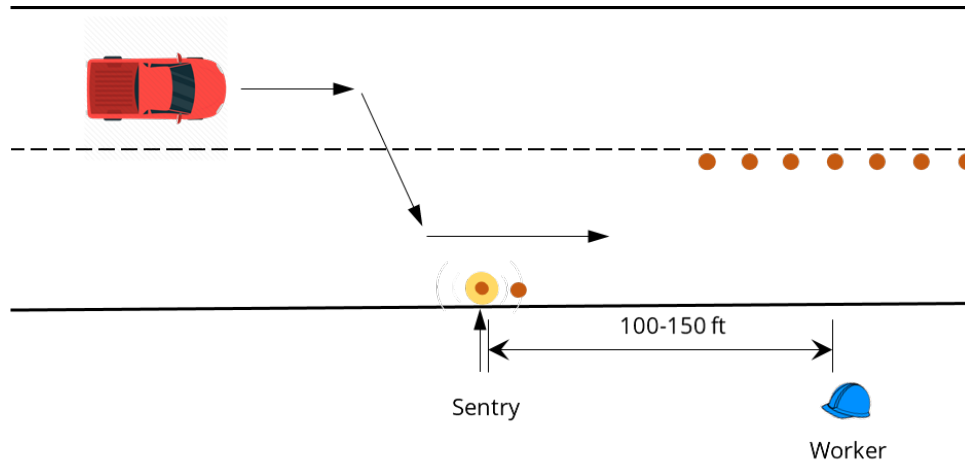
Figure 4-16. Experimental arrangement for testing AWARE Sentry: Scenario 3

abruptly moved to the lane with the Sentry as shown in Figure 4-16. As with Scenario 2, the Sentry was setup with a 10-mph speed limit and test vehicles were driven at a higher speed. Alarm activations were then recorded for each experimental trial for test speeds of 30 mph, 45 mph and 60 mph. Results from the experiment is shown in TABLE 4-8. As with previous scenarios, the Sentry was able to produce accurate alerts.

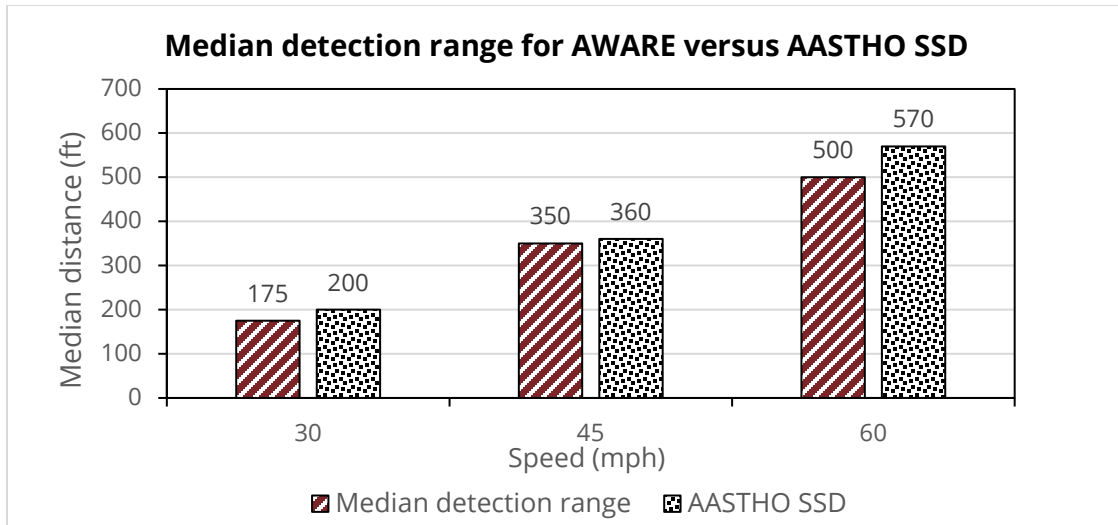
Figure 4-17. Detection range for the Sentry compared with AASTHO SSD

In WZIA technologies such as Intellicone, worker reaction time is a practical measure of a technology's ability to alert workers promptly. However, the Sentry is an advanced warning system, therefore, detection range of the system was evaluated as a substitute measure for worker reaction time in determining efficacy of the system. To determine detection range, a test vehicle was driven towards the Sentry at different test speeds. The exact location at which the sound alerts were activated on the Sentry was marked for each speed and the distance of the marked point from the Sentry was measured. Test speeds of 30 mph, 45 mph and 60 mph were considered. Results from the tests are shown in Figure 4-17. As expected, the observed detection range for the test speeds was found to be comparable to AASTHO SSD (equation (1) with $t=2.5$ seconds).

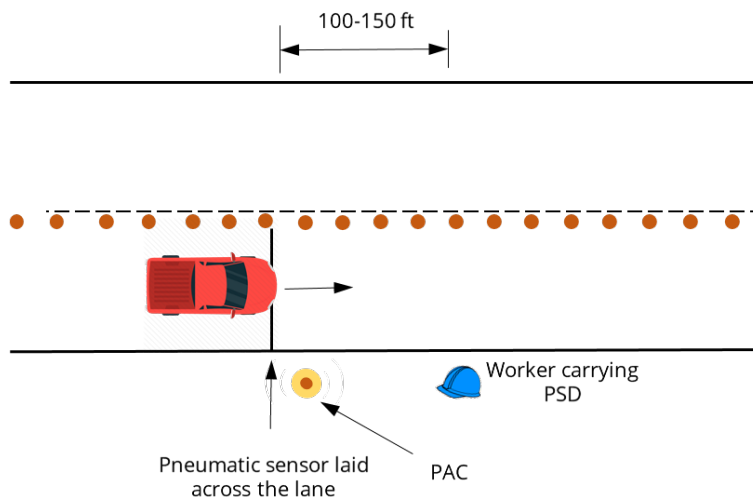
Figure 4-18. Experimental arrangement for testing WAS

The experimental procedure for evaluating the accuracy and work reaction for WAS was similar to that of Intellicone. As with Intellicone, a test vehicle was driven into a work zone set up with WAS to emulate intrusions. The field setup for the experiment is presented in Figure 4-18. The pneumatic sensor hose was laid across the lane closure with the PAC next to it. A worker carrying a PSD was placed at 100 ft from the sensor and instructed to react to alert on the PSD. The experiment was conducted using test speeds of 30 mph and 45 mph. Alarm activation and worker reaction were then recorded for the test speeds. The experiment was repeated with the worker placed 150 ft away from the sensor. A dump truck was used as the test vehicle for the experiments (Figure 4-19) to ascertain the durability of the sensor in the presence of a heavier vehicle.

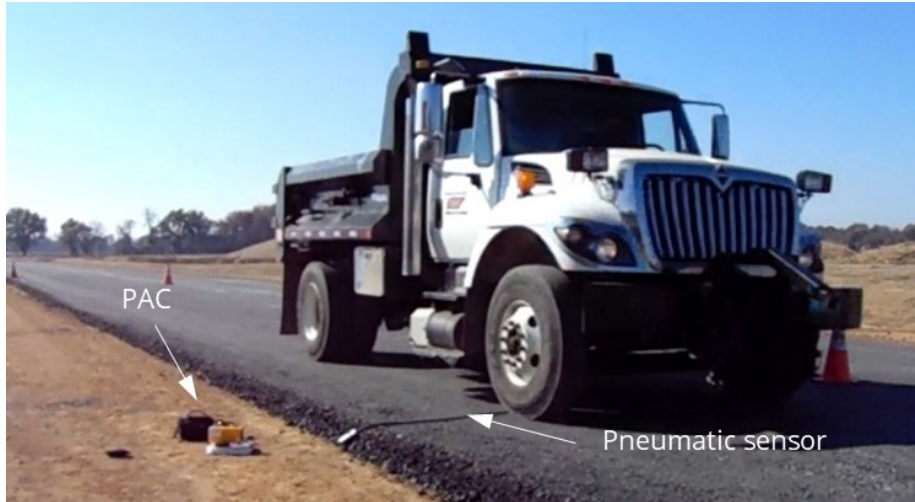
Figure 4-19. Test vehicle running over the pneumatic sensor

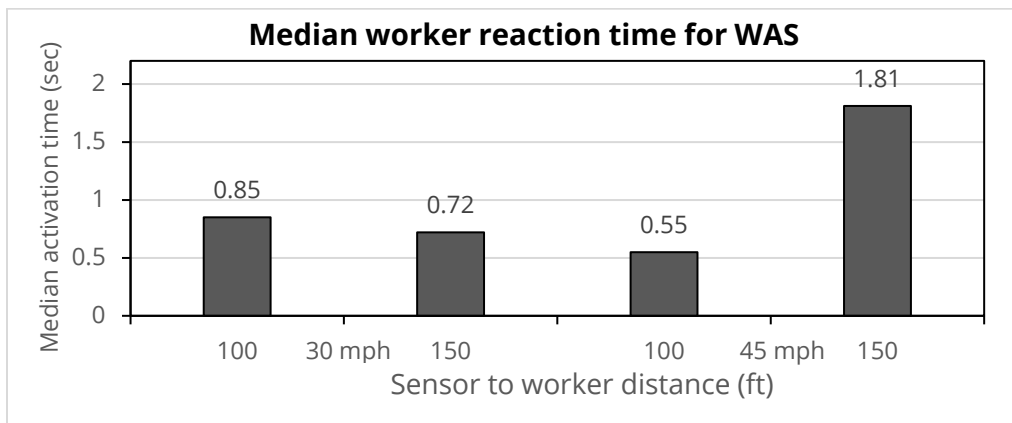
Figure 4-20. Observed worker reaction time

Result from the experiments on alarm activation are represented in TABLE 4-9. The experiment suggested that the transmission of signals from the pneumatic sensor to PSD was unreliable beyond 100 ft. When the distance between the two was greater than 100 ft, the accuracy of alerts was reduced.

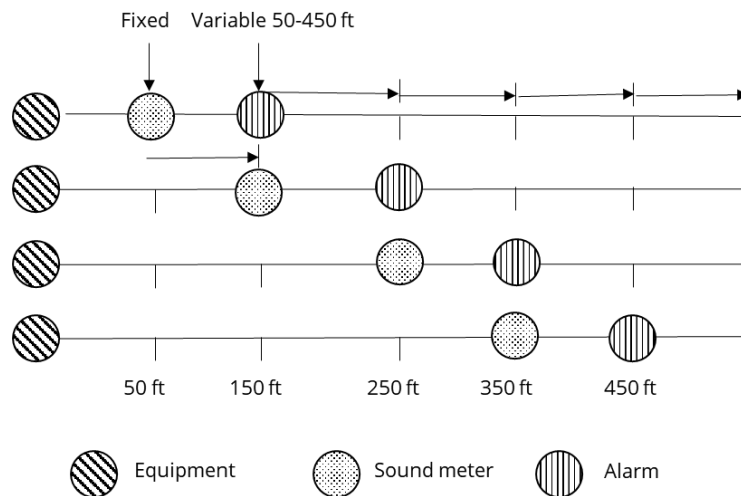
Figure 4-21. Experimental arrangement for evaluating sound intensity in presence of equipment: Scenario 1

In this scenario, the idling backhoe was fixed permanently at a point. With the sound meter temporarily fixed 50 ft away from the backhoe, the alarms were moved at 50 ft increments away from the sound meter. At each incremental distance, the sound intensity of alarms was measured up to 450 ft. The same procedure was repeated after moving and fixing the sound meter at 50 ft intervals away from the backhoe. Figure 4-21 presents the experimental procedure.

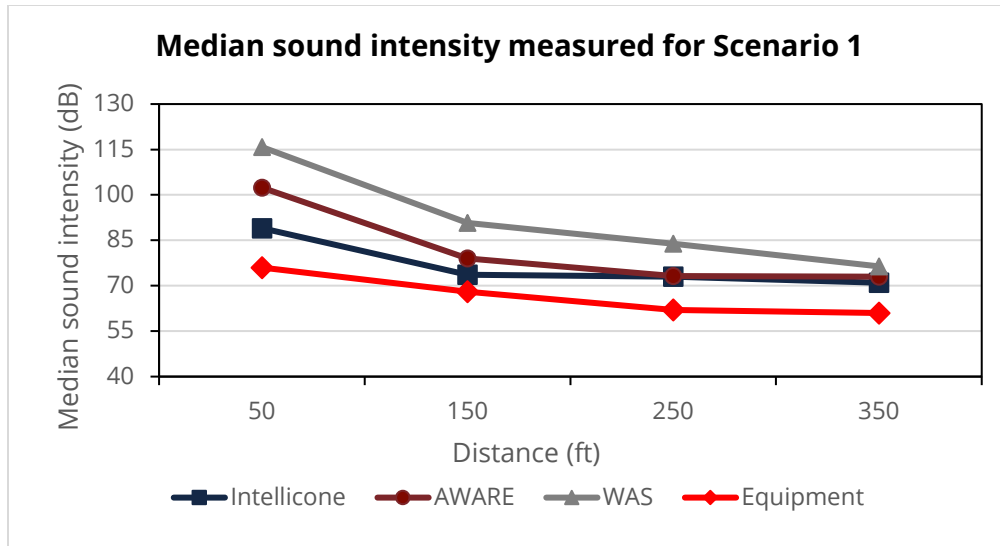
Figure 4-22. Results from experimental evaluating sound intensity in presence of equipment: Scenario 1

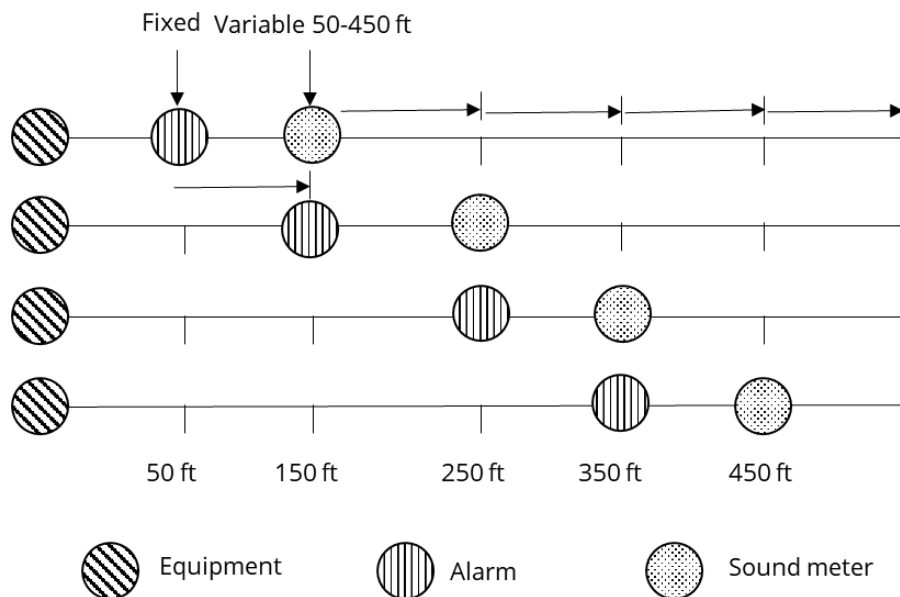
Figure 4-23. Experimental arrangement for evaluating sound intensity in presence of equipment: Scenario 2

A similar procedure to scenario 1 was adopted for the second scenario with one key difference. In the second scenario, the sound meter was temporarily fixed in place of the sound meter. Figure 4-23 outlines the experimental procedure followed for this scenario.

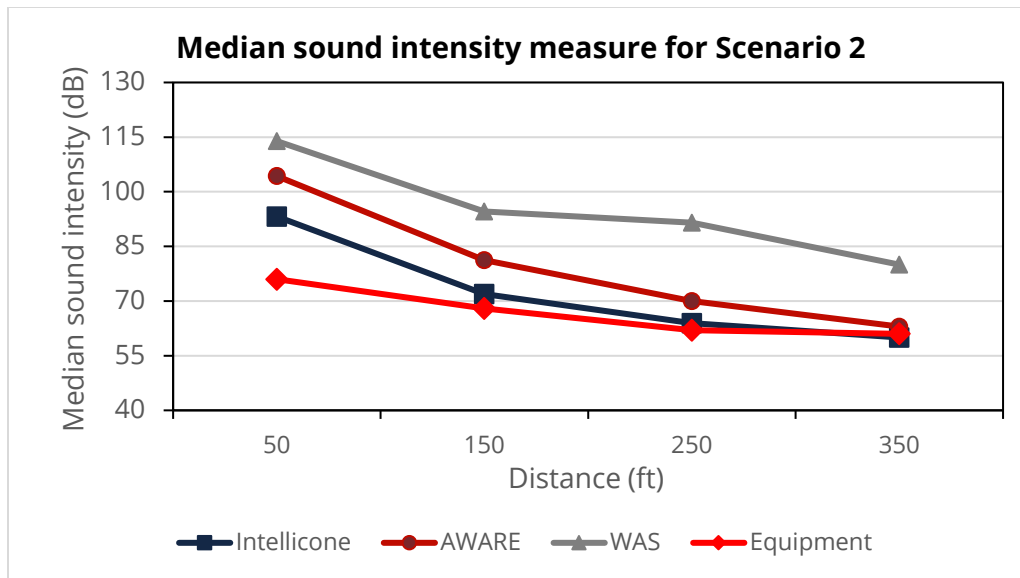
Figure 4-24. Results from experimental evaluating sound intensity in presence of equipment: Scenario 2
