Work Zone Alert Systems

Research Final Report from the University of Memphis | Sabysachee Mishra, Mihalis M. Golias and Diwas Thapa | April 1, 2021

Sponsored by Tennessee Department of Transportation Long Range Planning
Research Office & Federal Highway Administration

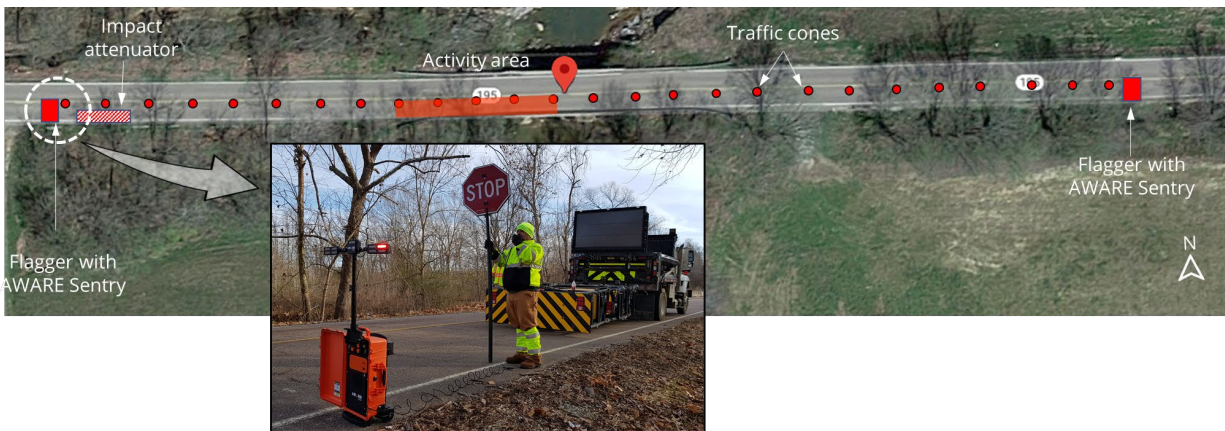
Figure 4-25. Project 1: Arrangement of AWARE Sentry

A bridge repair operation was being undertaken on a bridge deck on TN-195. The roadway consisted of a two-lane road (one lane in each direction) with narrow shoulders. The bridge deck was located at a lower elevation than the roadways connected to it in either direction. Therefore, vehicles needed to travel on a downgrade while approaching the work site and on an upgrade after crossing it. The eastbound lane on the road was closed for the duration of the repair and flaggers were deployed on both ends of the work zone to control traffic. The length of the lane closure was approximately 300 ft in either direction of the activity area. Two crews were working on the project, a seven-member crew for bridge repair and a four-member crew for flagging. An impact attenuator was used by the flaggers on the downstream end of the lane closure. Considering the need for flaggers, AWARE Sentry was chosen for testing. Figure 4-25 presents a layout of the work site.

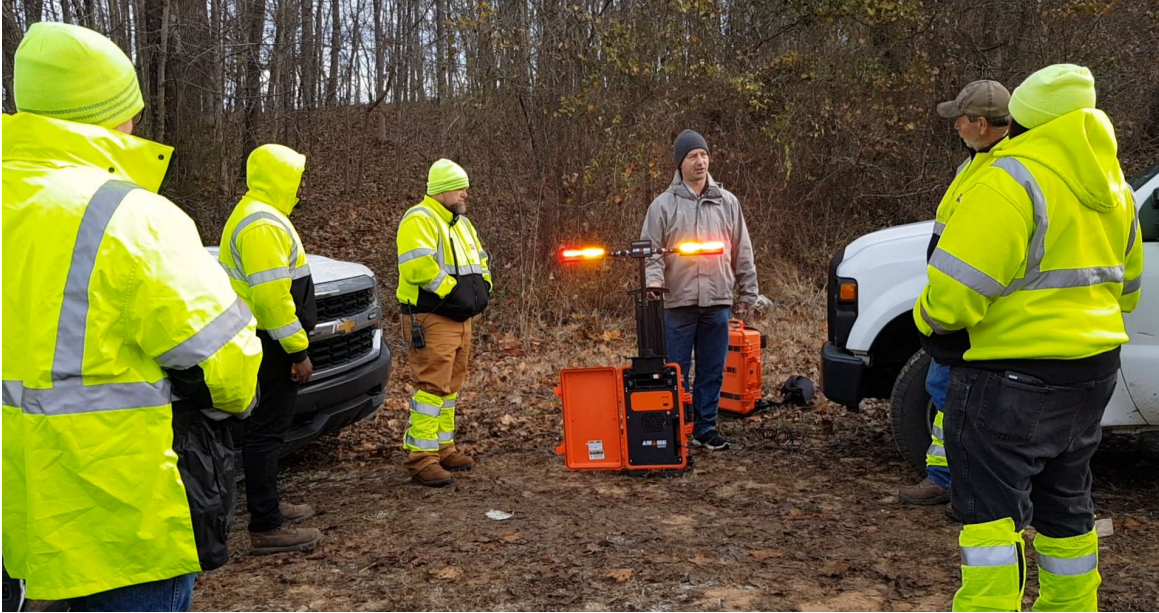
Figure 4-26. Project 1: A company representative providing an overview of the Sentry

The research team, along with a representative from the manufacturing company provided a 5-minute overview of the Sentry to the flaggers. The flaggers were shown the procedure for arming and disarming it when restricting and allowing vehicle to pass through, respectively. One Sentry was provided to each flagger positioned at the ends of the work zone closure. Worktrax personal alarms were distributed to the flaggers. No speed limits were posted within 1 mile of the work area; therefore, the Sentry was set up with a speed limit of 30 mph since vehicles approaching the work site encountered a downward grade. During the duration of the work, a video camera was set up close to the flaggers to record the reaction of drivers while they are approaching the Sentry. After completion of the project, a paper survey and a short interview was administered to the flaggers.

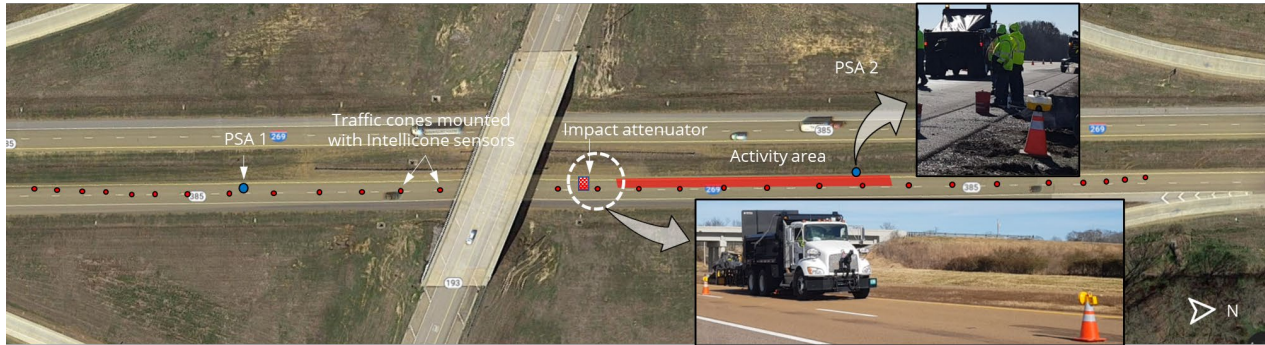
Figure 4-27. Project 2: Arrangement of Intellicone components

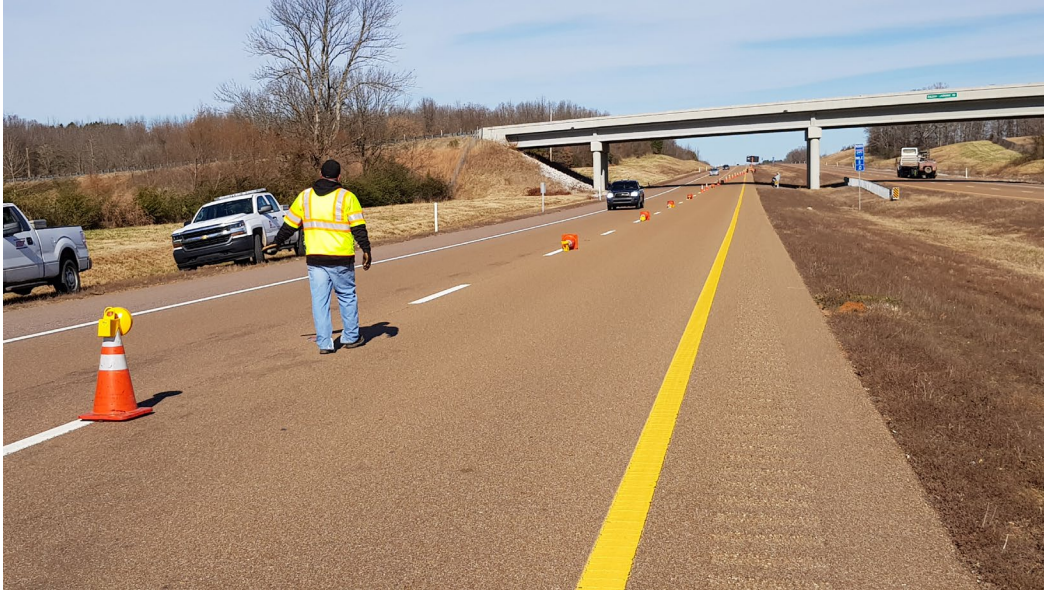
Figure 4-28. Project 2: Traffic cones knocked down by gusts from passing vehicles

Workers had mixed opinions on Intellicone. While the workers were optimistic about its ability to mitigate crashes, they were concerned about its effectiveness in the setting they were being tested. False alarms were frequently encountered during the testing as the traffic cones were knocked down several times by gusts from passing trucks (see Figure 4-28). To prevent this, the site supervisors suggested that the sensors could be mounted sideways to reduce the air resistance and prevent them from falling over. Although this prevented some false alarms, they could not be entirely avoided. Workers also suggested that false alarm could be reduced by making the cone mounted traffic cones more stable by lowering its center of gravity by allowing the sensors to mount further down the cones.

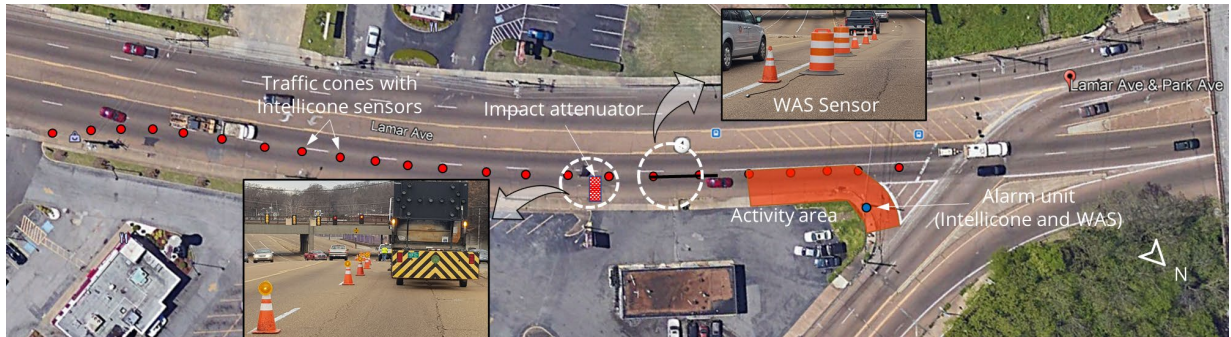
Figure 4-29. Project 3: Arrangement of Intellicone and WAS components.

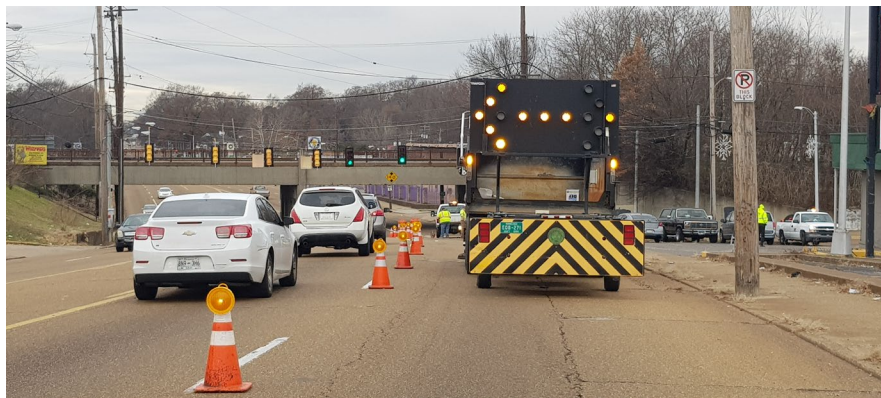
Figure 4-30. Project 3: LEDs on Intellicone sensors

A TDOT supervisor inspecting the work site reported that the traffic cones mounted with sensors made them more visible than conventional traffic cones as seen in Figure 4-30. Of the two attempts made to activate Intellicone alarms intentionally, only one was successful. Both attempts to activate alarms on WAS were successful. Sound alarms from Intellicone and WAS were clearly audible to the workers even when operating machinery. Workers also reported that the vibration from the PSD was noticeable, except when operating a concrete breaker.

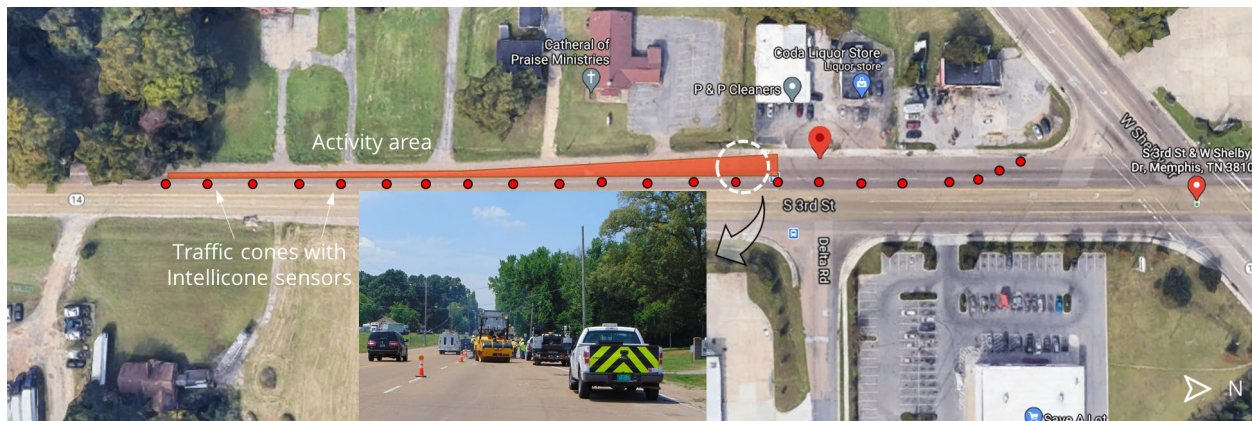
Figure 4-31. Project 4: Arrangement of Intellicone components

An asphalt resurfacing project on a four-lane (two lanes in each direction) section of South 3rd St. in Shelby county was chosen as the next project for live testing. About 1500 ft of the right southbound lane was closed to traffic as shown in Figure 4-31. The work was being undertaken by a private contracting firm and was overseen by a TDOT supervisor. Heavy machines, including an asphalt paver and a roller compactor, were actively used in the activity area. During maintenance, workers would typically pour concrete, use rollers to compact it and move to a new location further downstream to work on the next area. This necessitated a work zone to be set up over a long section of the newly resurfaced road. Considering the length of lane closure and duration of work, Intellicone was chosen for testing in this location.

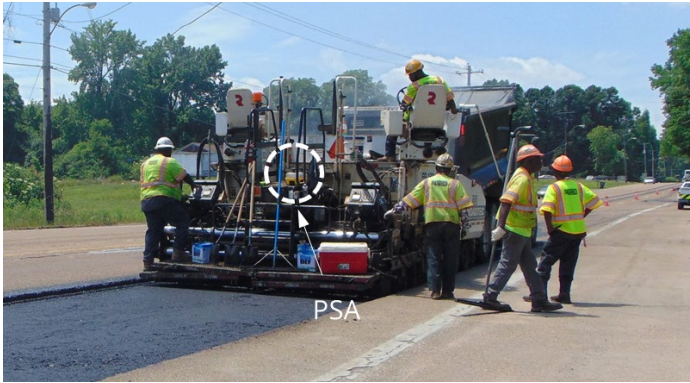
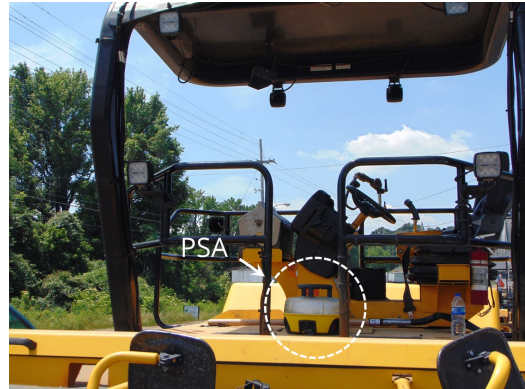
(a) PSA on a paver

(b) PSA on a roller compactor

The work crew was first briefed on the objective of the study and then provided instructions on Intellicone setup. The sensors were installed on the traffic cones with the help of the crew while the lane closure was being setup. Since the workers were using loud, heavy equipment and constantly moving, PSAs were placed on the equipment as shown in Figure 4-32. To prevent false alarms due to vibrations from nearby equipment, the crew was instructed to remove nearby sensors before they began working with heavy equipment and reinstall them before moving to a new location after the work was completed. After the testing was completed, a follow up interview was conducted on the workers.

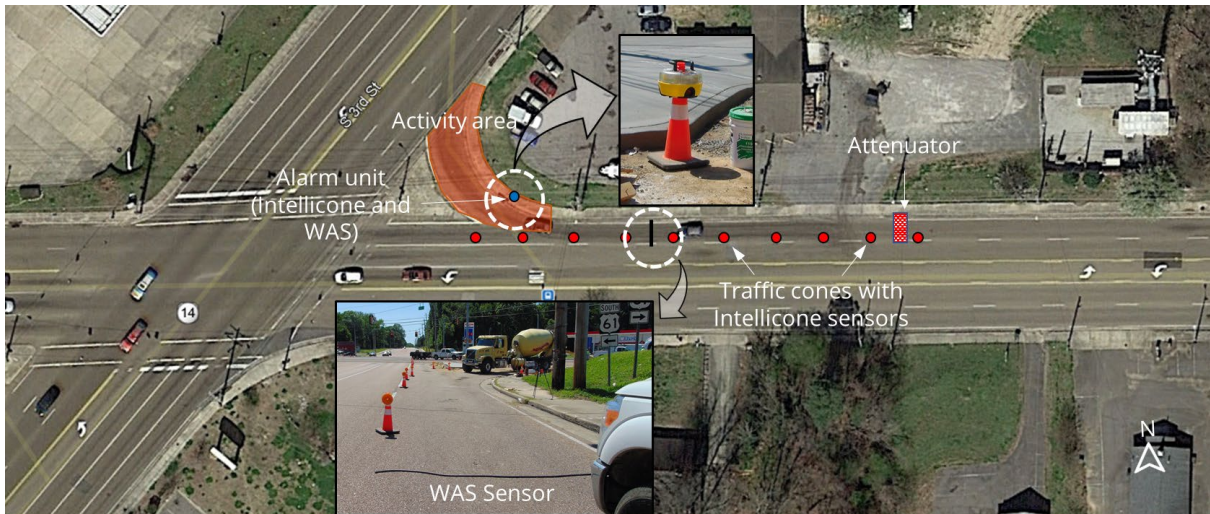
Figure 4-33. Project 5: Arrangement of Intellicone and WAS components

Similar to the procedure followed on earlier live tests, Intellicone and WAS were tested successively after providing a brief overview of the technologies. Since no intrusions were detected, alerts were deliberately triggered on the alarm units to gather worker reaction and feedback.

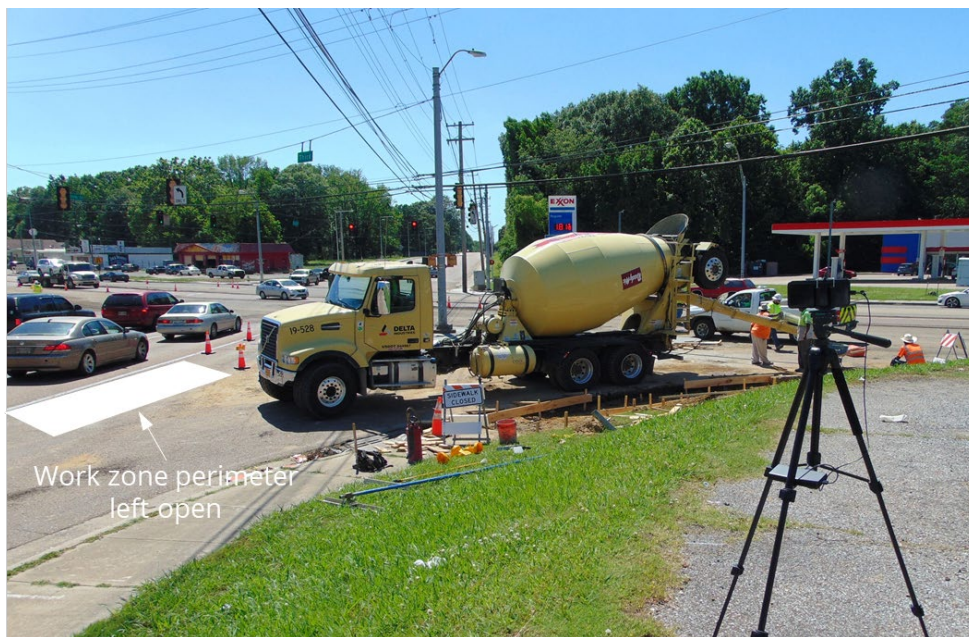
Figure 4-34. Project 5: Work zone perimeter left open

Survey and follow up interviews revealed similar findings to those of previous project. Workers expressed reluctance towards using the technologies, mainly due to the time involved in their setup. Since the nature of the work entailed working close to the traffic, according to the workers, their effectiveness was questionable. This was particularly relevant for Intellicone since the work traffic cones needed to be moved frequently to allow concrete mixer trucks into the work area. Although the workers were initially accepting towards using Intellicone, frequent false alarms when moving the cones resulted in workers ignoring the alarm sounds altogether and leaving the work zone perimeter open to avoid any further alarms.

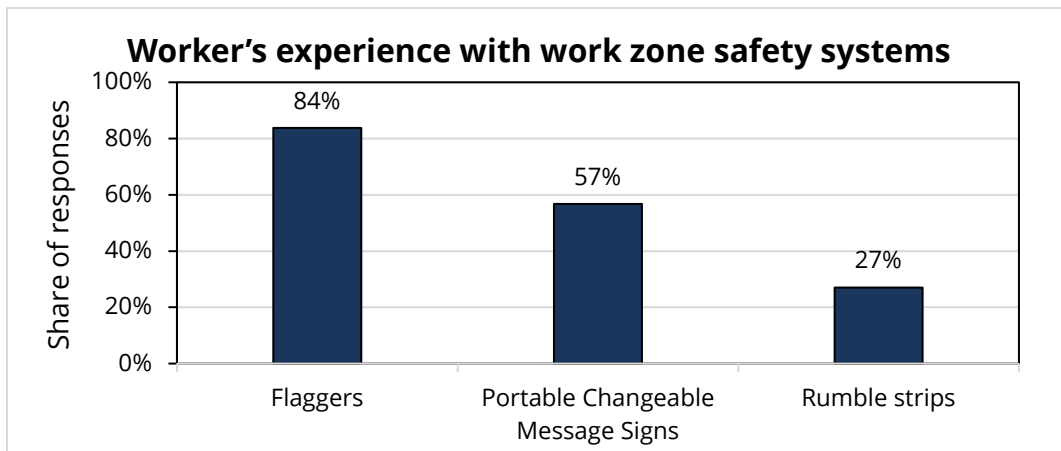
Figure 4-35. Workers' response: Prior experience with work zone safety systems

Reponses from on-site surveys suggested that most of the workers surveyed had some prior experience with at least one work zone safety system. The majority of workers reported familiarity with flagging operations followed by portable changeable message signs, and rumble strips.

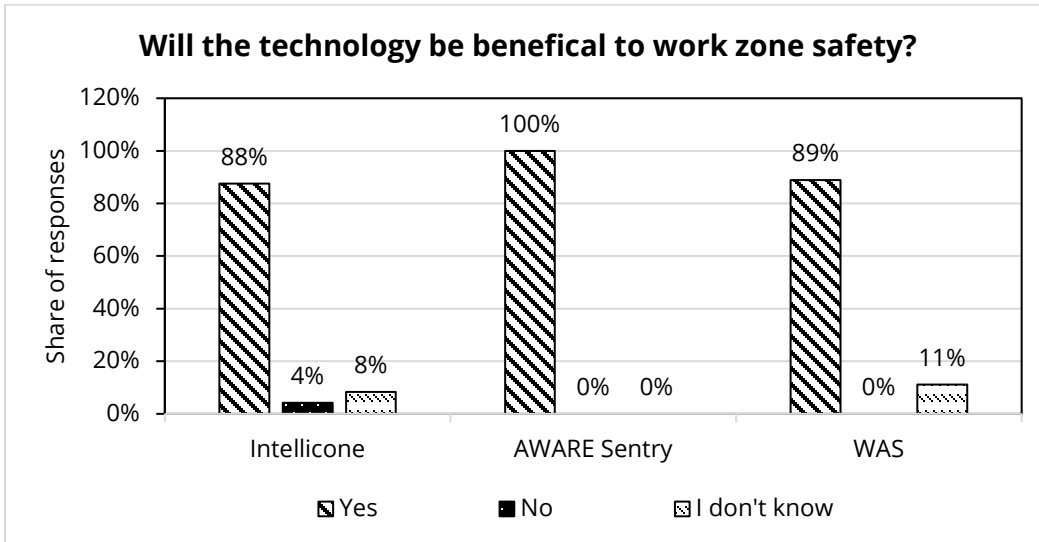
Figure 4-36. Workers' response: Effectiveness of systems

In response to the technology's potential to benefit work zone safety, workers were mostly optimistic. Flaggers found AWARE to be very effective (100%). A small portion of workers were doubtful regarding Intellicone (4%) while some workers were unsure whether Intellicone (8%) and WAS (11%) would be beneficial.

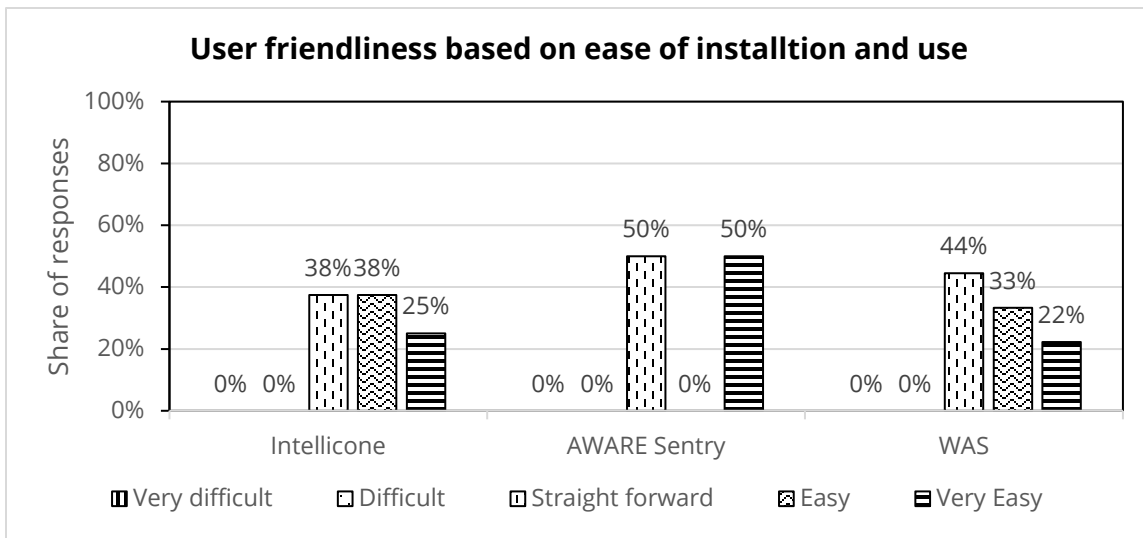
Figure 4-37. Workers' response: User friendliness

Overall, installation of the three technologies was convenient according to the workers. Responses indicated that all the systems were perceived to be user friendly to install and use.

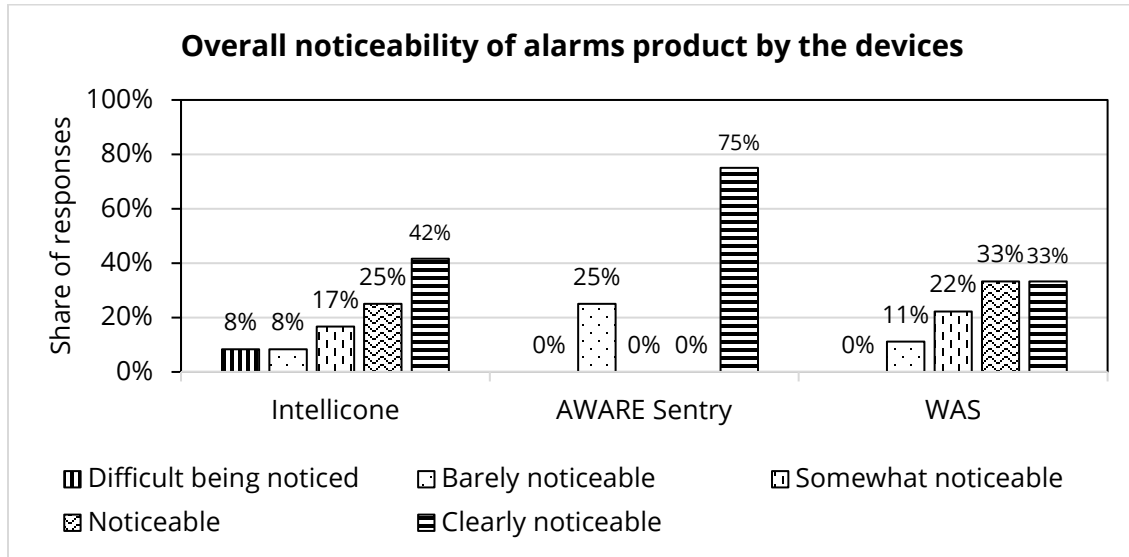
Figure 4-38. Workers' response: Noticeability of alarms

No considerable issues related to the noticeability of alarms was observed from experiments carried out on the technologies during controlled and live testing. Additionally, workers were also found to be generally content with the noticeability of alerts produced by the devices.

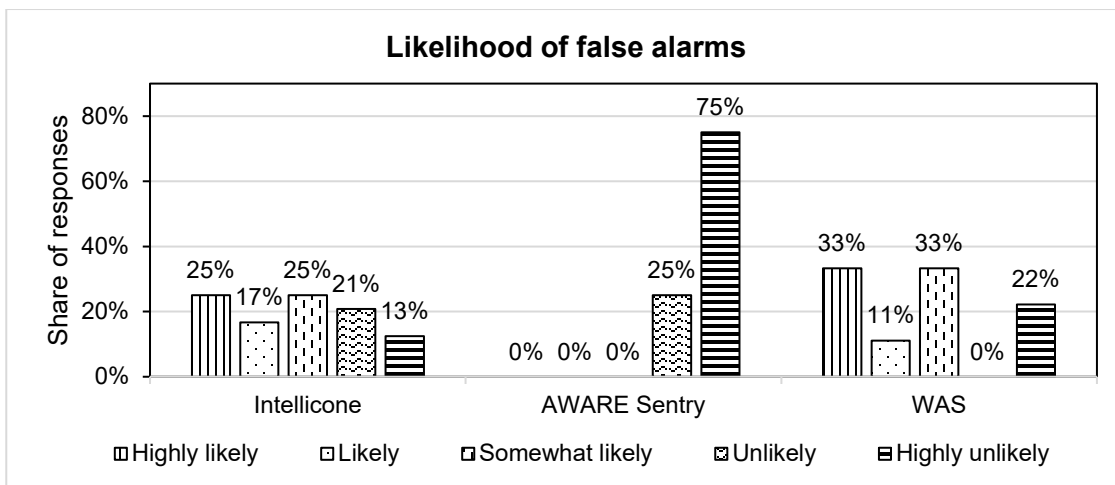
Figure 4-39. Workers' response: Likelihood of false alarms

Workers expressed that Intellicone and WAS were more likely to cause false alarms compared to the Sentry.

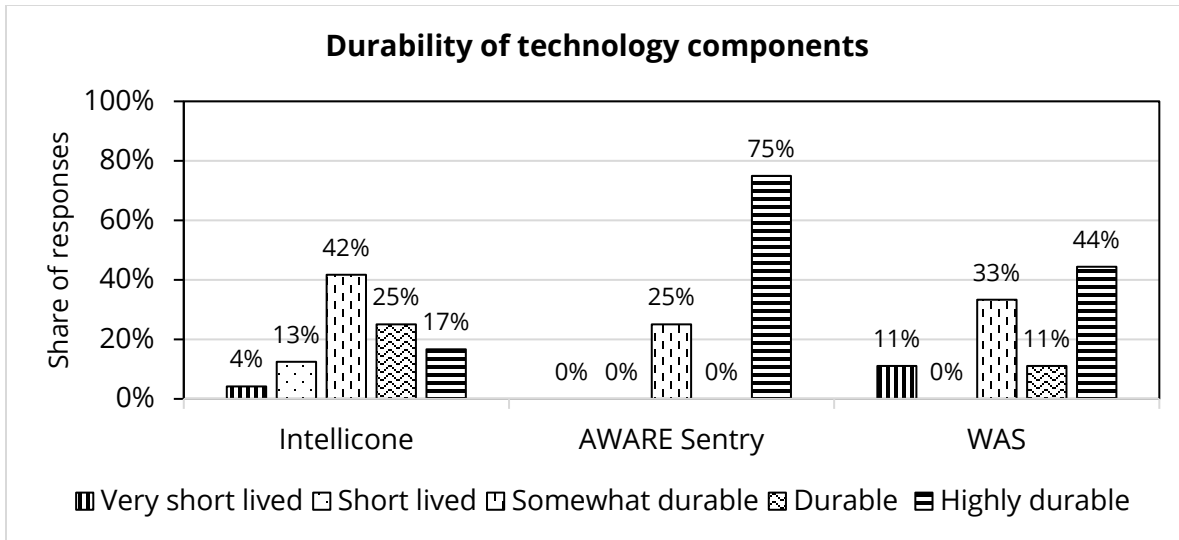
Figure 4-40. Workers' response: Durability of systems

Although workers in general believed the components of all three technologies were durable. In comparison to the Sentry, Intellicone and WAS were perceived to be less durable.

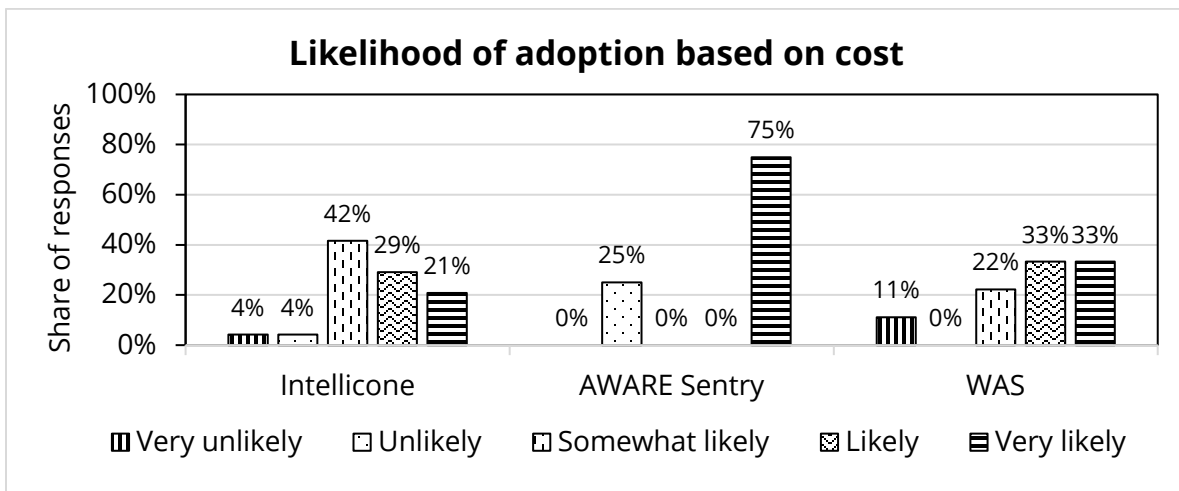
Figure 4-41. Workers' response: Adoption considering cost of the technology

Despite the high prices, workers believed that the technologies should be implemented on work zones.

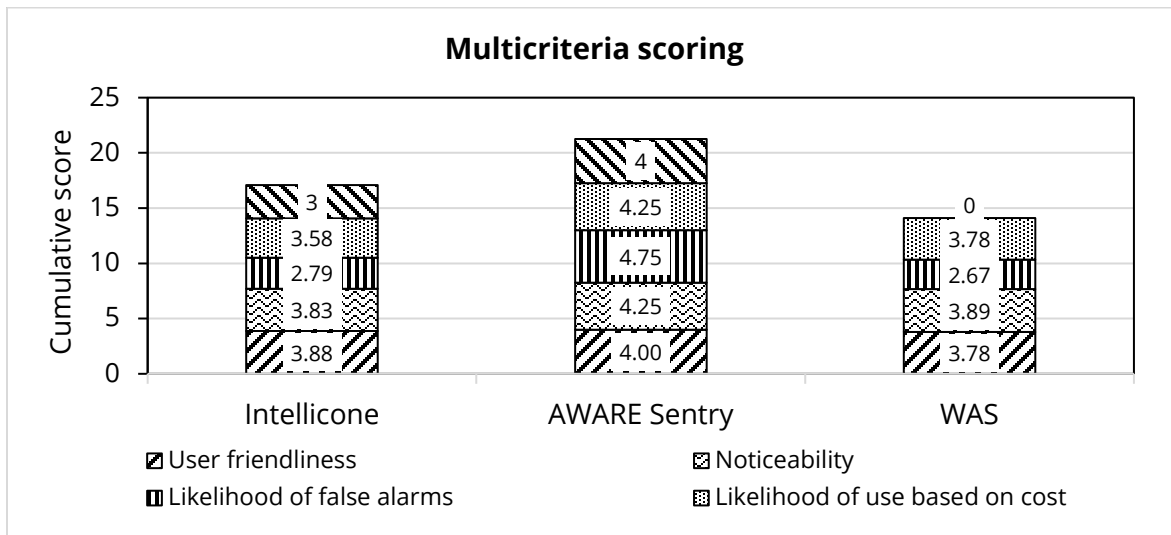
Figure 4-42. Multicriteria evaluation: Cumulative score of the systems

Worker responses from on-site surveys were used to score the first four criteria. Scoring of the last criterion was based on live tracking features presented in TABLE 4-12. The scores for the criteria is presented in TABLE 4-16 and presented in Figure 4-42. Of the three technologies, AWARE Sentry scored highest on multicriteria effectiveness. This is attributed to its higher scoring from surveys and also its live tracking abilities.
